7. GENERAL CONDITION SURVEY OF KEY SWALLOW HOLES – BLACKROCK TO KINVARRA AREA

7.1 SCOPE OF THE SURVEY

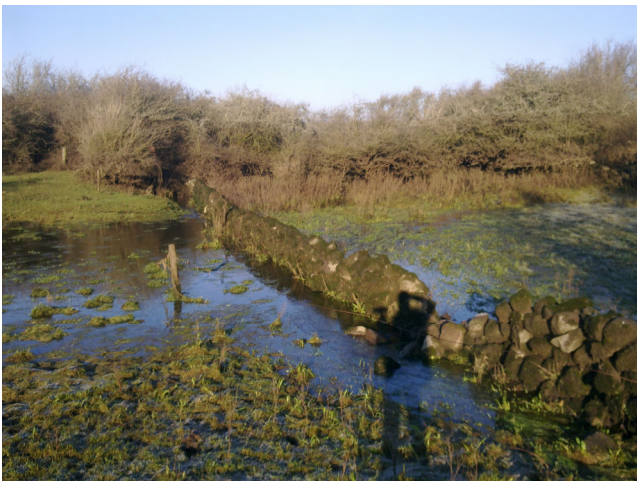
*Figure No.7.1 – Loughcurra South sink hole
Stone wall restricting the flow*

As can be seen above, a stone wall is located within the channel leading to the swallow hole and may be causing restrictions in flows. A significant amount of material is located on the right bank of the channel immediately upstream from the karstic feature which could be washed away by floods and partially block the entrance of the swallow hole.

Fencing of the swallow hole should be discussed with the landowner. Left and right banks of the channel leading to the swallow hole should be cleared from material. The length to be cleared is approximately 250 metres. Overgrown vegetation around the sink should also be cleared.

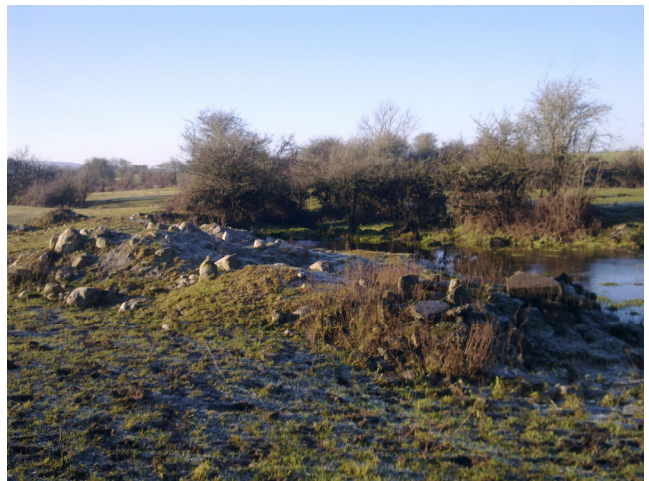
*Figure No.7.2 – Loughcurra South sink hole
Evidence of ground works – right bank of the
channel leading to the swallow hole*

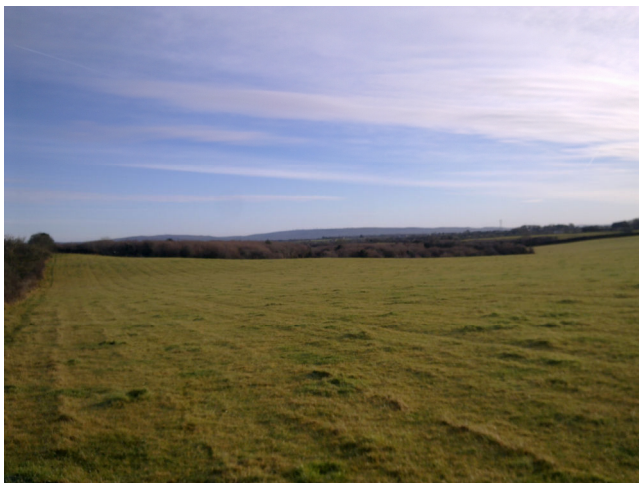
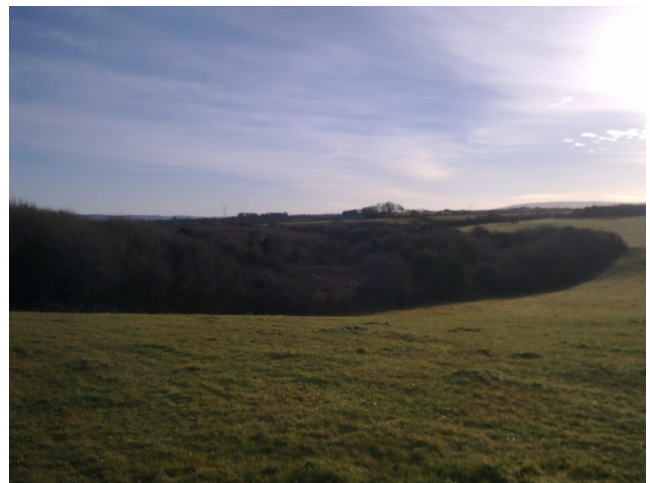
*Figure No.7.3 – Ballybuck North
Surveyed Area*

As part of the April 1998 South Galway Flood Study Report, swallow holes were listed and located on maps. Records show that a swallow hole is located at Ballybuck North however, on the day of the survey, the sink could not be found and no evidence of water running was observed. The area is overgrown as can be seen above and the feature could be hidden by

the vegetation. Further investigation is required and the vegetation could be cleared in order to find the sink.

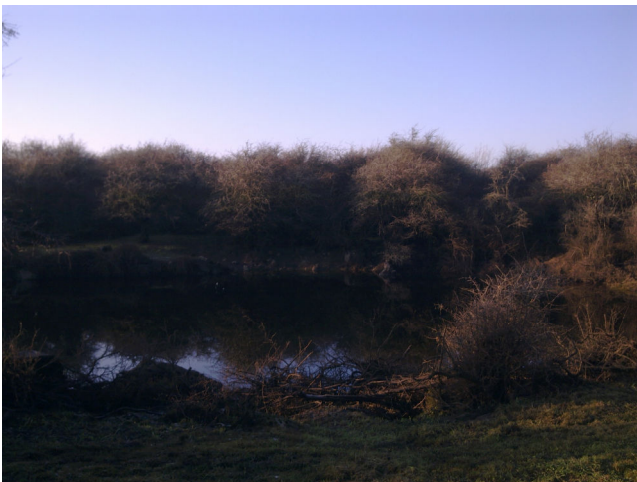
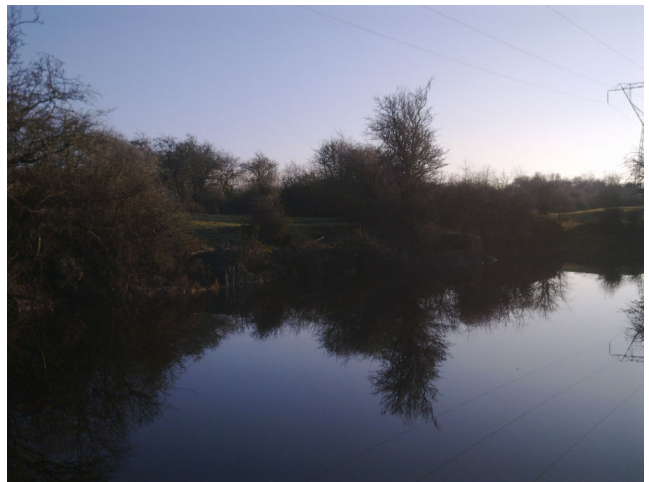
Figure No.7.5 – Pollnamona sink

This pond is surrounded by dense vegetation. It is recommended that the area including the pond be cleared of debris and that bushes and wood lying on the banks be removed. Fencing off the area should also be discussed with the landowner.

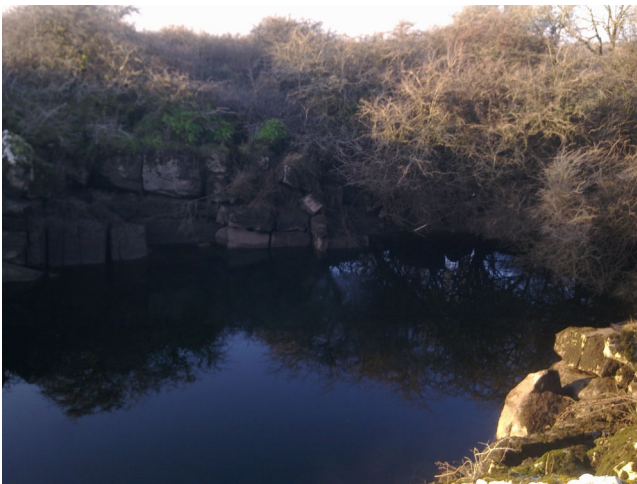
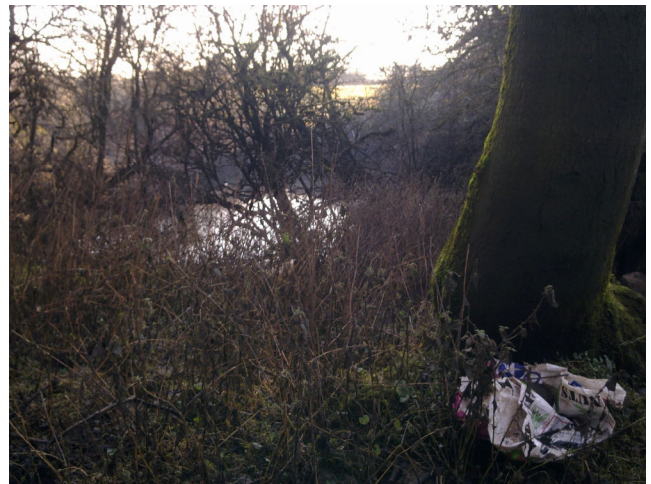
Figure No.7.7 – Polldalagha sink

This pond is located 150 metres east of Pollnamona sink. It is also surrounded by dense vegetation which should be cleared in the immediate vicinity of the pond to limit flow restrictions under flooding conditions. Debris and other material obstructing flow should be removed from the pond area. Fencing off the area should be discussed with the landowner.

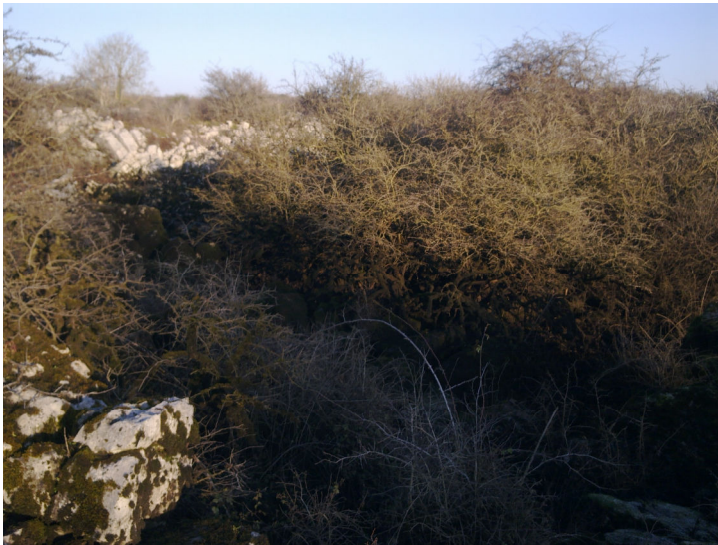
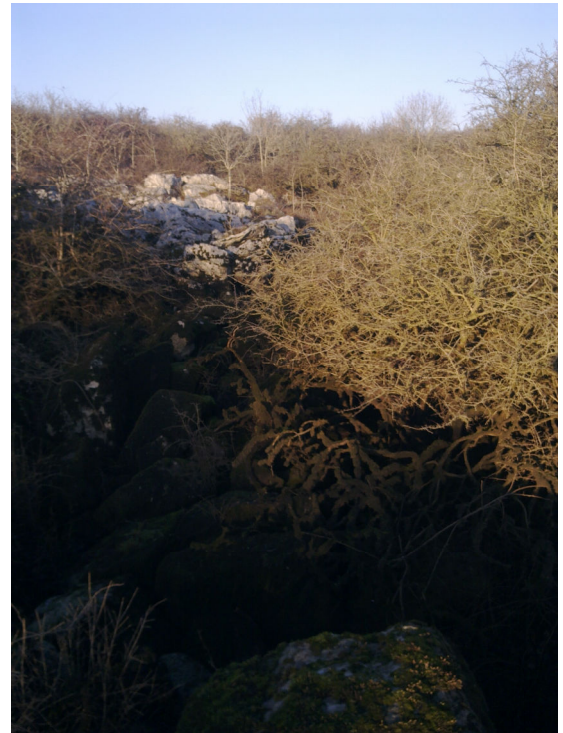
Figure No.7.9 – Area East of Polldalagha Pond

A significant flow of water was observed approximately 80 metres east of Polldalagha pond. Numerous boulders and dense overgrown vegetation made the identification of the outlet difficult however, the northerly direction of the flow suggests the presence of a significant sink hole in the area. It is recommended that boulders be removed to expose the channel path and the outlet. The channel path should also be cleared from the dense vegetation and fencing off the area should be discussed with the landowner.

Caherglassaun East of Polldalagha Sink	E140865 N206181	Poor	Numerous boulders restricting the flow of water. Boulders to be cleared. Fencing off the feature (when exposed) should be discussed with the landowner.
Caherglassaun Pollnapasty Sink	E141234 N206531	Moderate	Bushes / vegetation surrounding the basin to be cleared. Discussions with the landowner should take place to consider replacing the stone wall by post and wire fencing. Numerous plastic bags at the bottom to be cleared. Consideration should also be given to carrying out an underwater survey to assess siltation / bed condition.

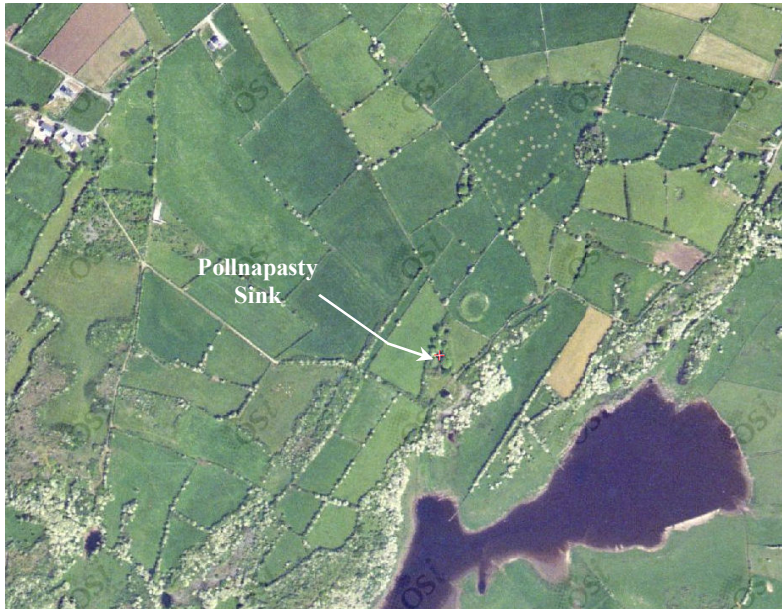
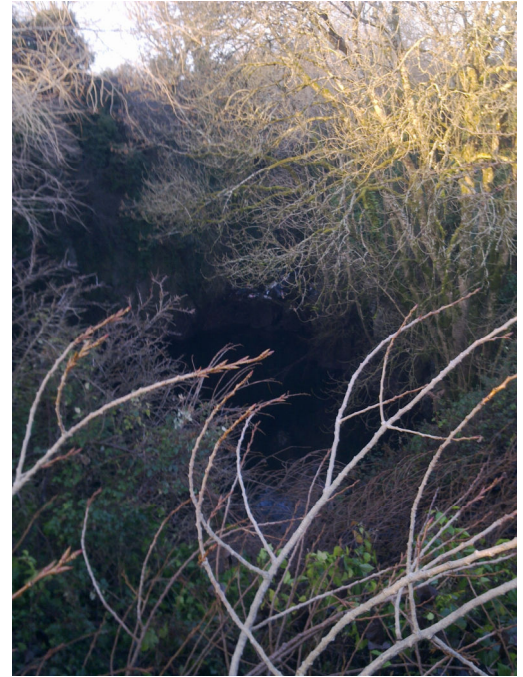
*Figure No.7.11 – Pollnapasty sink
Aerial photograph*

This swallow hole is a major outlet in the Caherglassaun area. The bottom of the sink could not be inspected as it is more than 10 metres deep with steep embankments. Dense bushes and trees surround the sink which made the inspection from the top difficult as little light could reach the bottom. Numerous plastic bags were observed on the northern embankments and should be cleared. It is recommended that trees, bushes and pieces of wood be cleared and that fencing of the area be discussed with the landowner.

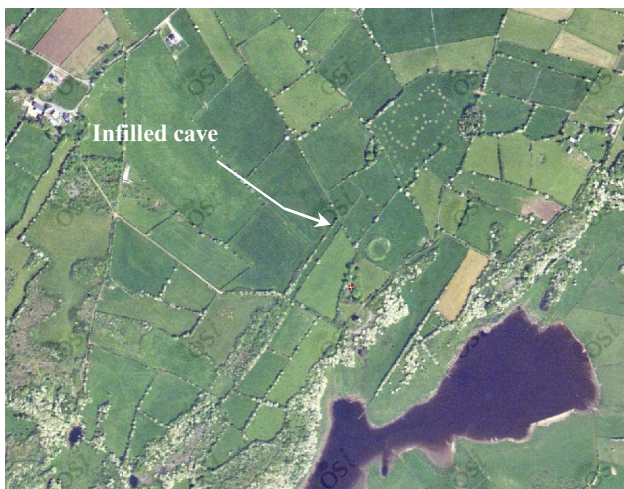
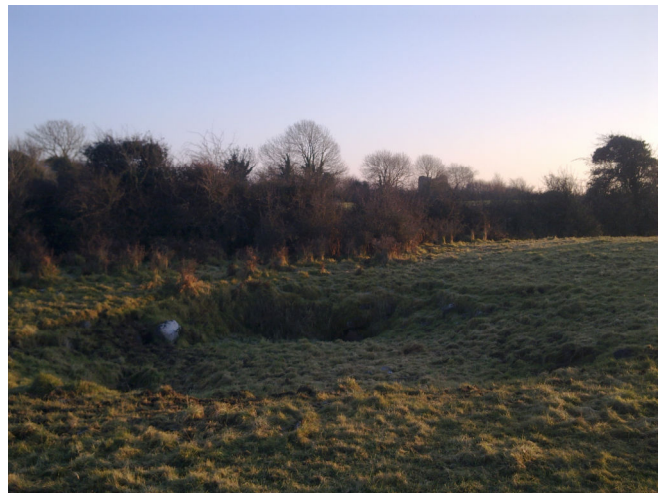
*Figure No.7.13 – Infilled cave
Aerial photograph*

This cave is located 150 metres north of Pollnapasty. It is currently blocked off. Evidence suggest that this cave is active and linked to Pollnapasty sink hole. It is recommended that the entrance be cleared and that fencing be discussed with the landowner.

Caherglassaun Infilled cave	E141185 N206674	Blocked	Cave likely to be linked to Pollnapasty only 150m to the southeast. Entrance of the cave located in a field. Entrance is blocked. To be cleared and further assessed. Fencing off the entrance should be discussed with the landowner.
Coole Lough Garryland North	E142141 N205128	Moderate	Surrounding lands are cleared from debris. Fencing off the area should be discussed with the landowner. Consideration should be given to carrying out an underwater survey to assess siltation / bed condition.
Kiltartan Pollomuiir Sink	E144722 N206056	Poor to moderate	Numerous debris / plastic bags / waste / wood on embankments and in the water. To be cleared. Fencing to be considered as well as an underwater survey to assess siltation / bed condition.
Kiltartan Pollonora Sinks	Refer to Section No. 7.2.6.2	Poor	Overgrown vegetation to be cleared. Fencing off each feature should be discussed with the landowners.

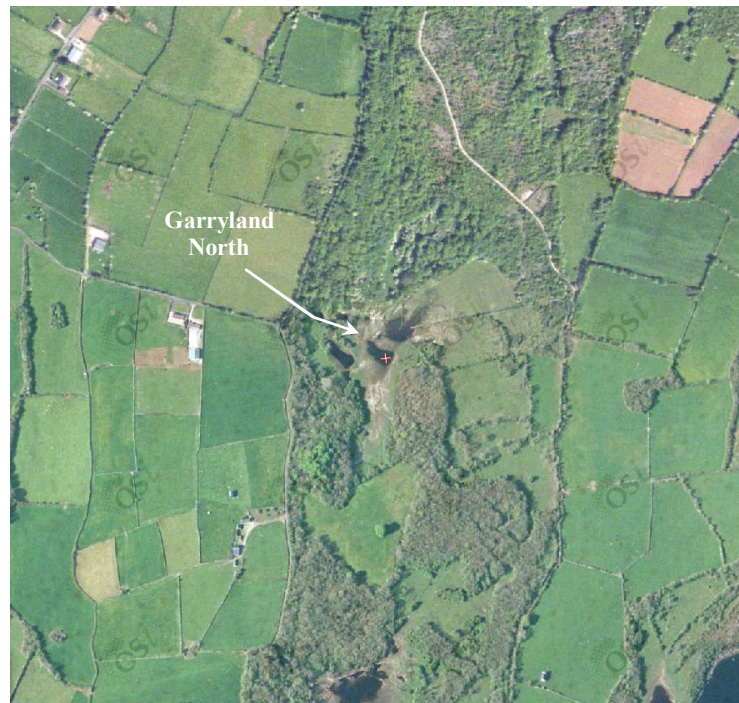
*Figure No.7.15 – Garryland North
Aerial photograph*

Records available as part of the April 1998 South Galway Flood Study Report show that an active karstic feature is located at Garryland North. On the day of the survey, water levels at Coole Lough were unusually low and did not reach the feature. The general condition in the area is considered good. Underwater water surveys to identify siltation levels and general bed conditions should be considered. Discussions should also take place with the landowner in relation to fencing.

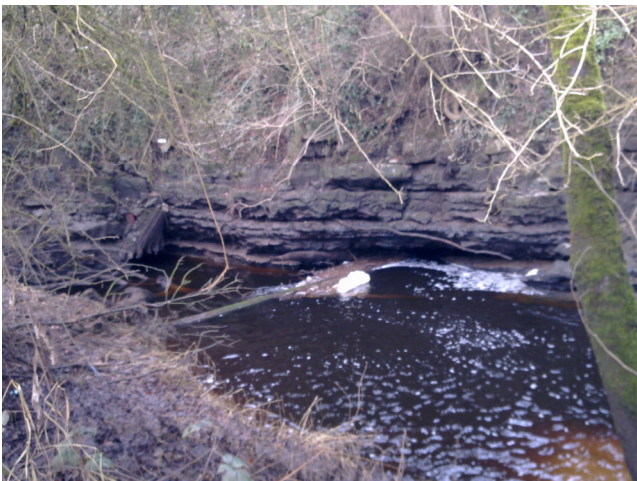
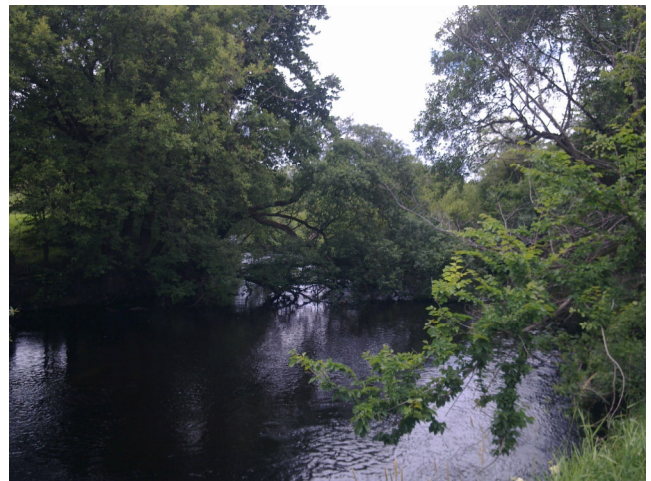
Figure No.7.16 – Pollomuiro sink

Pollomuiro sink hole is a major outlet at Kiltartan. The area is overgrown and it is recommended that the dense vegetation be cleared. Discussions should take place with the landowner in relation to fencing around the sink. Debris and other material should be cleared from the entrance to the swallow hole.

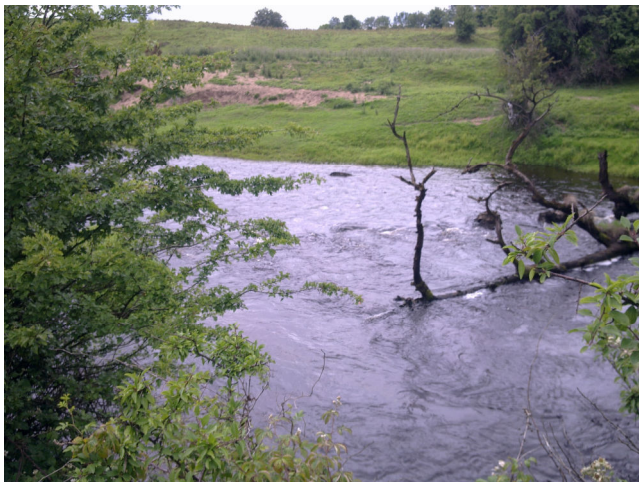
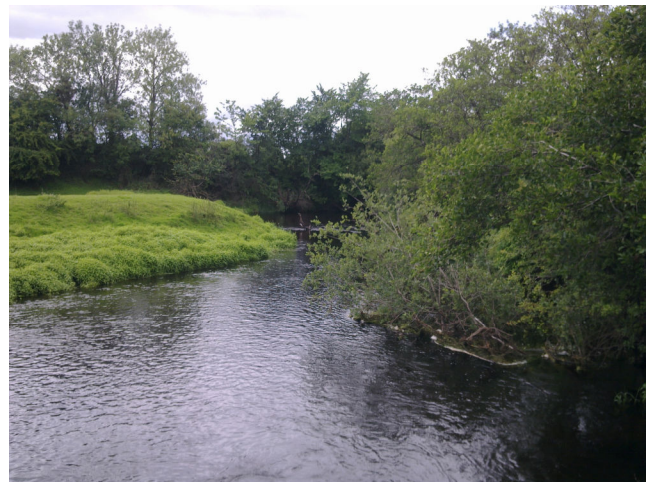
*Figure No.7.18 – Polldeelin rise to Pollomuiiri
sink overground channel*

The overground river channel upstream from Pollomuiiri should also be cleared from fallen trees and pieces of wood. The length of the channel to be cleared from the spring at Kiltartan (Polldeelin) to Pollomuiiri is approximately 700 metres. Further photographs of the channel are shown below :

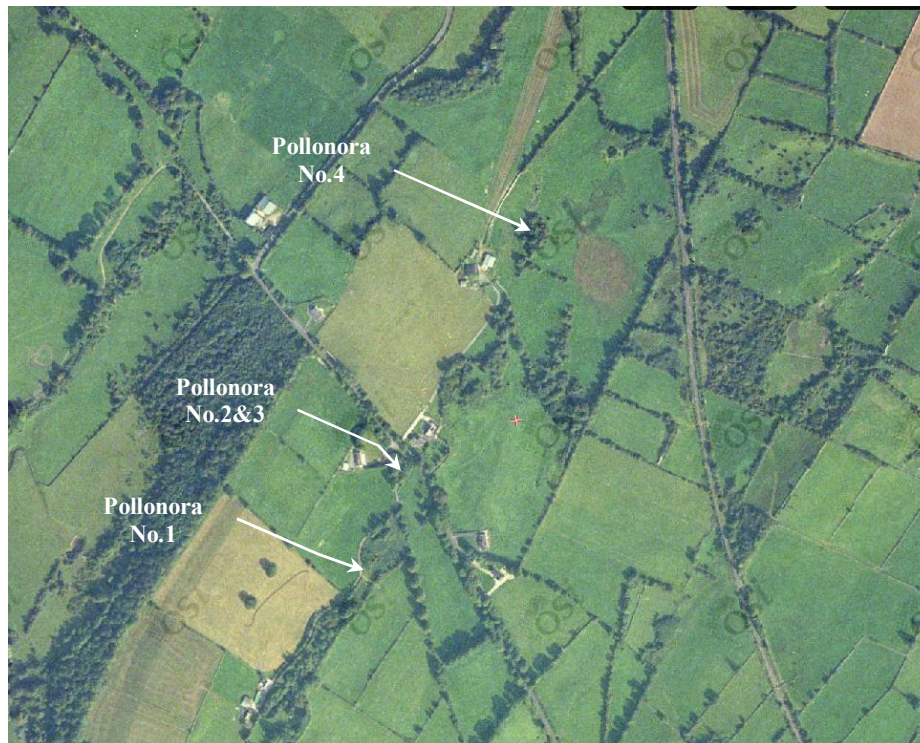
Figure No.7.20 – Pollonora Sinks

Pollonora sinks 1 to 3 could not be access and inspected as they are surrounded by dense vegetation. It is recommended that each site be cleared and that discussions take place with landowners in relation to fencing around the feature. Pollonora sink No.4 was inspected

and found to be active although the entrance of the sink was partially blocked by silt. It is also recommended that this sink be cleared.

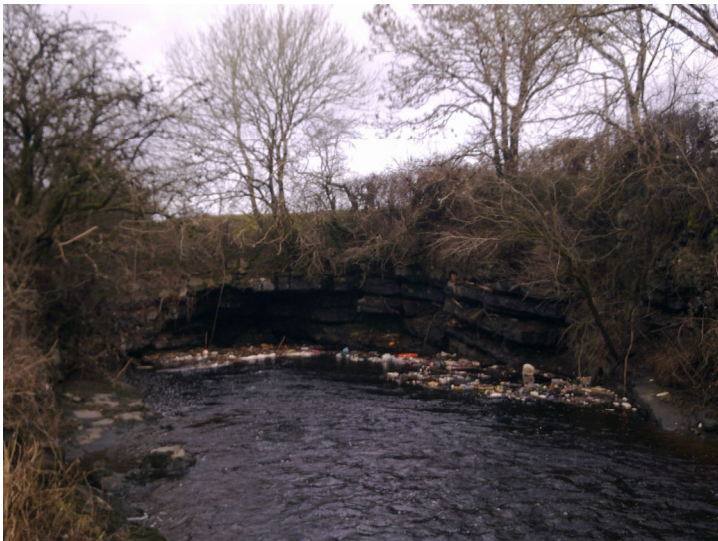
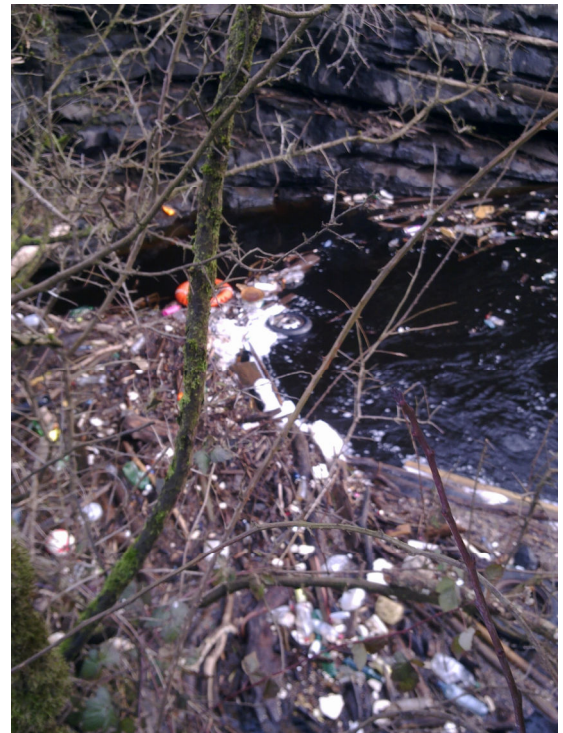
Figure No.7.21 – Polltoophil North

A significant amount of debris and waste can be seen floating in the water. This sink receives water from the Gort River and as a result, it is particularly prone to blockages from material washed away by the river within the Gort city area. It is recommended that

Castletown Polltoophil North Sink	E145921 N204888	Poor	Numerous debris / plastic bags / waste / wood on embankments and in the water. To be cleared. Fencing to be considered as well as an underwater survey to assess siltation / bed condition.
Castletown Polltoophil South Sink	E145973 N204731	Partially Blocked	Flow of water very low. Weedy growth / overgrown vegetation. Evidence of siltation. Fencing to be considered as well as an underwater survey to assess siltation / bed condition.
Ballylee South Pollaleen South Sink	E147514 N206135	Poor to moderate	Embankments to be cleared from bushes / wood. Fencing to be considered as well as an underwater survey to assess siltation / bed condition.
Ballylee North Pollaleen North	E148069 N206596	Poor to moderate	Embankments to be cleared from bushes / wood. Fencing to be considered as well as an underwater survey to assess siltation / bed condition.
Lough Coy	E149005 N207455	N/A Lake – consider underwater survey	Consideration should be given to carrying out an underwater survey to assess siltation / bed condition.

the water be cleared from floating debris and waste. Discussions should take place with the landowner in relation to fencing around the feature. Consideration should be given to carrying out an underwater survey to identify siltation issues / blockages / conditions of the bed.

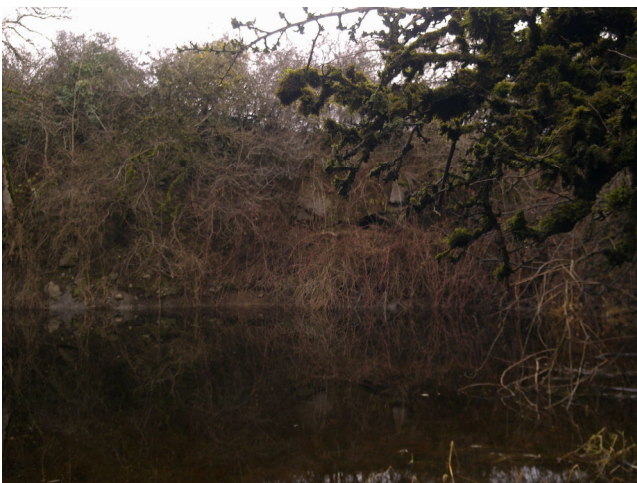
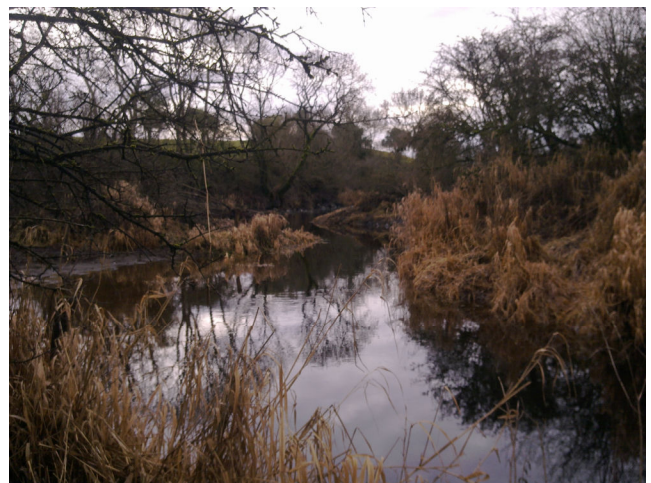
Figure No.7.23 – Polltoophil South

This sink is located 180 metres upstream from Polltoophil North on the Gort River. On the day of the survey, the flow to Polltoophil South sink was very low and most of the water from the Gort river was drained underground via Polltoophil North sink. As can be seen in the photographs above, the channel leading to the southern sink shows significant weed growth. It is recommended that the banks and inlet channel be cleared. Discussions should take place with the landowner in relation to fencing around the feature. Consideration

should be given to carrying out an underwater survey to identify siltation issues / blockages / conditions of the bed.

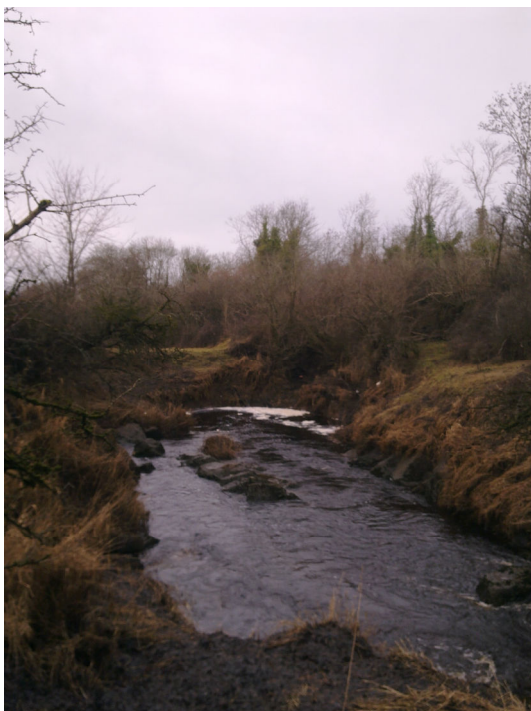
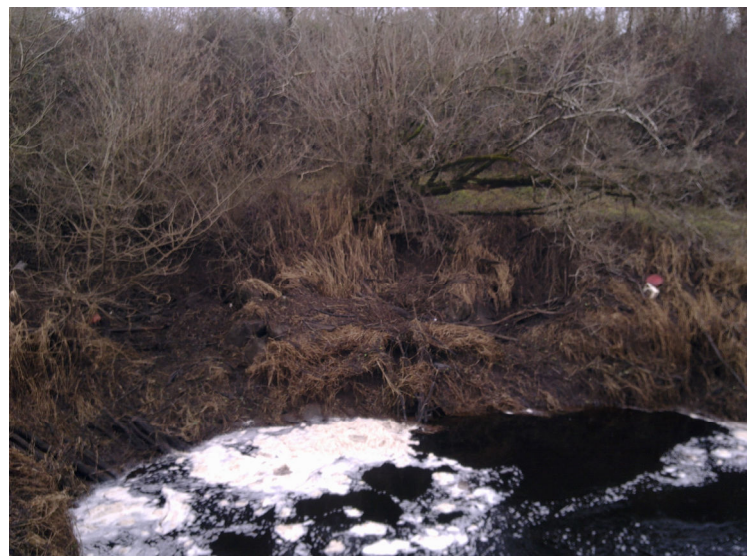
Figure No.7.25 – Pollaleen South

No significant amount of debris was found in the area surrounding Pollaleen South sink hole on the day of the survey. The upstream channel and banks show significant weed growth and it is recommended that weed be cleared. Discussions should take place with the landowner in relation to fencing around the feature. The flow capacity of this sink was

greatly exceeded during last November 2009 floods and excess flood waters overflowed to the sinks at Castletown and Kiltartan. Consideration should be given to carrying out an underwater survey to identify siltation issues / blockages / conditions of the bed.

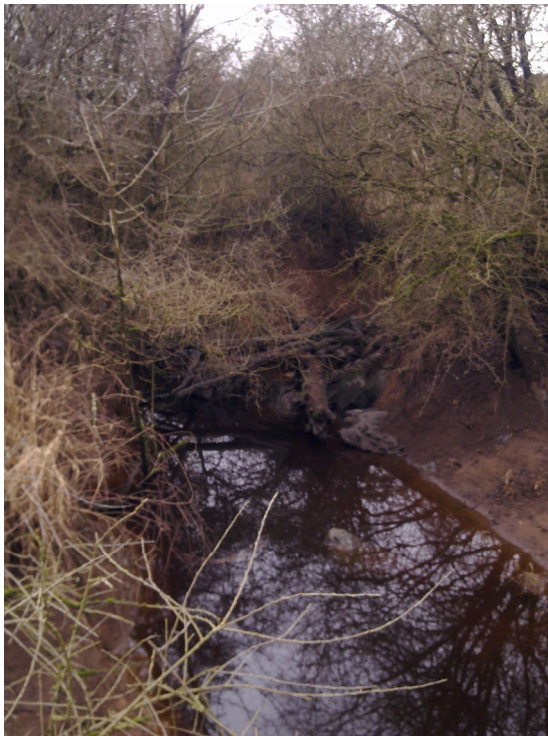
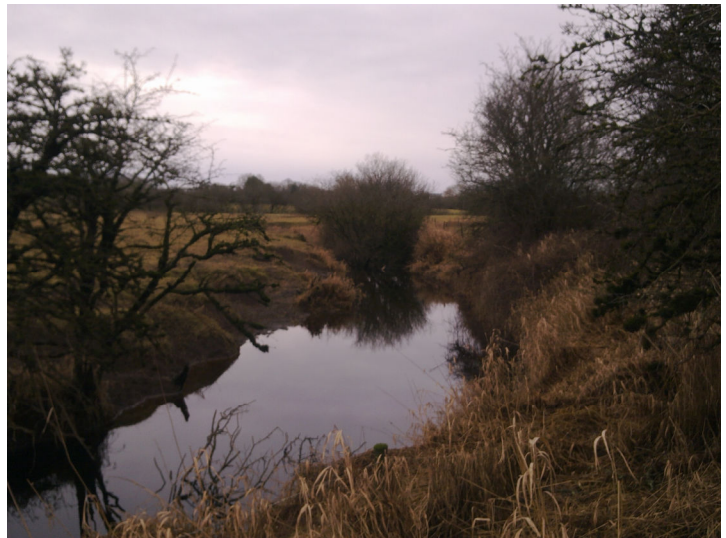
Figure No.7.27 – Pollaleen North

On the day of the survey carried out on the 11th of January 2011, there was little or no flow at this location. This hole is surrounded by dense vegetation. It is recommended that the area be cleared from bushes and pieces of wood lying on the banks. Discussions should take place with the landowner in relation to fencing around the feature.

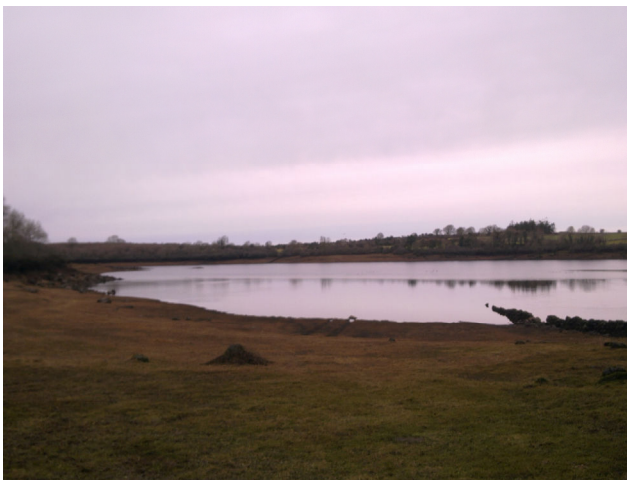
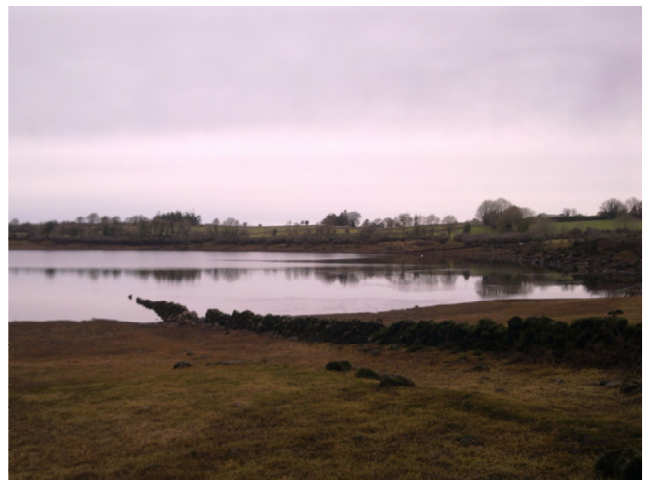
Figure No.7.29 – Lough Coy

The area surrounding Lough Coy was found to be in good condition. Consideration was given to fencing off the lake to prevent cattle from disturbing the grounds in the immediate vicinity of the lake but was discounted on cost grounds. Consideration should be given to carrying out an underwater survey to identify siltation issues / blockages / conditions of the bed.

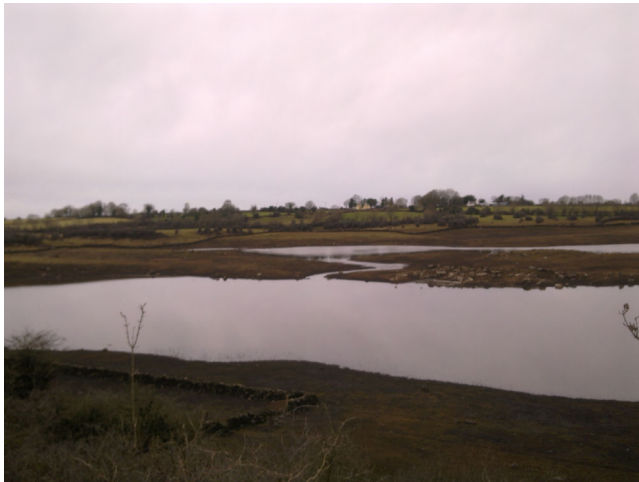
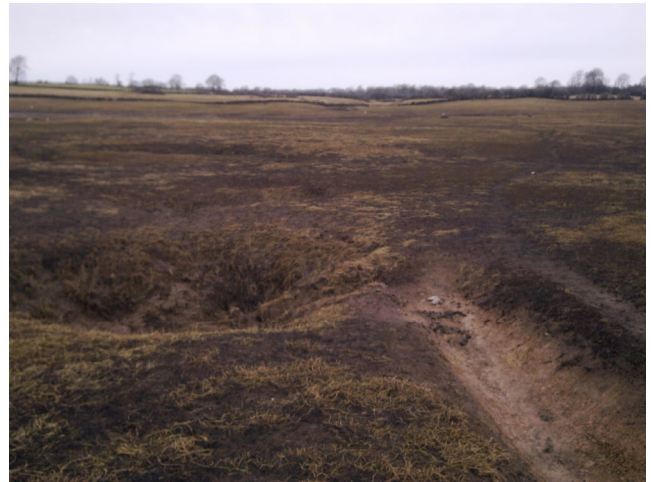
Figure No.7.31 – Blackrock turlough

As can be seen above, water levels were low on the day of the survey carried out on the 11th of January 2011 and the bed of the turlough was partially exposed. Numerous localised holes and depressions could be inspected and small debris such as plastic bottles were found as illustrated overleaf.

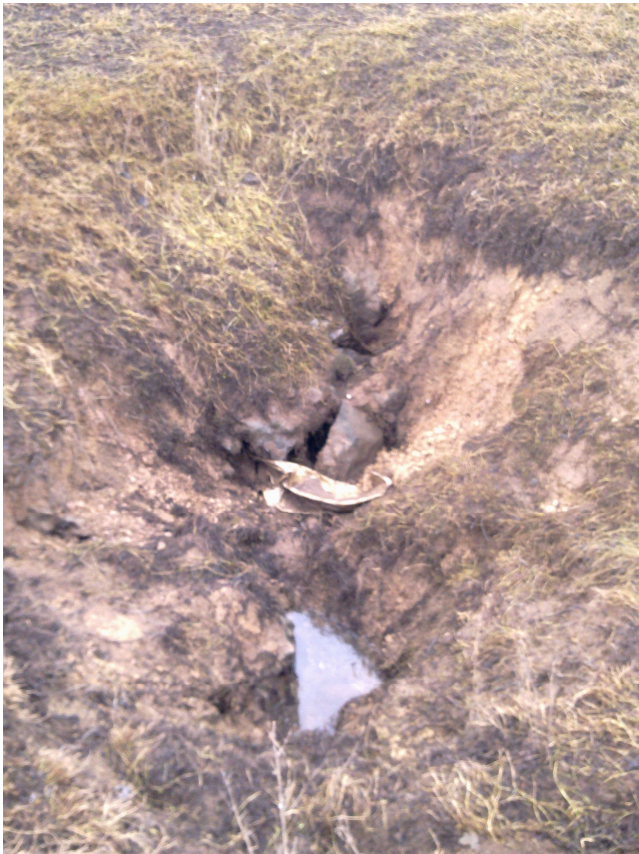
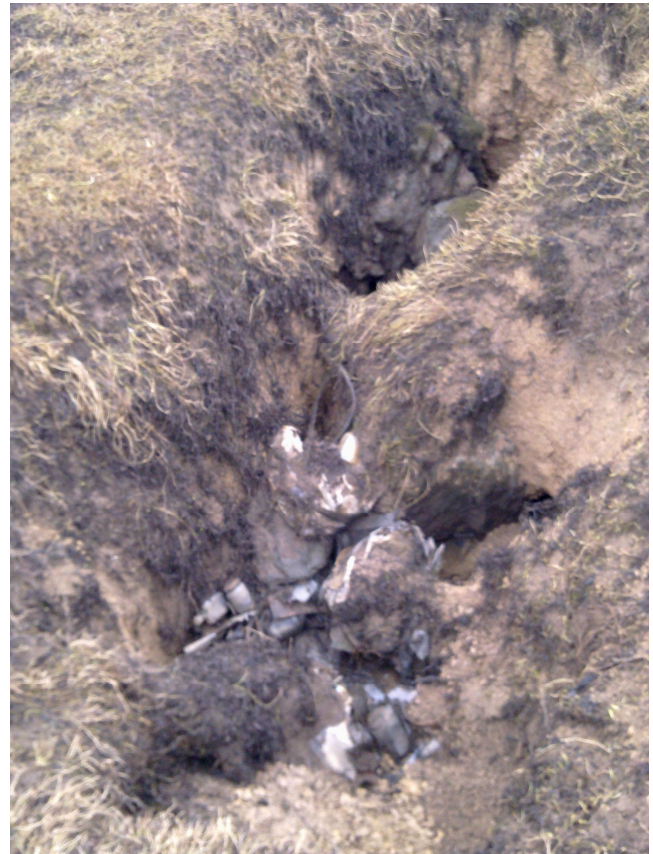
Figure No.7.33 – Blackrock turlough

Most of the water on the 11th of January 2011 was flowing to the eastern pond where it is expected that most of the underground drainage occurs. It is recommended that the numerous holes on the bed of the turlough be cleaned and cleared from debris. Consideration was also given to fencing off the turlough to prevent cattle from disturbing the grounds but was discounted on cost grounds.

Blackrock Turlough	E149946 N208044	N/A Lake – consider underwater survey	Evidence of siltation on part of the bed exposed on the day of the survey. Bed to be cleared from debris. Consideration should be given to carrying out an underwater survey to assess siltation / bed condition.
