River Fealge (Clonakilty) Drainage Scheme: Final Addendum to Environmental Impact Statement

February 2017

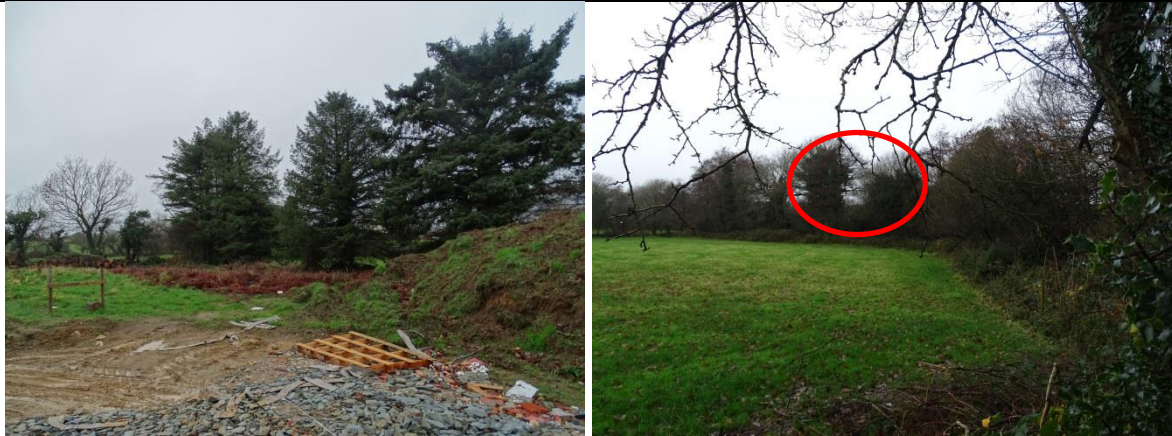
trees with heavy ivy growth.		Protect trees adjacent to the work area from damage
G15	Treeline / hedgerow located to rear of new build. Primarily deciduous hedgerow with individual trees with heavy ivy growth.	Two trees with heavy ivy growth deemed as PBR C-value (marked with Red Circle in photograph below, RHS). Hedgerow provides potential commuting routes for bats and feeding areas for bats.	Summer bat survey Retain hedgerow / trees Protect trees adjacent to the work area from damage
G16	Four large mature trees as single stands. One deciduous, three conifers. (Photograph below: LHS)	No PBR value. Potential commuting routes for bats and feeding areas for bats as part of the landscape.	Summer bat survey

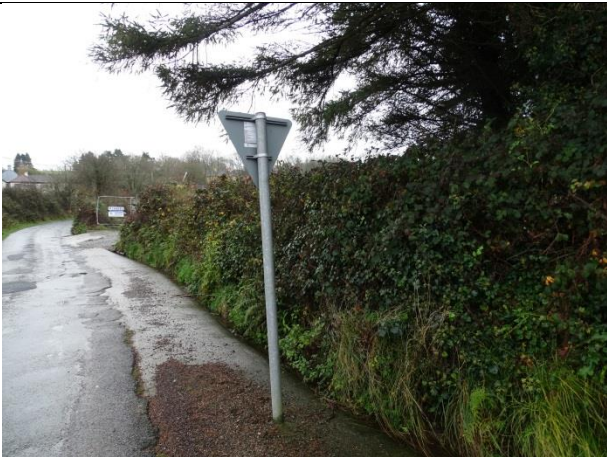
D15	Deciduous hedgerow - low quality. Section of hedgerow removed to facilitate entrance to house under construction.	No PBR value Limited bat foraging and commuting route potential	No recommendations

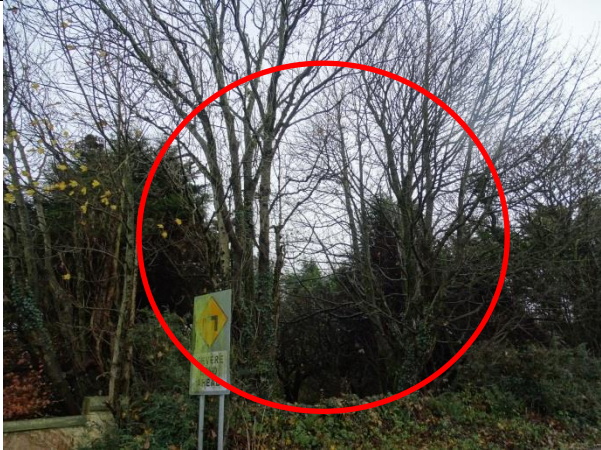
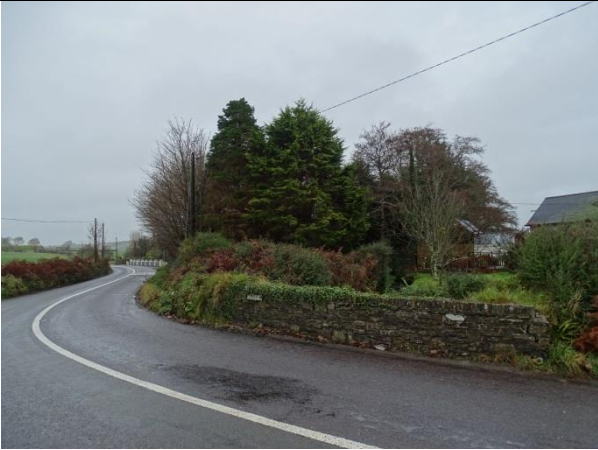
E3	<p>Small area of woodland located along stream, primarily comprised of conifer trees. Some mature specimens.</p>	<p>Potential foraging area for bats. Some individual trees deemed suitable to provide roosting sites for bats. At least two deciduous trees deemed as PBRs (C-value) but these are located adjacent to a house (approx 15m from stream) and therefore unlikely to be within the clearance zone of the immediate area adjacent to the stream (Red Circle).</p> <p>The trees immediately adjacent to the stream are not deemed as PBRs.</p>	<p>Summer bat survey</p> <p>Retain trees / woodland</p> <p>Retain PBRs</p> <p>Protect trees adjacent to the work area from damage</p>
<div>

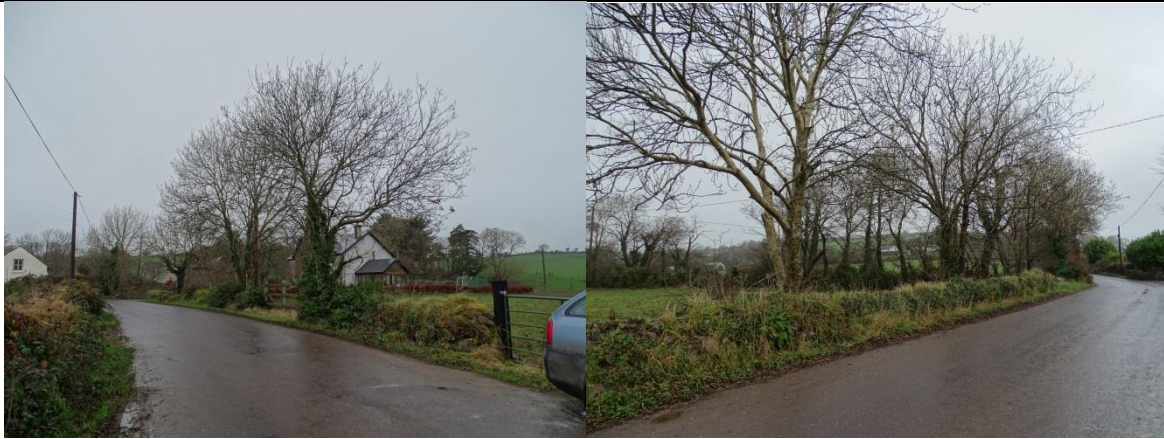
Code Name	Description	Bat Potential	Recommendation
G12	Individual immature ash trees along side of road	Trees have no PBR value Landscape provides potential commuting routes for bats and feeding areas for bats.	Summer bat survey Retain hedgerow / trees

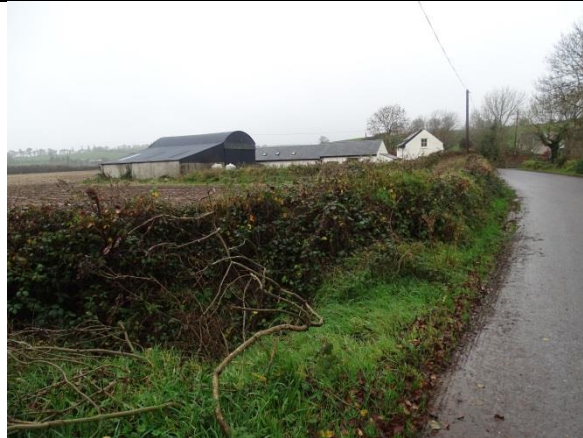
G18	Low hedgerow along side of road	Little commuting and foraging value to bats.	No recommendations
------------	---------------------------------	--	--------------------

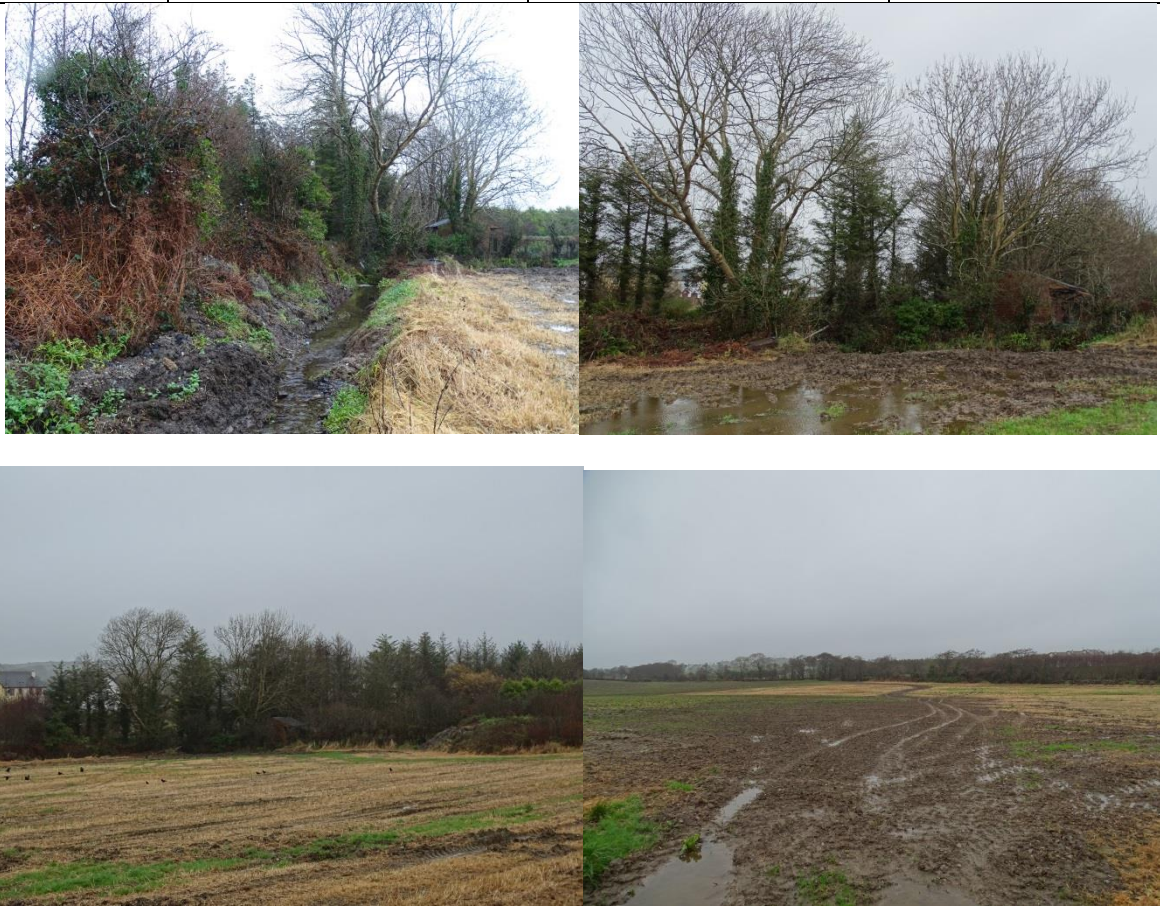
Code Name	Description	Bat Potential	Recommendation
G10 G10 & G11 are located beside each other.	Individual mature ash tree located at corner of cereal field.	Tree has a PBR C-value due to ivy growth on tree. Landscape provides potential commuting routes for bats and feeding areas for bats.	Summer bat survey Retain hedgerow / trees Protect trees adjacent to the work area from damage
G11	Individual mature ash tree located at corner of cereal field.	Tree has a PBR C-value due to ivy growth on tree. Landscape provides potential commuting routes	Summer bat survey Retain hedgerow / trees

for bats and feeding areas for bats.	Protect trees adjacent to the work area from damage

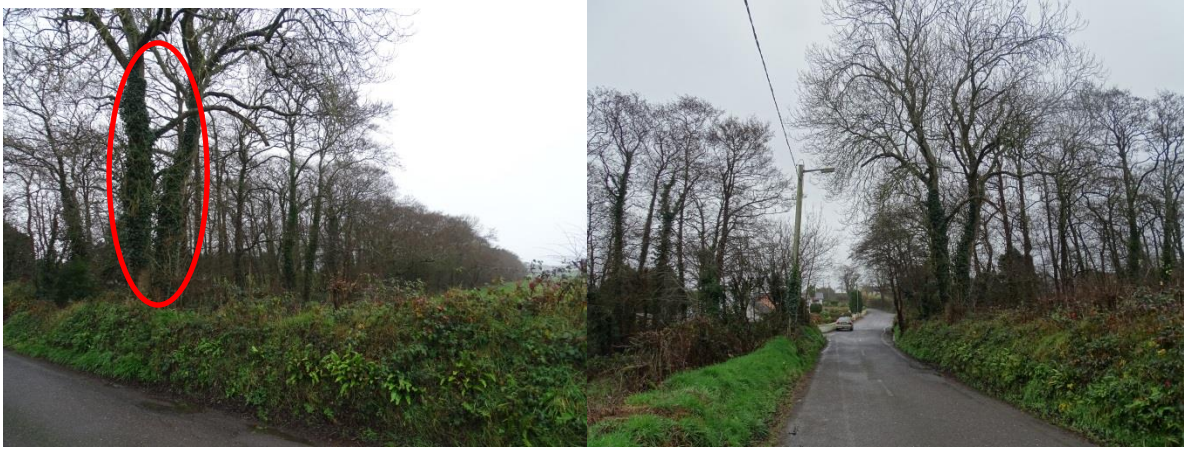
G8 / G9 G8 & G9 are located beside each other.	This area provides good foraging and commuting habitat for bats. On both sides of the road there are stands of trees creating a small woodland area.	Ash Tree has a PBR C-value due to ivy growth on tree (Red Circle in photo). Landscape provides potential commuting routes for bats and feeding areas for bats.	Summer bat survey Retain hedgerow / trees Protect trees adjacent to the work area from damage

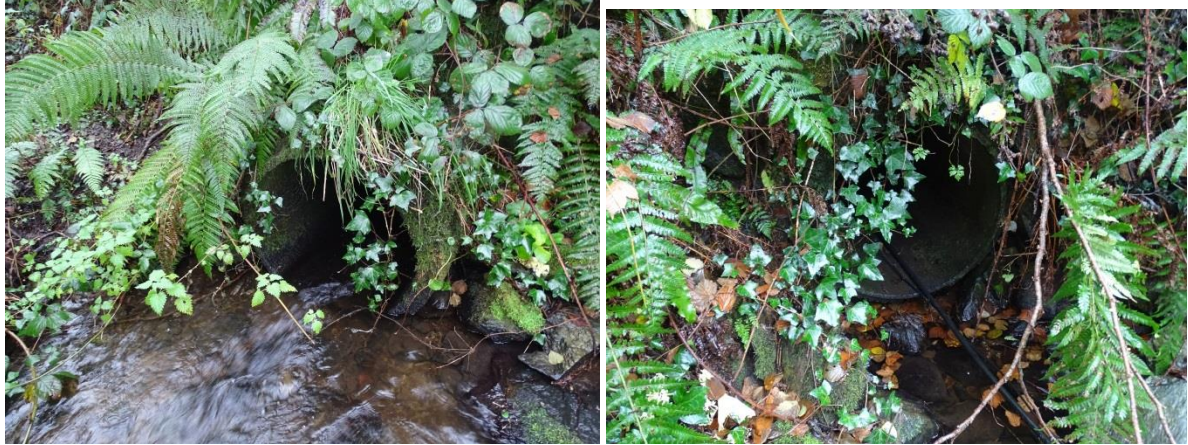
Culvert adjacent to G8/G9	<p>This area provides good foraging and commuting habitat for bats. On both sides of the road there are stands of trees creating a small woodland area.</p>	<p>2 concrete pipes. No potential roosting sites for bats.</p>	<p>It is presumed that a new culvert will replace the concrete pipes. Therefore it is recommended that BAT TUBES are inserted in to the culvert (Please see Mitigation Section of report for more details).</p>

Garage	Section A & B (Figure 3.3)	<ul style="list-style-type: none"> - Installation of new road culverts (G8 & G9) - Installation of new instream trash screen & bankside access road 	<ul style="list-style-type: none"> - Escapement of solids in surface water drainage. - Escapement of concrete & other pollutants from construction areas. - Direct impact to substrate & channel profile from instream culvert excavation & replacement (also from trash screen installation downstream). Associated impacts to existing salmonid and

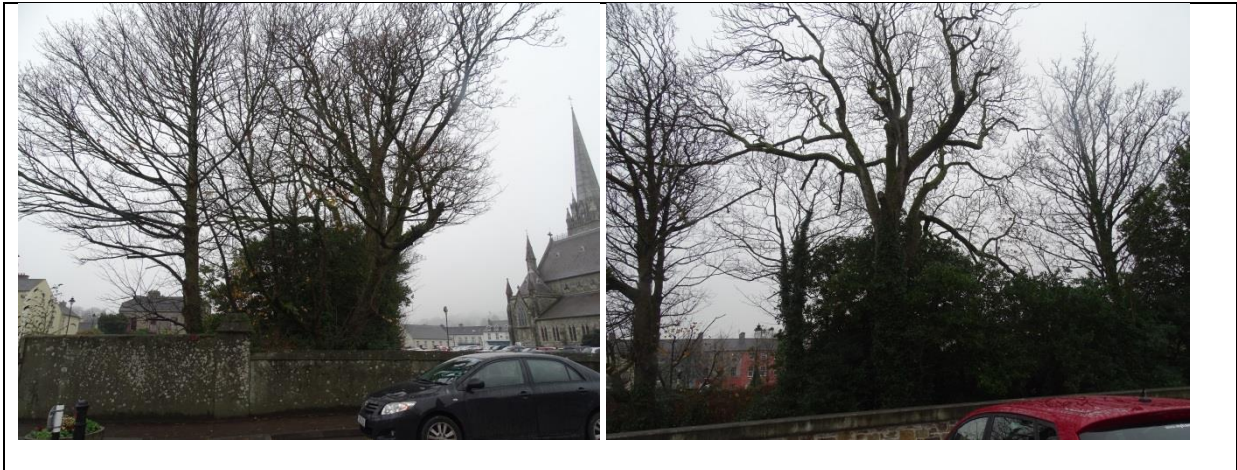
Code Name	Description	Bat Potential	Recommendation
G17	Individual mature trees located along one river bank.	One tree has a PBR C-value due to spilt limbs and tree holes. Landscape provides potential commuting routes for bats and feeding areas for bats.	Summer bat survey Retain hedgerow / trees Protect trees adjacent to the work area from damage

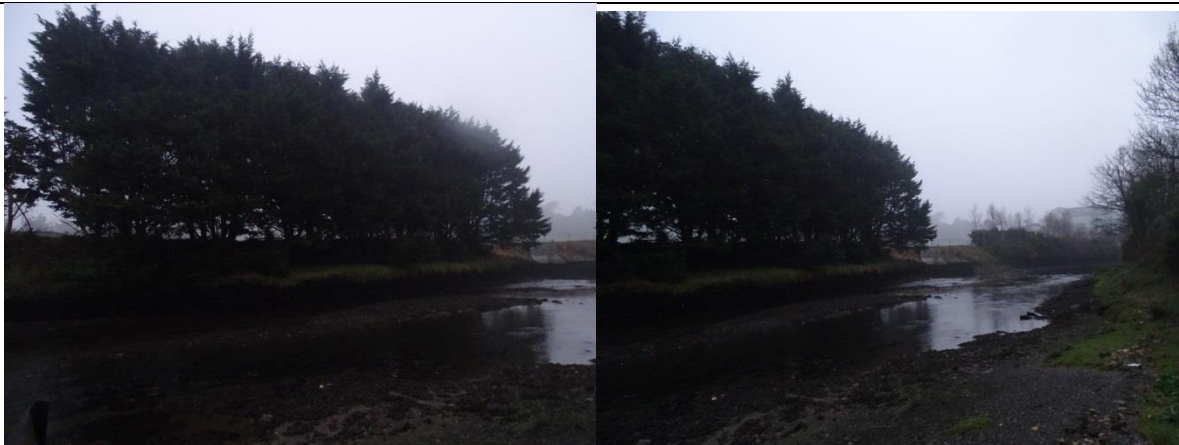
Code Name	Description	Bat Potential	Recommendation
L35	Line of conifer trees, small sections of immature deciduous trees and individual trees.	No PBR potential. Little commuting and foraging habitat for bats.	No recommendations

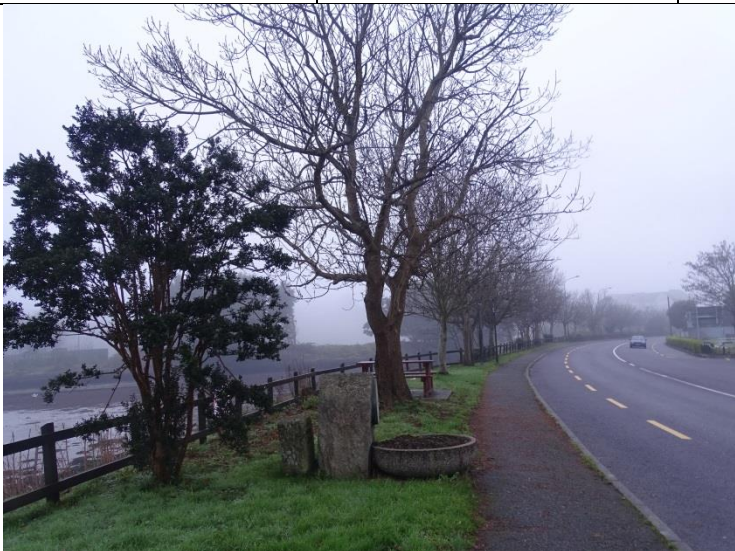
L36	Individual trees of the road verge along Croppy Road	<p>No PBR potential.</p> <p>Little commuting and foraging habitat for bats.</p>	No recommendations

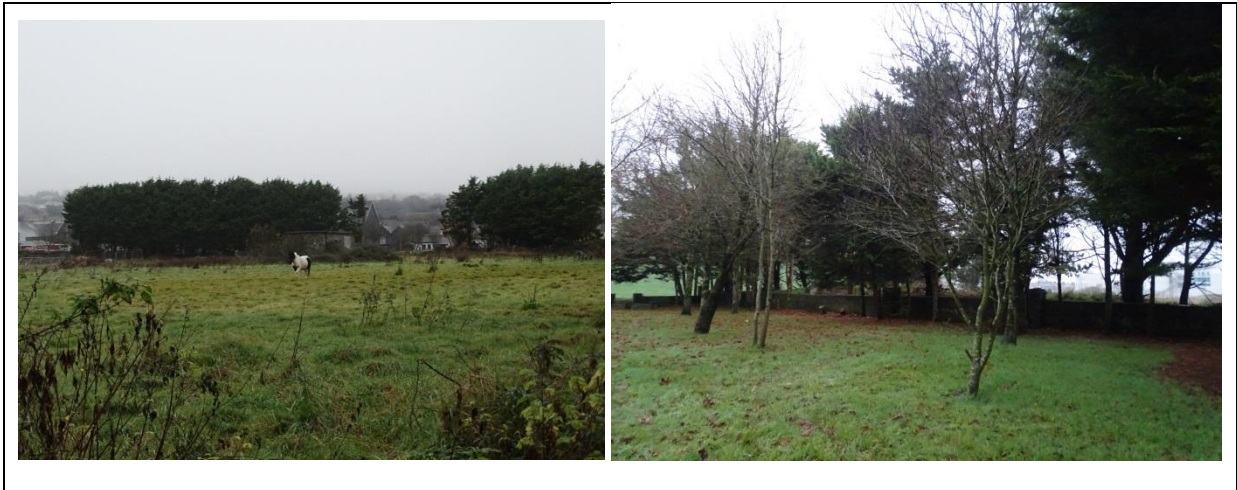
E13 & E9	<p>Trees and treelines located around the sports grounds adjacent to Waldaschaff Park and Model Railway Centre.</p> <p>Line of conifer trees, small sections of immature deciduous trees and individual trees along the park boundary.</p>	<p>No PBR potential.</p> <p>Little commuting and foraging habitat for bats.</p>	<p>No recommendations</p> <p>The trees in Waldaschaff Park is an potential location for a bat box scheme.</p>

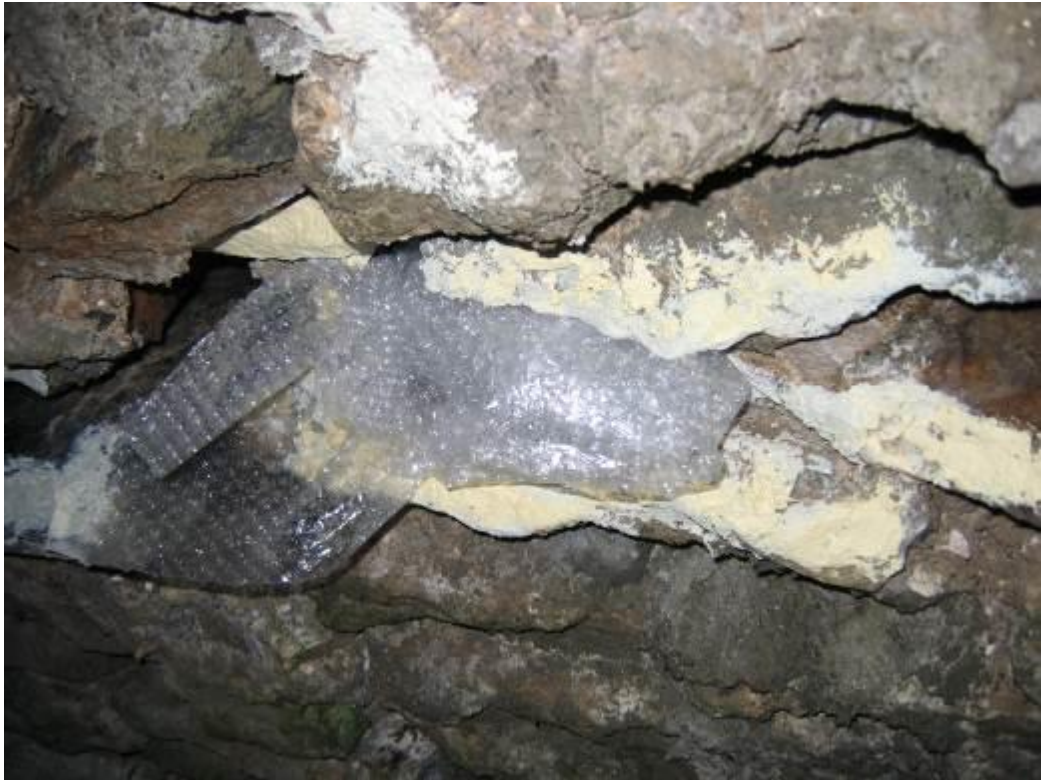
- a) In relation to bridges with crevices suitable for roosting bats: in discussion with engineers, a selection of crevices should be retained and blocked temporarily. Once works are finished, the crevices should be unblocked to allow bats to use the structures post-works.
- b) However, a bat survey is required prior to such works for these bridges/culvert to ensure that there are no bats present prior to and during works. This survey work should involve a detailed examination of all arches and crevices. The bat specialist should mark any crevices to be retained. Such crevices, once no bats are present should be filled with bubble wrap in order to prevent filling in of such.
- c) Crevices that remain open will have to be daily checked prior to filling in not unless the canvas sheeting procedure as recommended below in undertaken.

Figure 1: Example of a bat-suitable crevice filled/blocked with bubble wrap to prevent bat occupancy during proposed works (Photograph courtesy of Caroline Shiel).

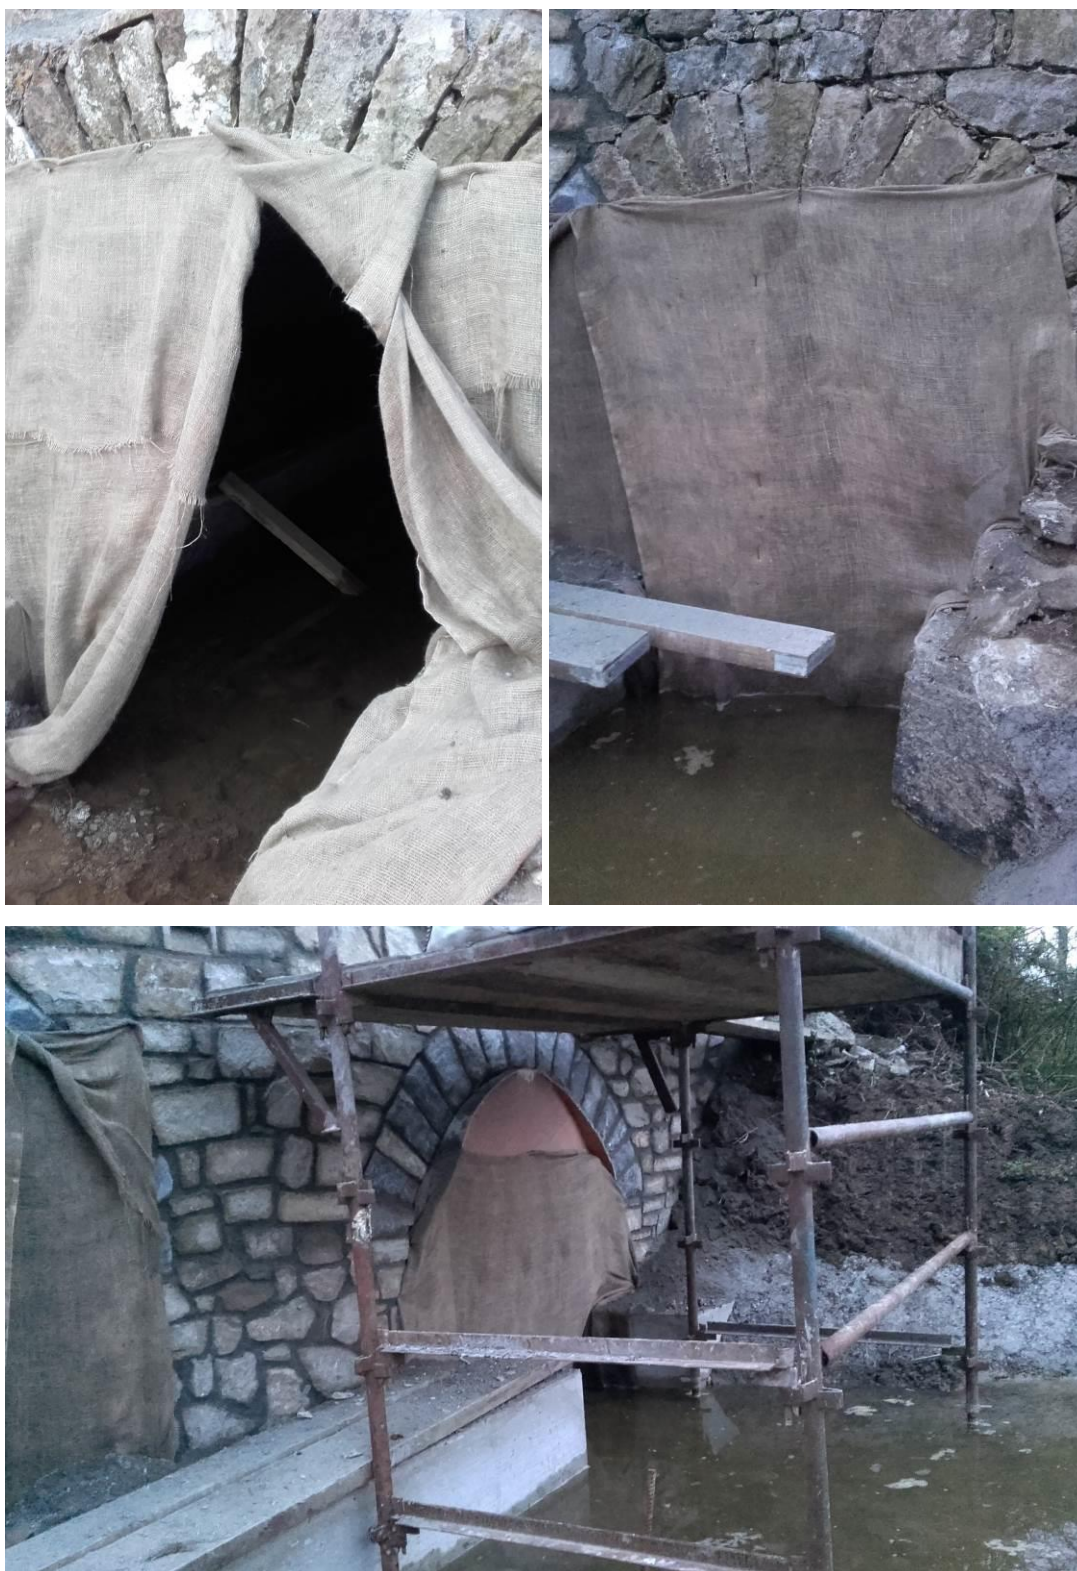
- d) For bridges where proposed strengthening is to be undertaken and with open crevices, a bat inspection of the bridge is recommended the night before works are due to be undertaken. In preparation for this survey, two sheets of canvas that will close the arches (post bat survey), are required to be in place (i.e. canvas sheeting to be erected from the top of the bridge and held in place. When the sheeting is unfurled, the length of it should reach the water level. The width of the sheeting should also ensure that entire opening to the 1/2 arches of the bridges (upstream and downstream) are covered to prevent bats accessing the bridge for the duration of the works. Once the bat inspection and survey determines that there are no bats within the bridge, the canvas sheets are to be released. While the canvas sheeting can be opened during the daytime to allow works to be undertaken, it is of paramount importance that each evening, the canvas sheets are released to close the arches during the night for the duration of the works under the arches. Once the works are finalised and a bat inspection is completed, the crevices blocked to be retained are unblocked and the canvas sheets removed.

Figure 2 a, b, c: Example of canvas sheets used to close the bridge once it has been declared bat free by a bat specialist.

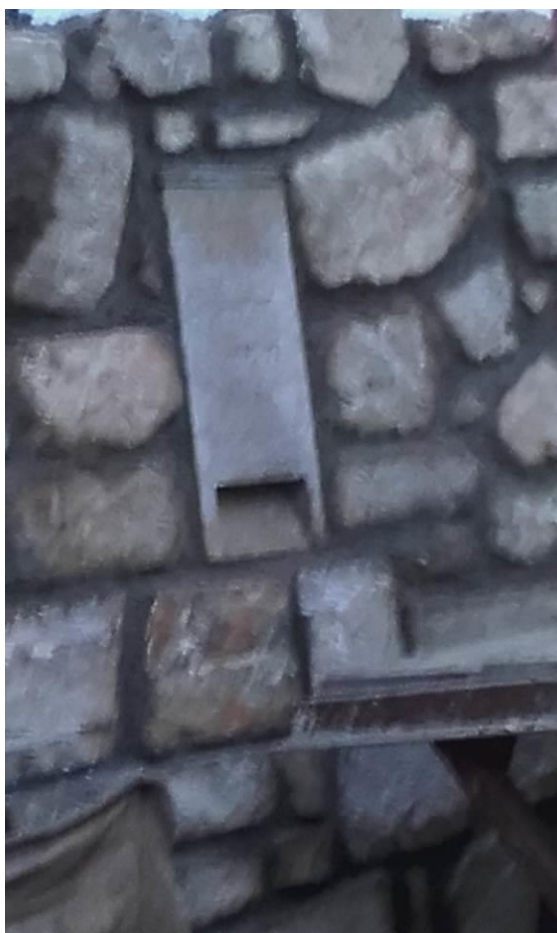
- d) Bat tubes should be incorporated into new structures, where possible – e.g. into the parapet walls for example or attached to the underside of box culverts.

Figure 3: Example of a bat tube incorporated into the parapet walls of a newly maintained bridge (Ross Bridge, County Clare).

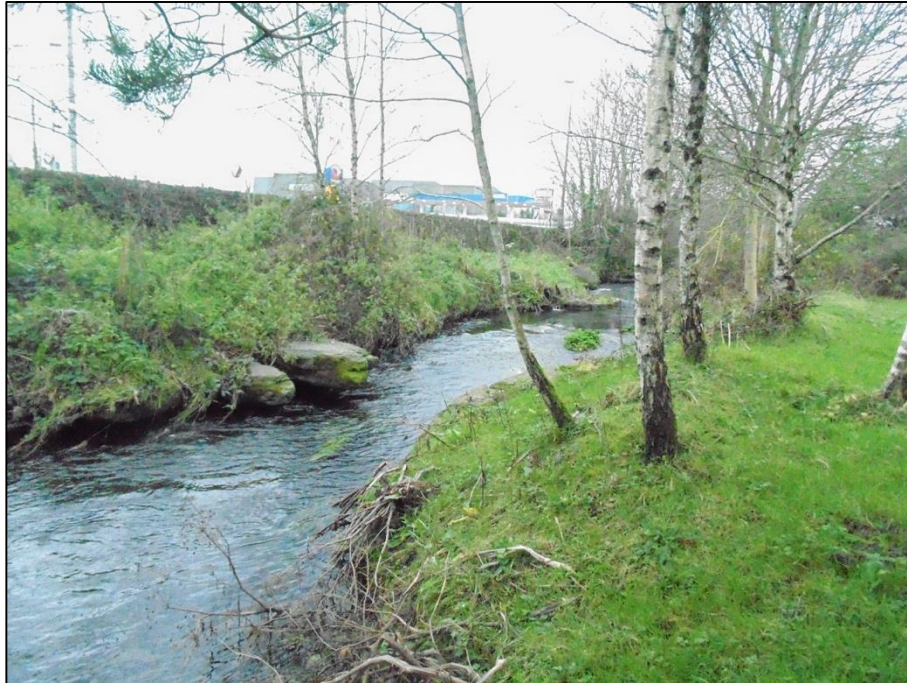
The lower River Fealge (i.e. tidal channel sections) was also surveyed. This area was exclusively of shallow riffle glide habitat at low tide and was considered a good trout nursery (i.e. score of 4). Fast flowing open and large tidal sections of river channel in known salmonid rivers can have high densities of trout (e.g. River Bandon at Innishannon) because of high productivity and thus are important nursery areas. The lower River Fealge may also be of importance to sea trout migrating upstream, although it is very difficult to identify juvenile sea trout from brown trout. The lower River Fealge may also be of importance to European eel elvers that can be present at high abundances in the lower tidal reaches of river channels as has been observed in other surveys in West Cork (pers. obs.).

Plate 3.2 – River Fealge (Section C) illustrating excellent holding habitat

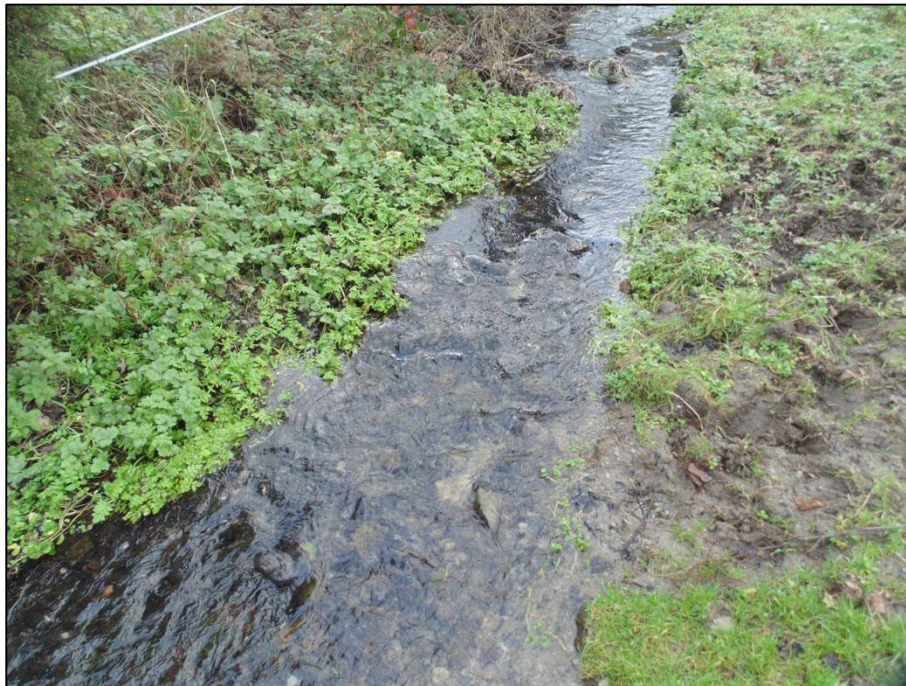
The lower extent of section C (i.e. behind Clonakilty Service Station) declined in quality because of storm drain input and historical realignment of the river. This was evident from increased sedimentation of the gravels, with a deeper (circa 1-1.5m) straightened channel, in addition to increased shading. Despite the lower quality of the lower extents overall the stream scored well for spawning and nursery (i.e. moderate to good – 2.5 and good – 2 respectively), with a lower score for holding habitat given limited pools (i.e. moderate – 3). Refer to Figure 3.3 for a graphic summary of the fisheries habitat evaluation.

Plate 3.3 – Garage Stream (Section C) illustrating moderate to good quality spawning and nursery habitat

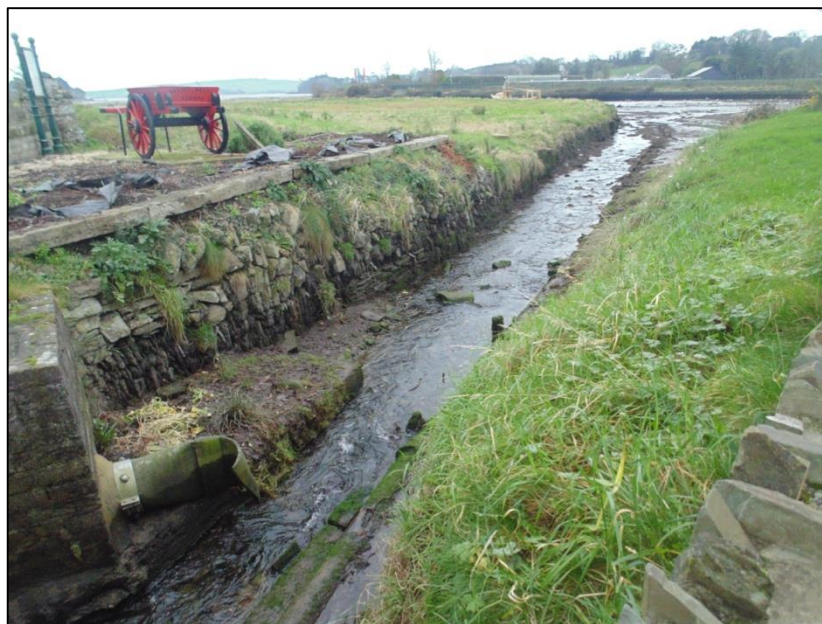
Plate 3.6 – Mouth of Convent Stream discharging to Clonakilty Bay
