# BANDON FLOOD RELIEF SCHEME

## FISH STOCK ASSESSMENT

Version: 1<sup>st</sup> November 2011 (Final)

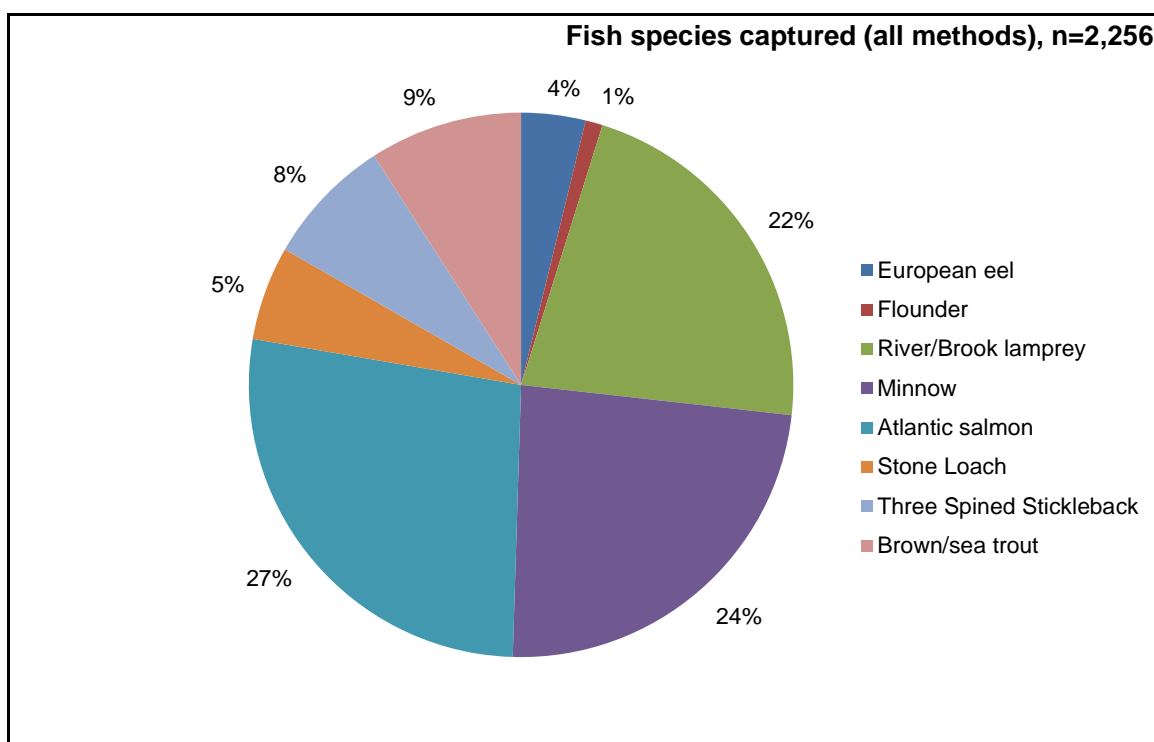
**Figure 10** Fish species compositor (all methods combined) for the September 2011 fish stock assessment on the Bandon River.

Over the 12 sites surveyed a total of 1,605m<sup>2</sup> of habitat was surveyed for juvenile salmonids; 60m<sup>2</sup> was surveyed for European eel; while a total of 36m<sup>2</sup> of suitable habitat was surveyed for lamprey. The current survey also included 240 sweep net samples within the study area. The survey resulted in the capture of 2,256 fish in total, comprising eight species. The most common species recorded was Atlantic salmon *Salmo salar*, followed by minnow *Phoxinus phoxinus*. Additional fish species recorded include three-spined stickleback *Gasterosteus aculeatus*, stone loach *Barbatula barbatula*, European eel *Anguilla anguilla* and flounder *Platichthys flesus*. The relative abundance of all species recorded during the current survey is shown in Figure 10.

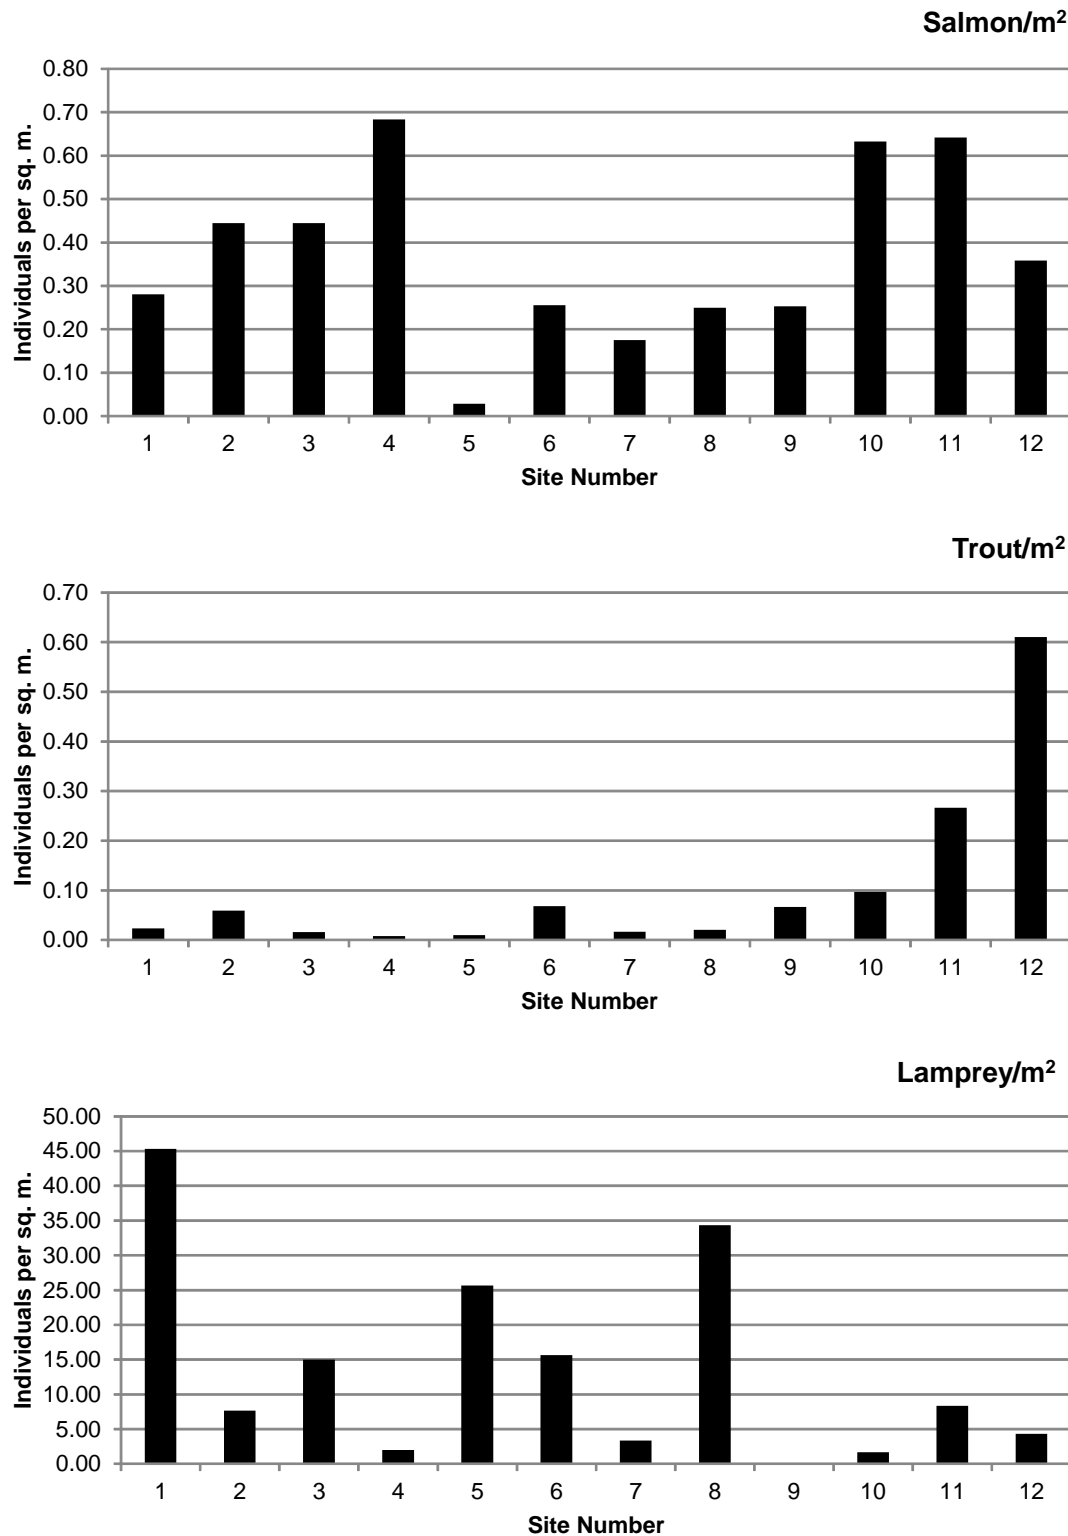
**Figure 11** Density (no. per m<sup>2</sup>) of juvenile Atlantic salmon *salmo salar*, Brown/sea *Salmo trutta*, and River/Brook lampreys *Lampetra* sp. at the 12 sites investigated during September 2011. Note densities are based on catch per area and are a semi-quantitative index of abundance only.

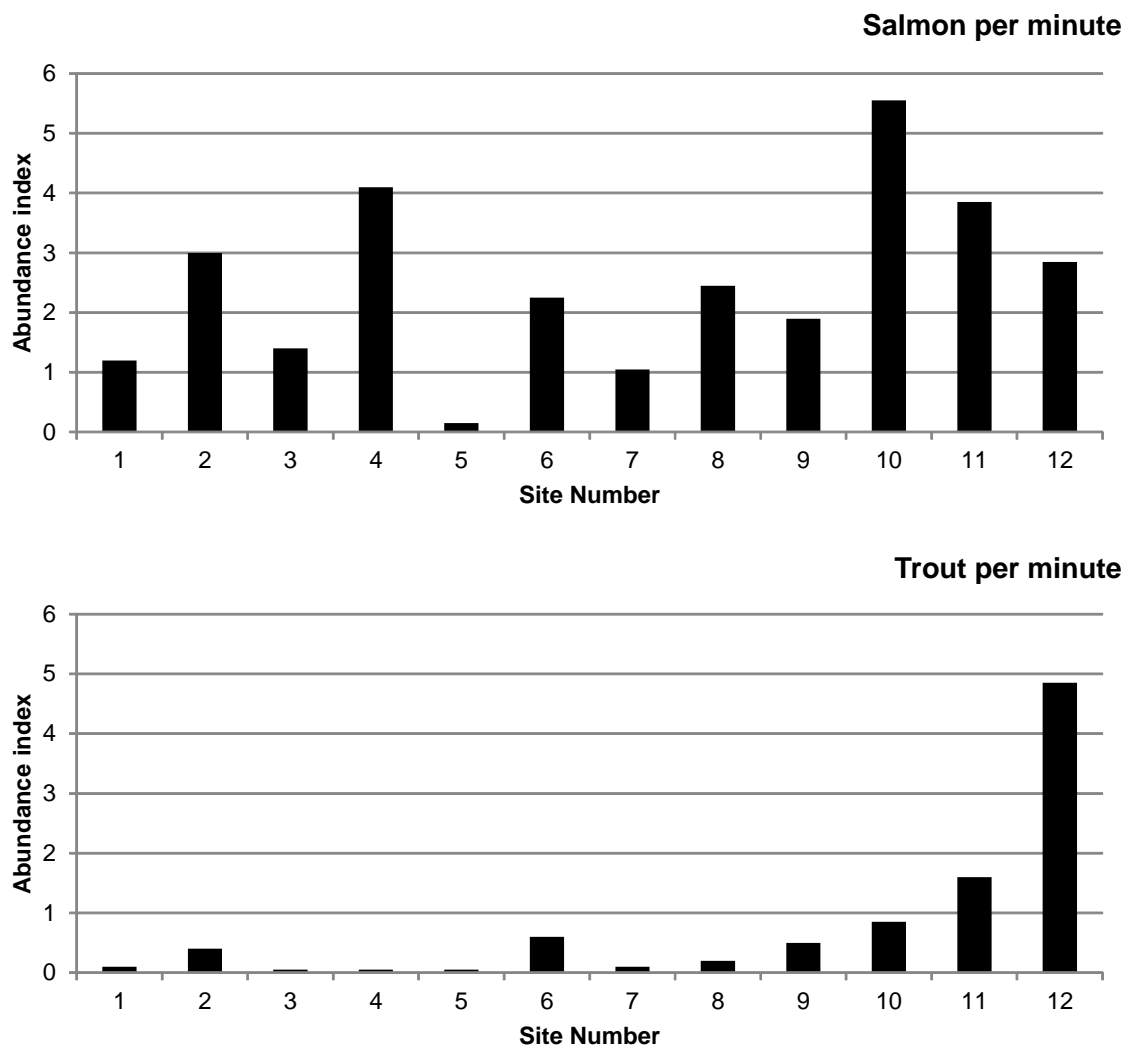
**Figure 13** Abundance index (catch per minute) of juvenile Atlantic salmon *salmo salar* and Brown/sea *Salmo trutta* at the 12 sites investigated during September 2011.

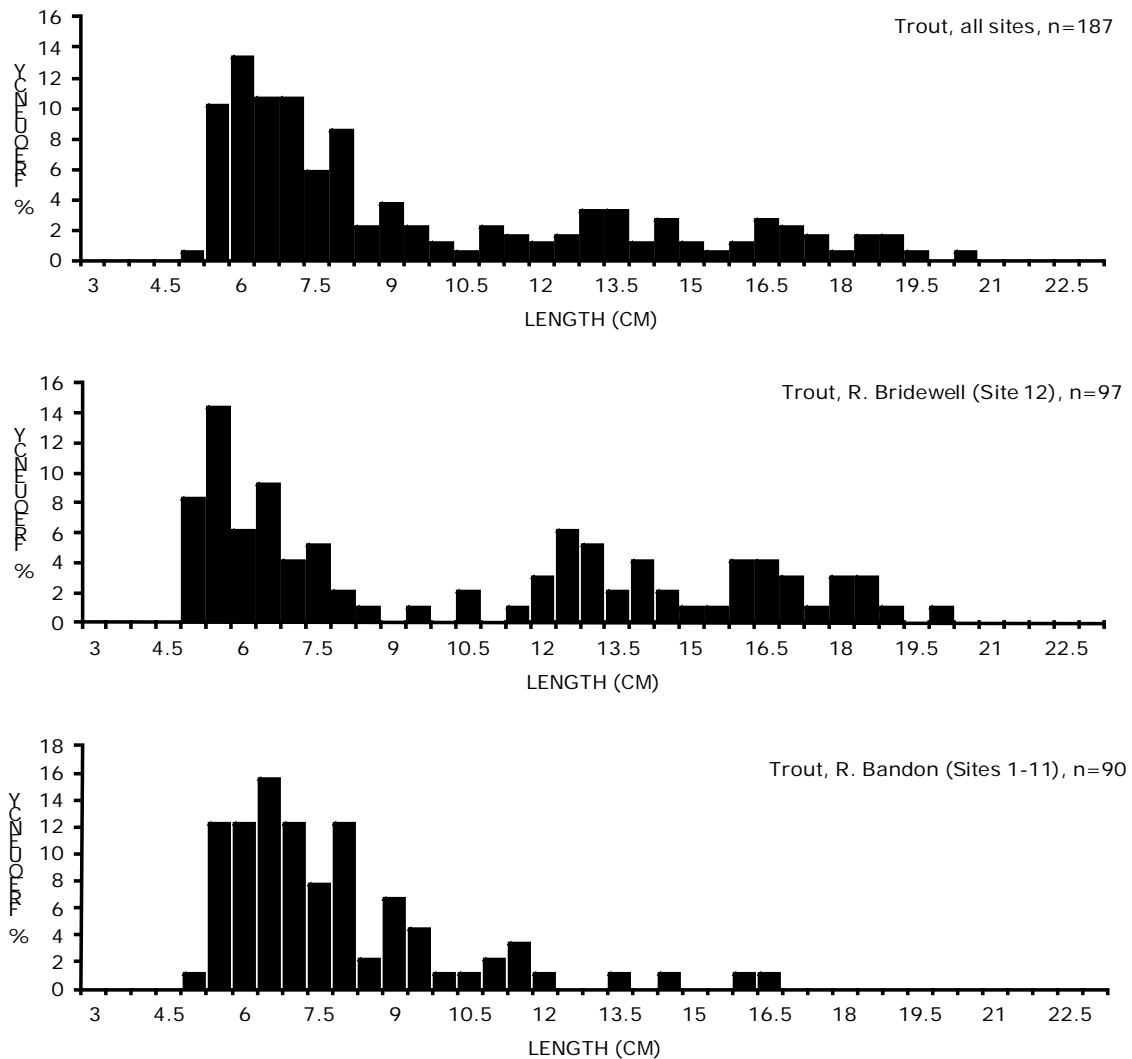
**Figure 15** Length percentage frequency distribution of brown trout captured at all sites (top), and in the River Bridewell (Sites 12), and River Bandon (Sites 1-11).

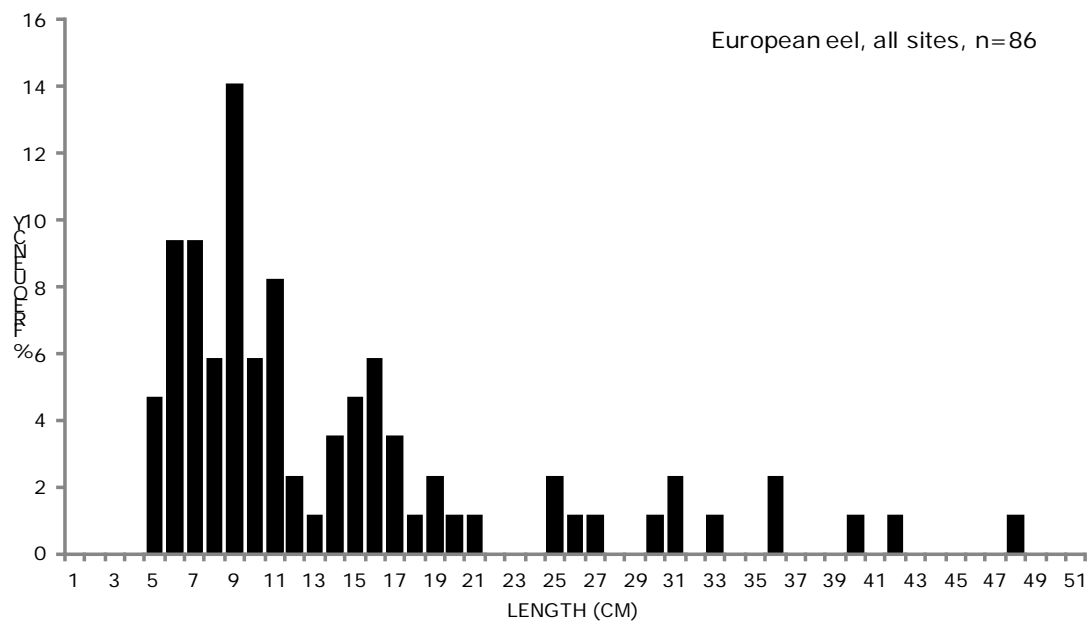
**Figure 16** Length percentage frequency distribution of 88 European eel *Anguilla anguilla* captured at the 12 sites investigated during September 2011.

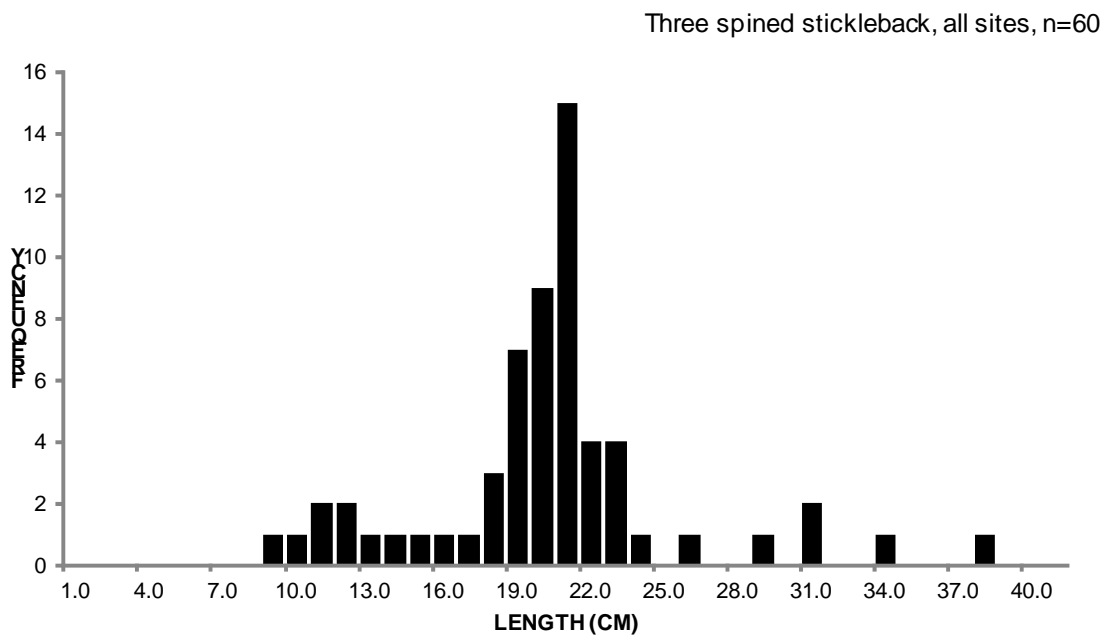
**Figure 17** Length frequency distribution of 60 Three spined sticklebacks *Gasterosteus aculeatus* captured at the 12 sites investigated during September 2011.

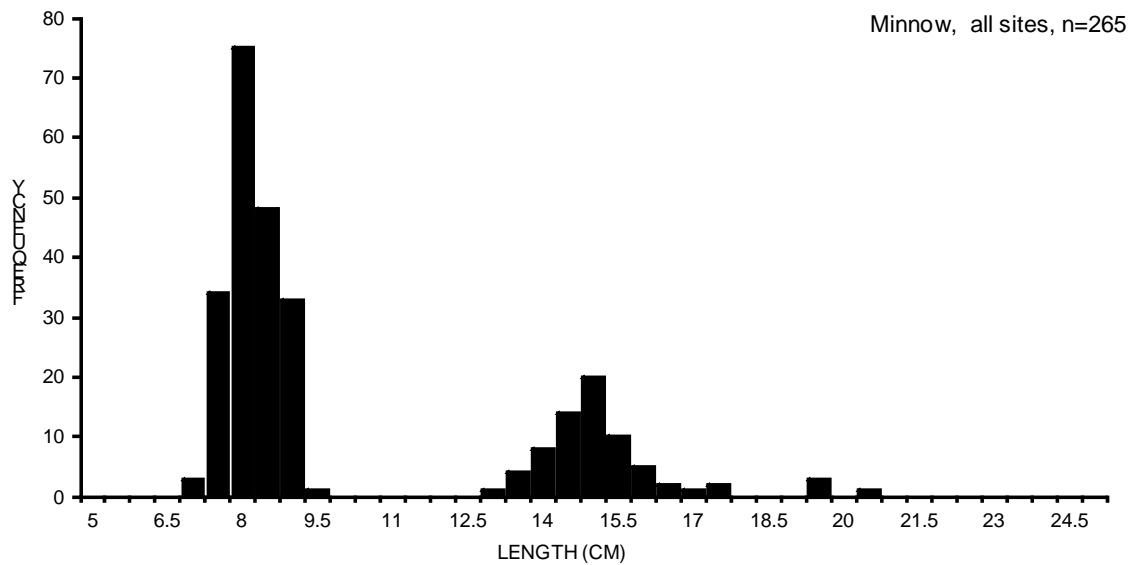
**Figure 18** Length percentage frequency distribution of 265 Minnow *Phoxinus phoxinus* captured at the 12 sites investigated during September 2011.

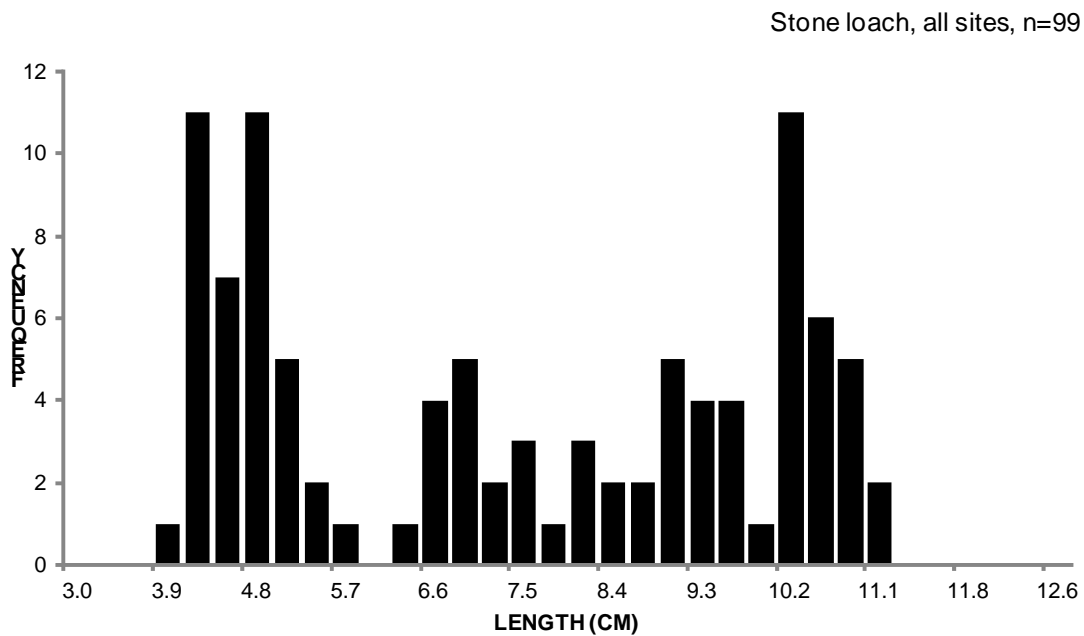
**Figure 19** Length percentage frequency distribution of stone loach captured at the 12 sites investigated during September 2011.

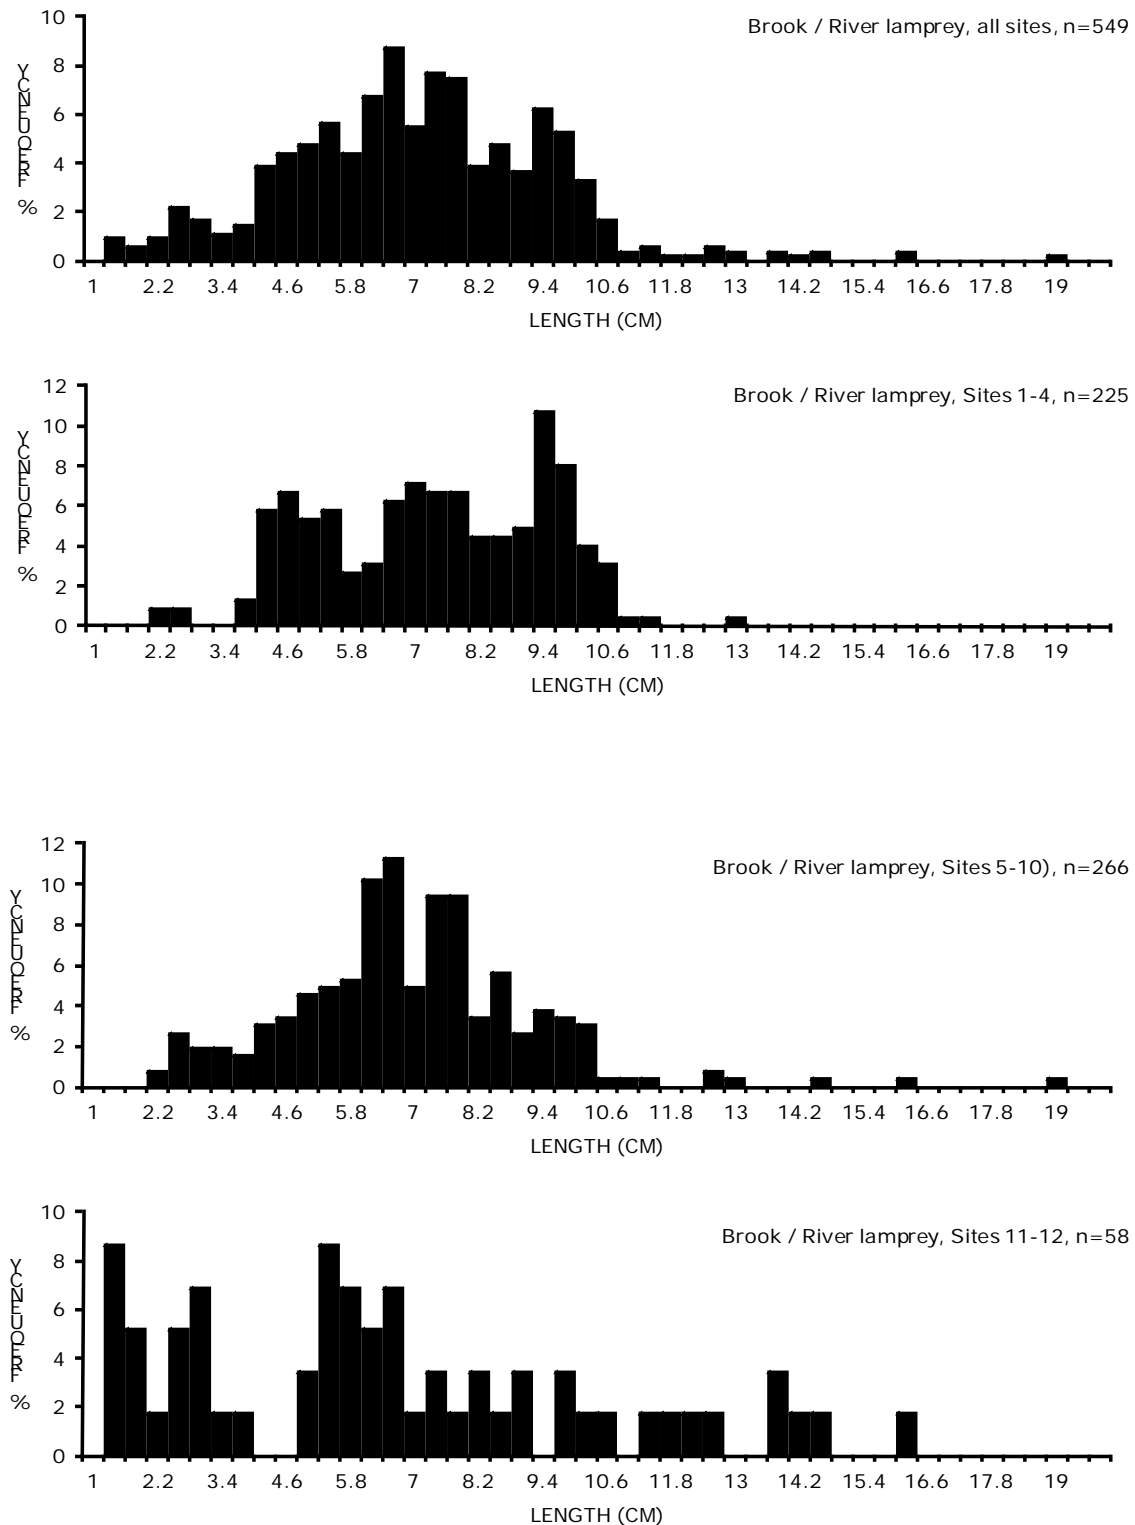
**Figure 20** Length percentage frequency distribution of juvenile Brook/River lampreys *Lampetra* sp. captured at all sites (top), and at sites 1-4 (indirectly affected by proposed works, Sites 5-10 (directly affected by proposed works, and at Sites 11-12 (reference sites). Note no lampreys were recorded at Site 9 which had been affected by dredging in 2010.

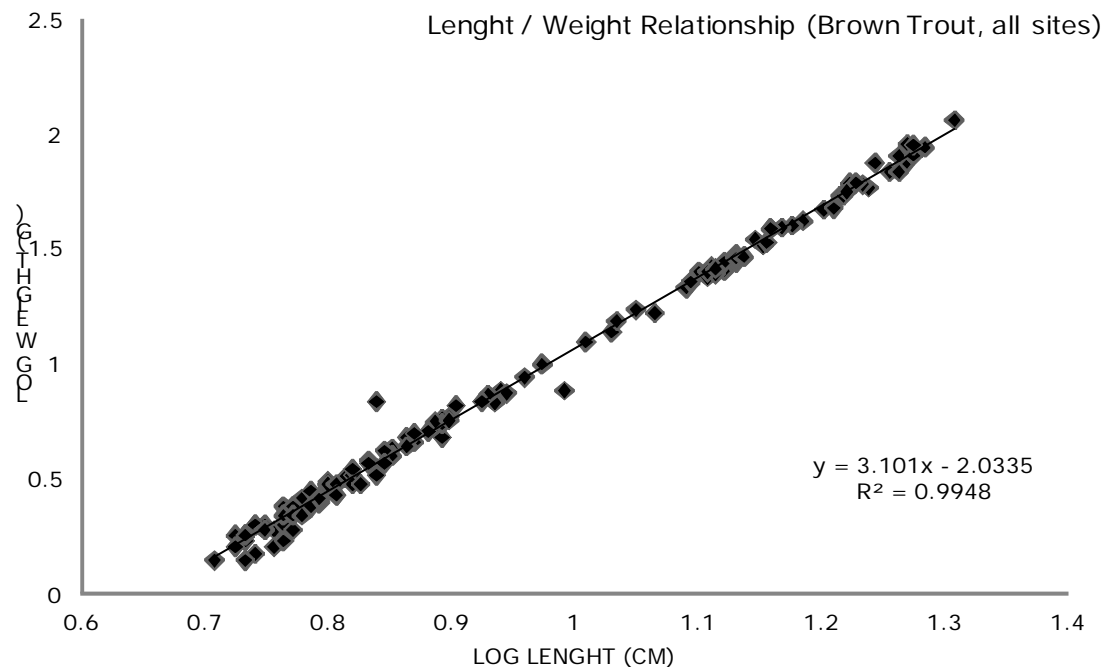
**Figure 22** Length weight relationship of brown trout (all sites).

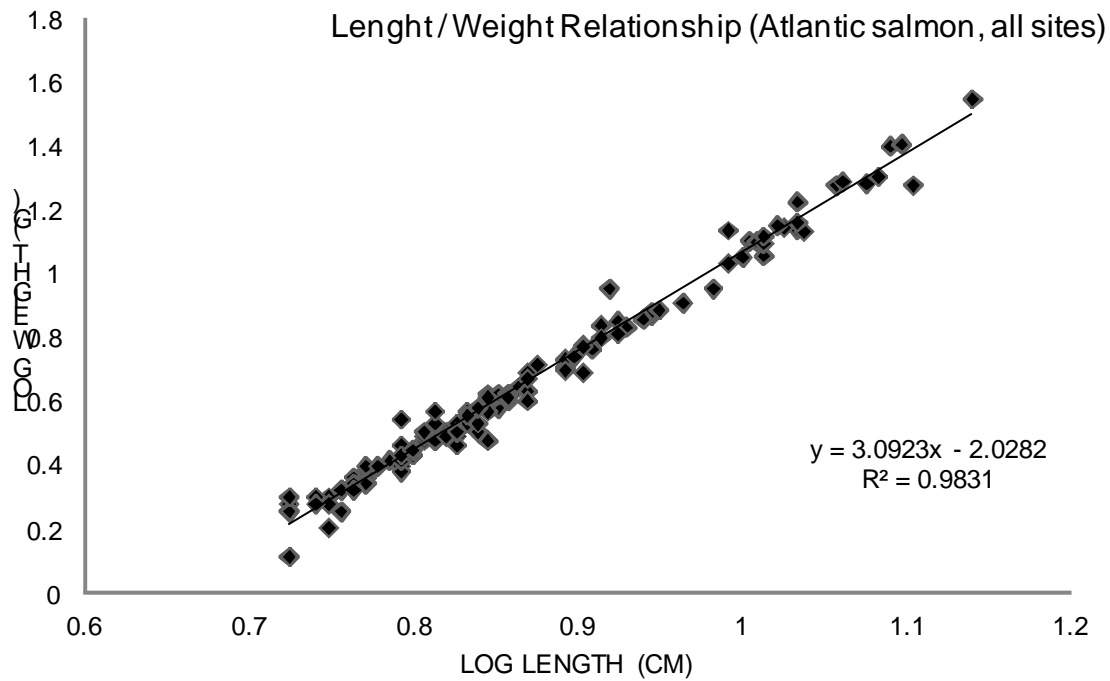
**Figure 23** Length weight relationship of Atlantic salmon (all sites).

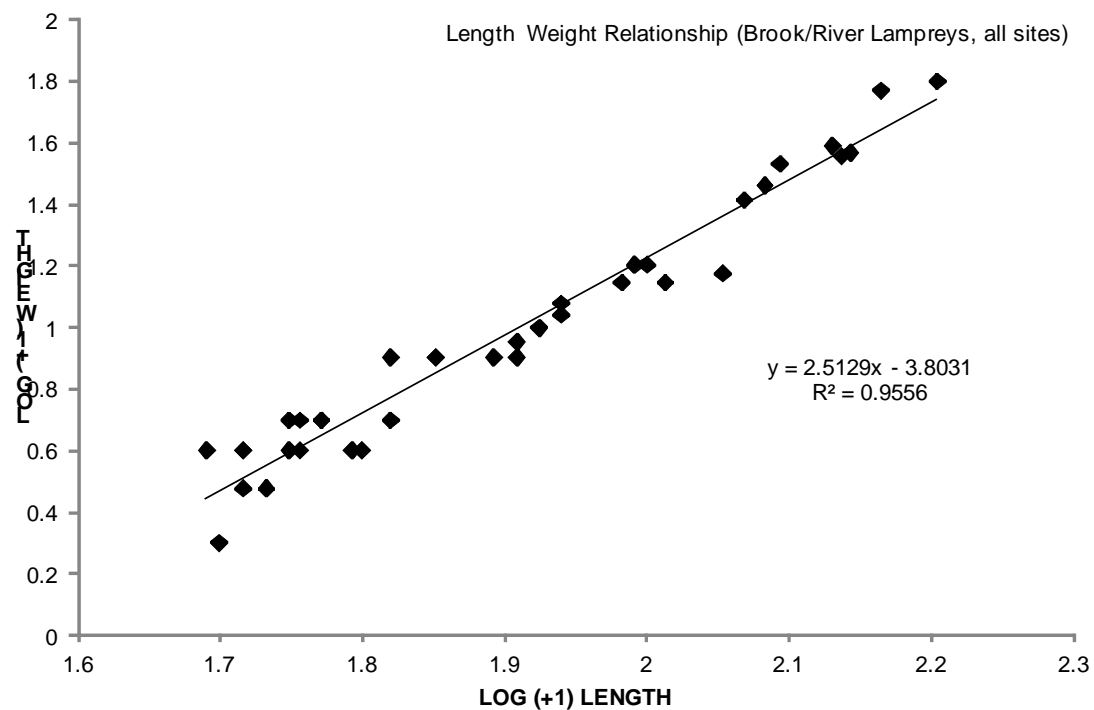
**Figure 23** Length weight relationship of Brook/River lampreys (all sites).

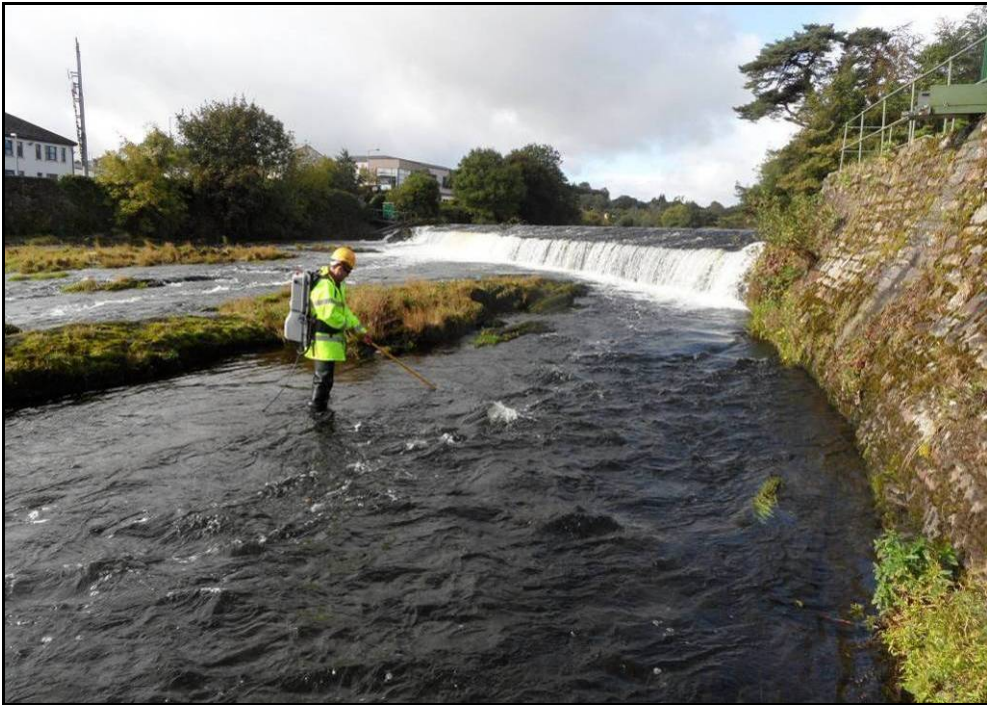
**Plate 1** Juvenile salmonid electrical fishing survey location at Site 10 in Bandon town. Salmonid electrical locations were chosen on riffled parts of the river.

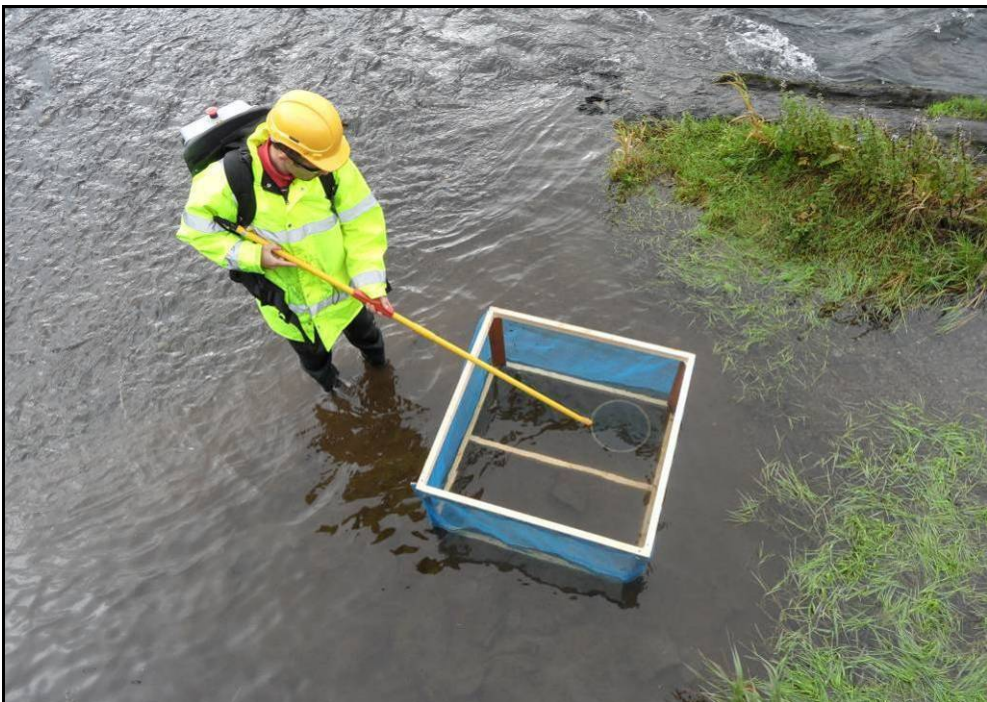
**Plate 2** Electrical fishing for juvenile lampreys at Site 10. Sites for juvenile lampreys were located in depositing parts of the river in areas where the substrate was dominated by soft substrates.

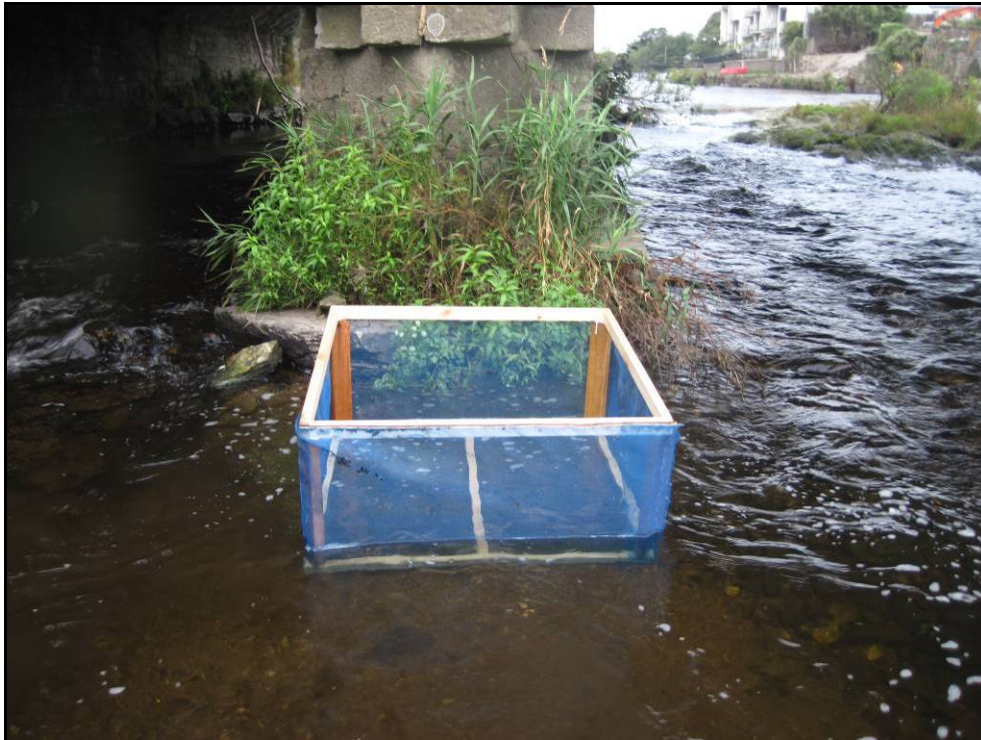
**Plate 3** One of three electrical fishing locations selected for the lamprey survey at Site 9. This 1m<sup>2</sup> frame which was fitted with fine mesh was used at three sub-sites at each site.

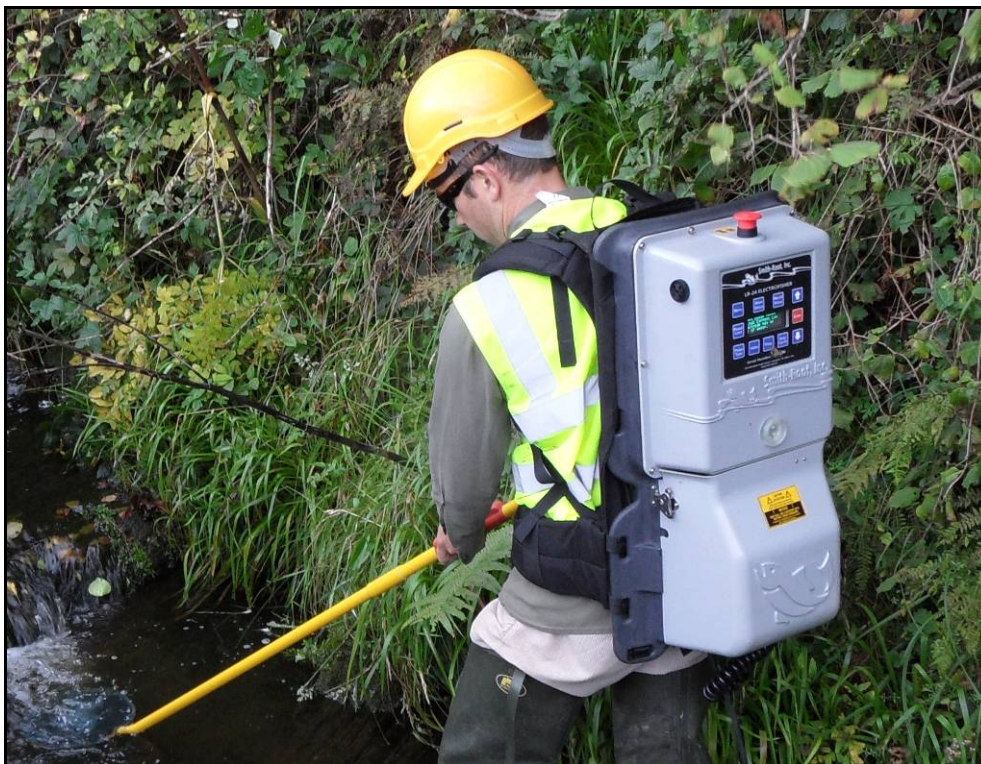
**Plate 4** Electrical fishing with the portable electrical fishing unit (Smith Root-LR 24 backpack) on the Bridewell River. Electrical conductivity within the study area was typically low at around 220µS/cm. This machine automatically adjusts the power output according to conductivity and water depth, therefore providing a standardized sampling effort.

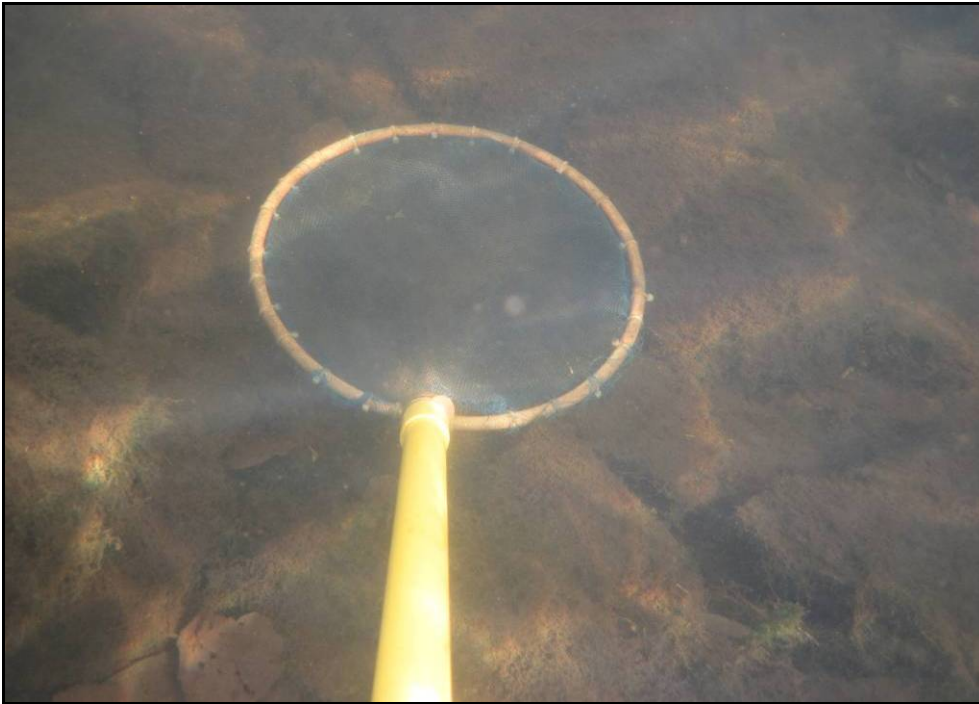
**Plate 5** Electrical fishing for European eel among submerged rock habitat at Site 10.

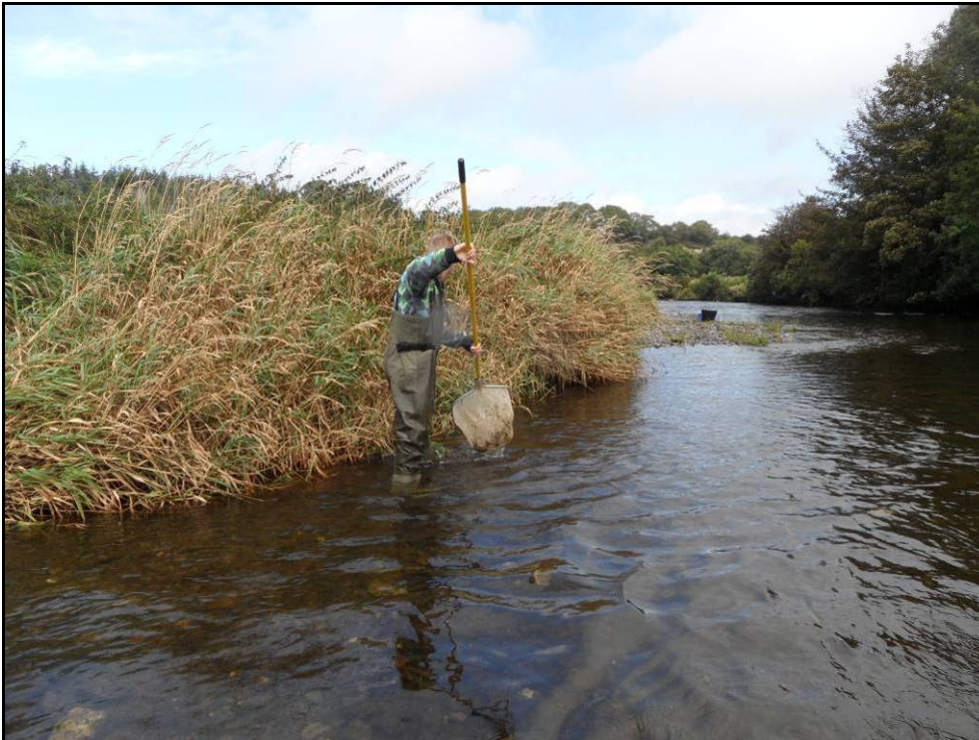
**Plate 6** Sweep netting for fish along the margins of the River Bandon at Site 7. Sweep netting at each location consisted of 20 sweeps of a dip net through aquatic vegetation.

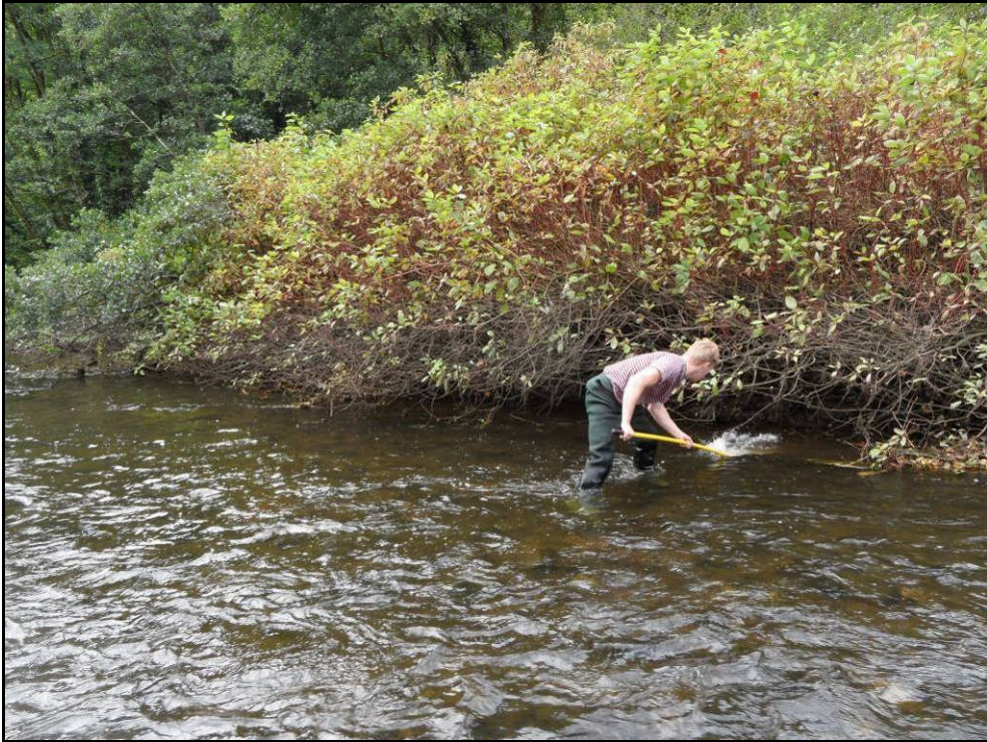
**Plate 7** Sweep netting at Site 1. A total of 20 sweeps were carried out at each site at random locations along the bank of the river.

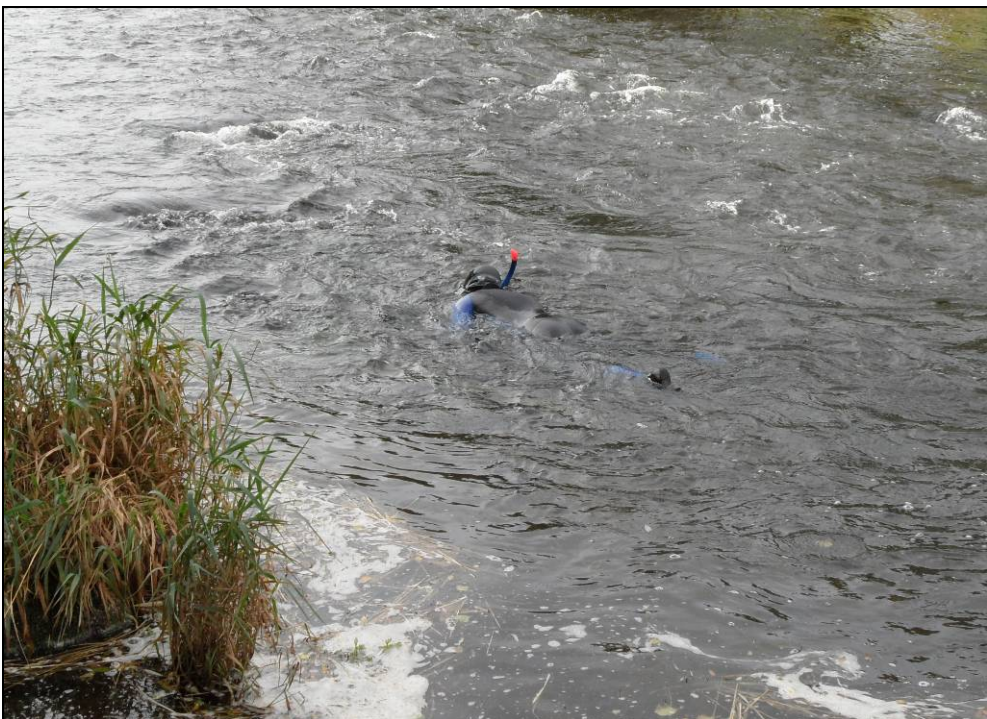
**Plate 8** Snorkel survey being carried out in riffled habitat in the River Bandon at Site 2.

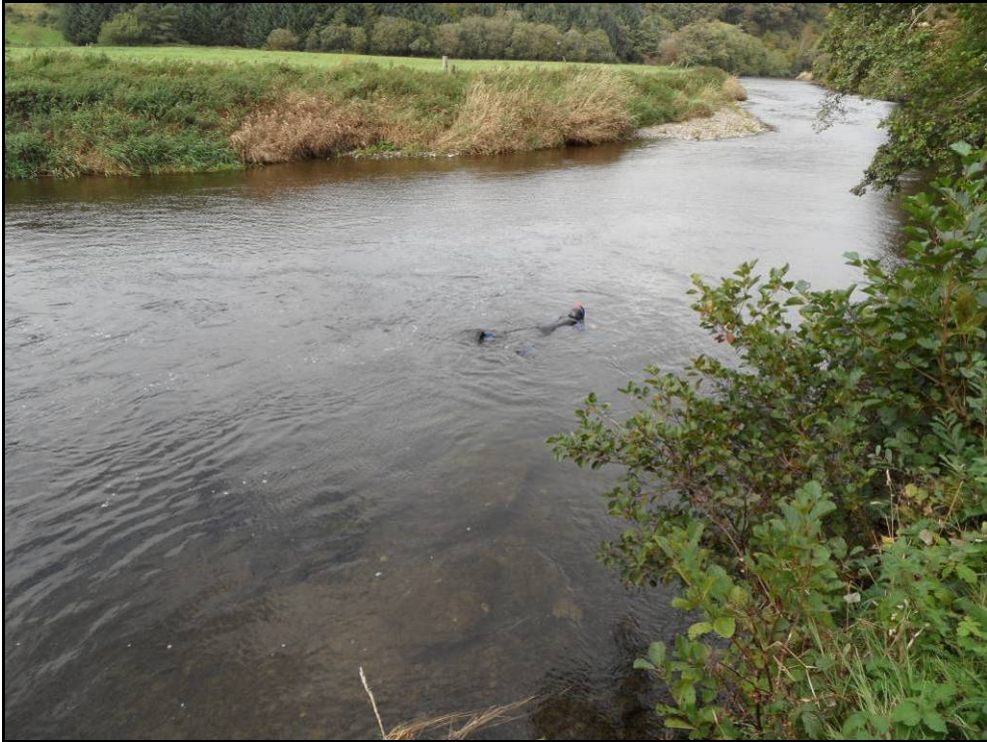
**Plate 9** Snorkeling in the Bandon River at Site 7. Adult salmon were located in this pool and also in the next pool downstream.

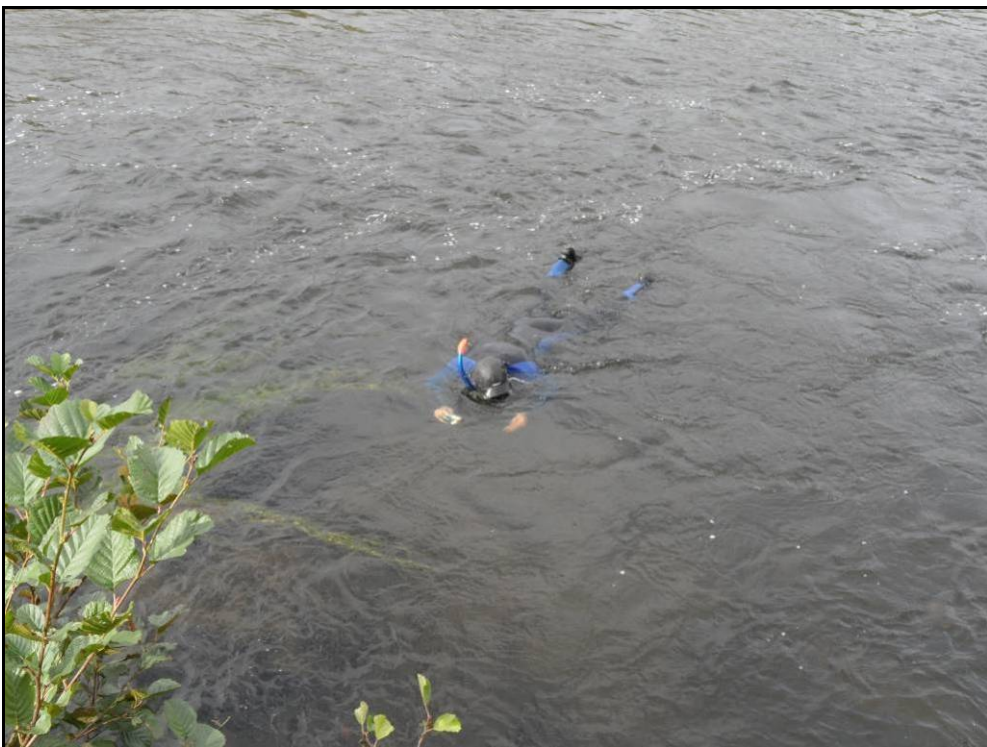
**Plate 10** Snorkeling at Site 11, the uppermost site on the Bandon River. This surveyed confirmed that this part of the river is an important area for both juvenile and adult salmon and trout.

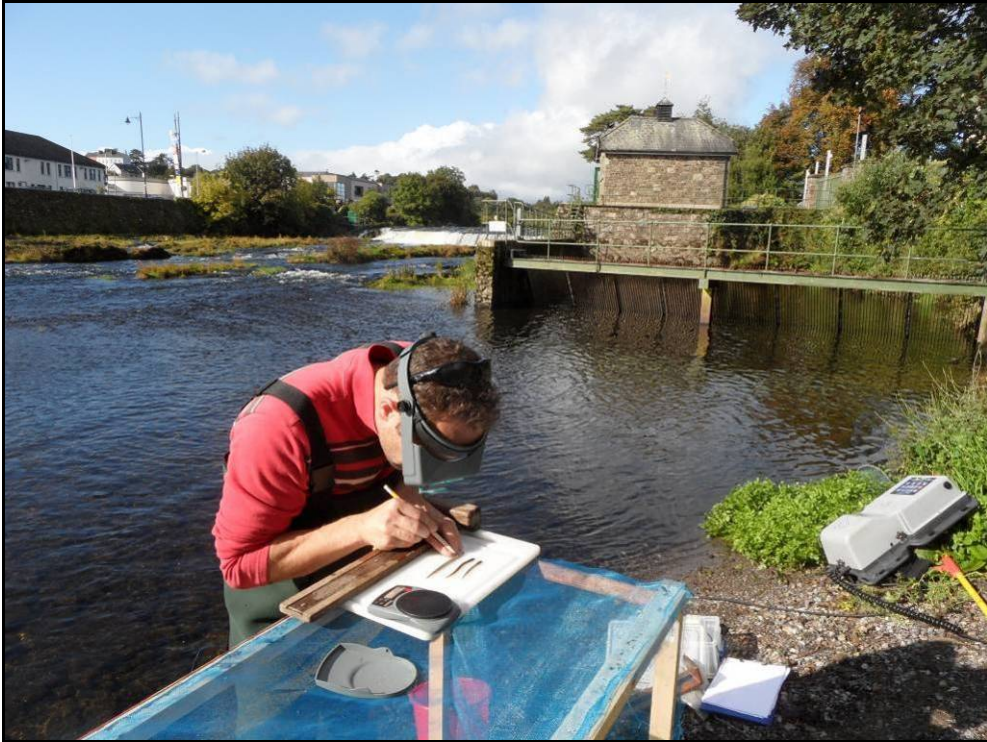
**Plate 11** Identification of juvenile lampreys captured at Site 10. This procedure involved counting trunk myomeres, assessing oral hood and caudal fin pigmentation and length measurement.

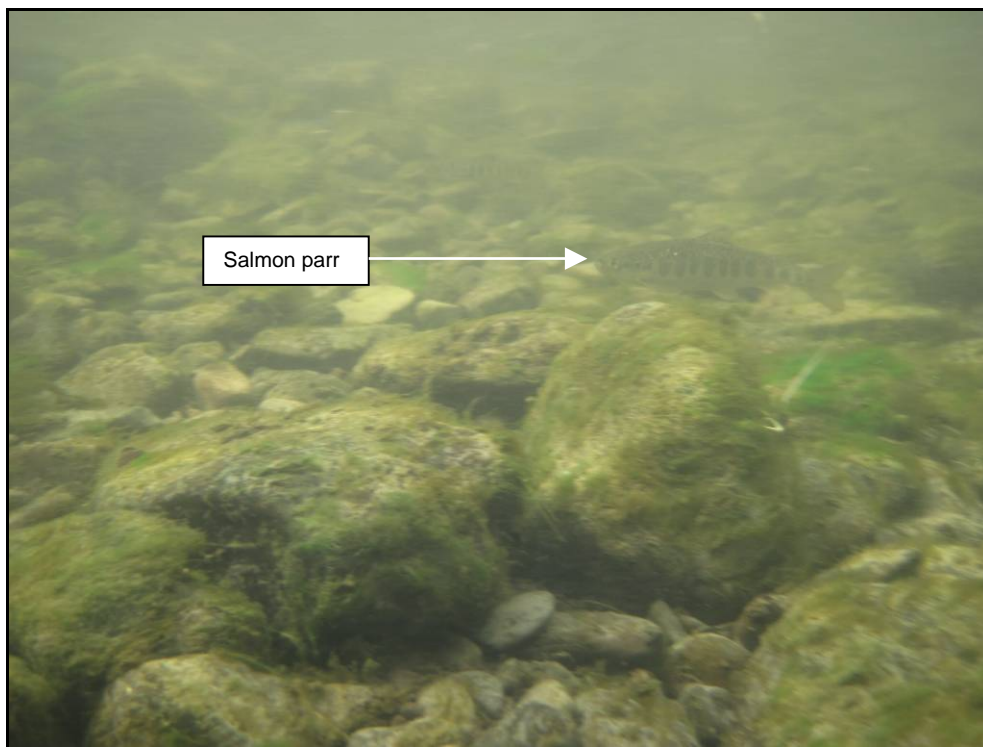
**Plate 14** Salmon parr *Salmo trutta* recorded while snorkeling at Site 7. Siltation of the substrate is evident in this picture. This was the result of the instream works that were carried out in the river in Bandon town.

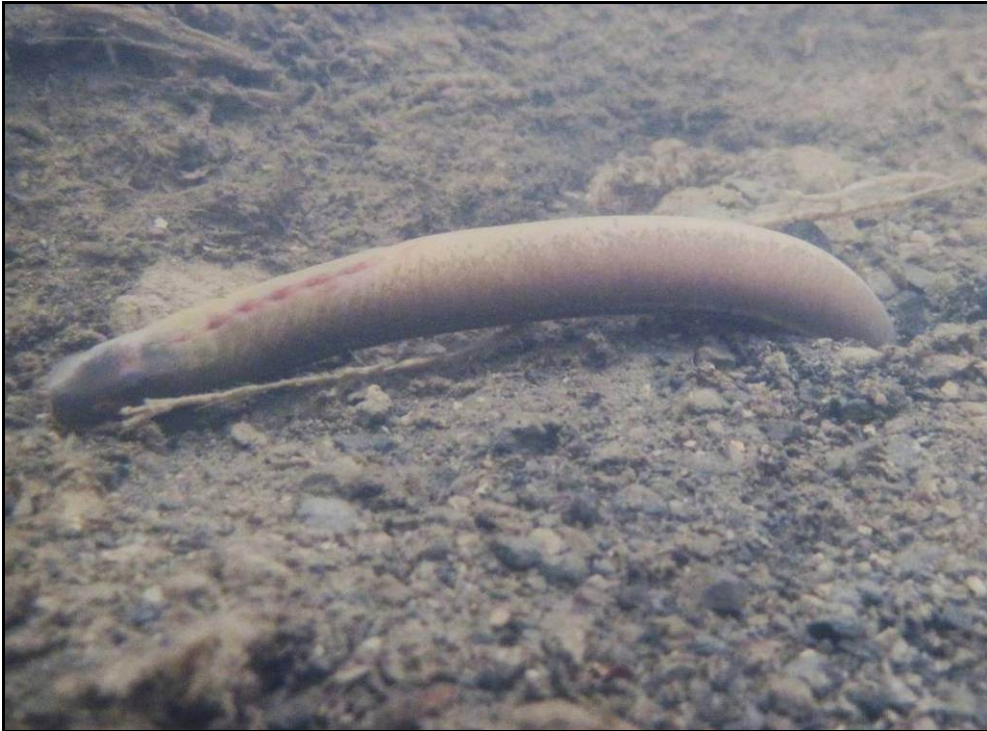
**Plate 28** Juvenile river/brook lamprey *Lampetra* sp. exiting its burrow. Most of the juvenile lamprey habitat used by lampreys at this life stage occurs along the edges of the river and are very susceptible to dredging works.

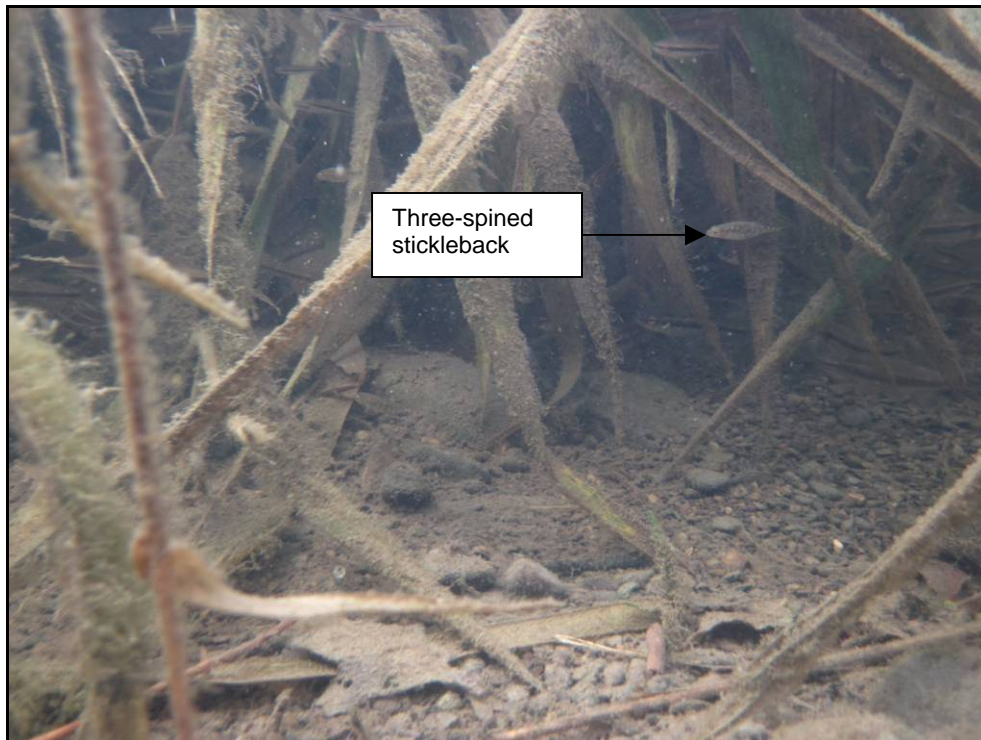
**Plate 29** Underwater image of the margin of the River Bandon at Site 4.
