# BANDON FLOOD RELIEF SCHEME

## FISH STOCK ASSESSMENT

Version: 1<sup>st</sup> November 2011 (Final)

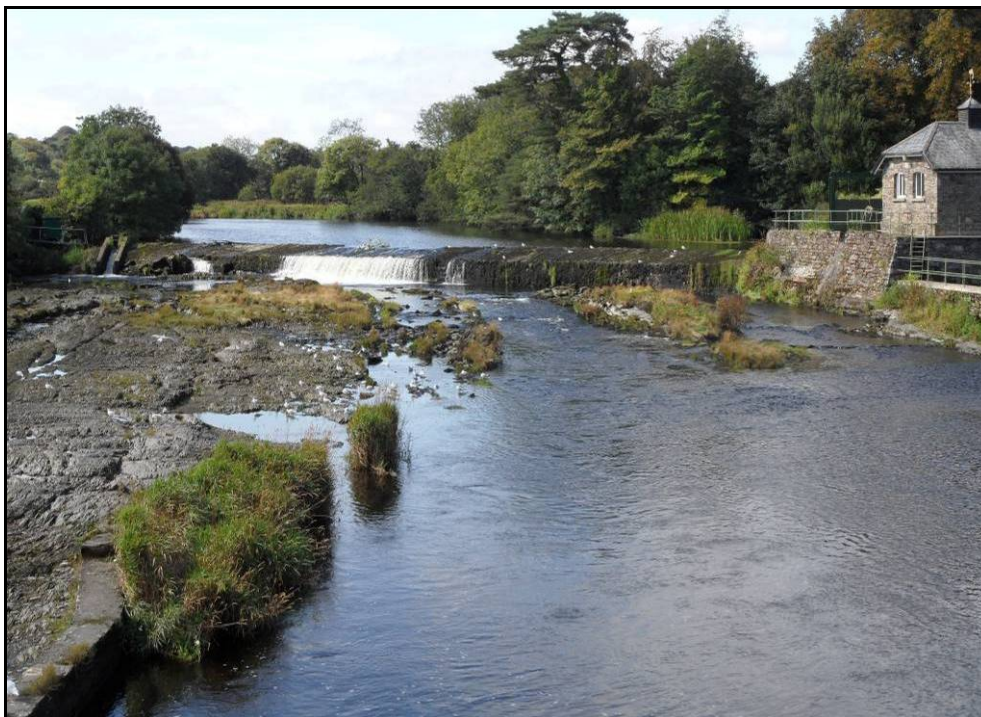
**Plate 30** Weir on the River Bandon in Bandon town. This point on the river is thought to be the upper limit for river lamprey (and flounder). This structure could also be a difficult obstacle for European eel to pass.

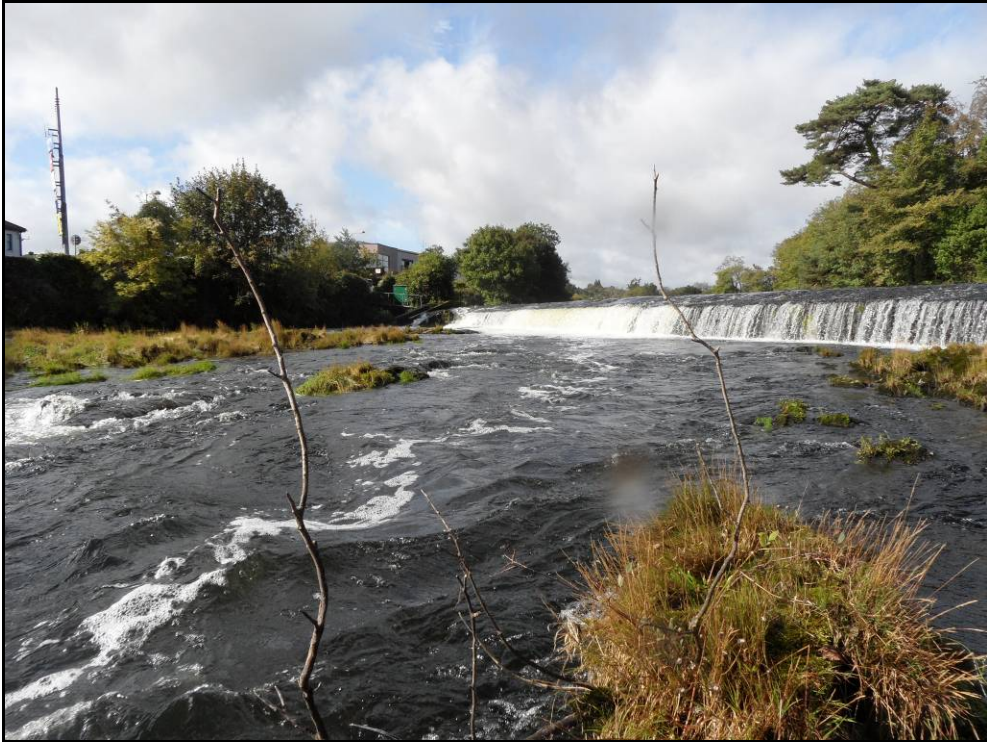
**Plate 31** River Bandon at the time of the survey was higher than normal.

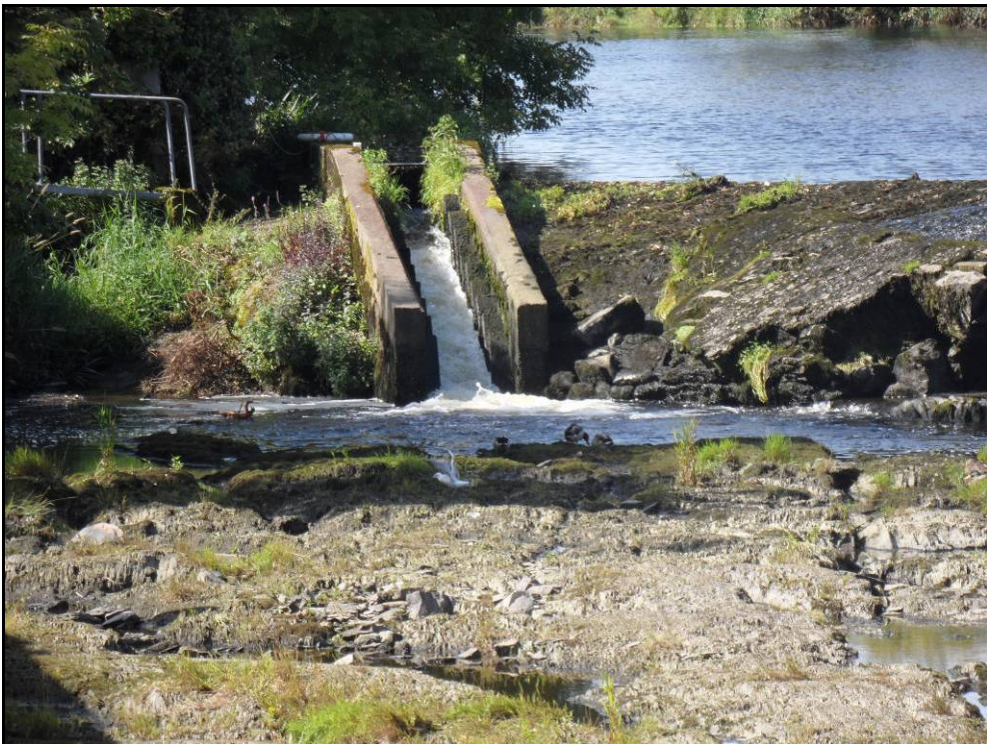
**Plate 32** Fish pass at the weir in Bandon. This picture was taken in early September when water levels were low.

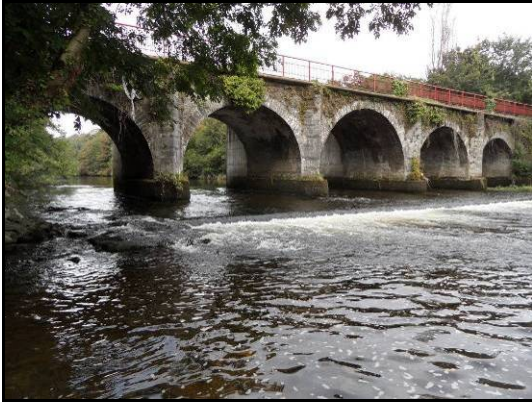
**Plate 33** Site 1 on the River Bandon at Inishannon Bridge, ca. 3km downstream of the proposed works. This is a very important part of the river for all life stages of salmon.

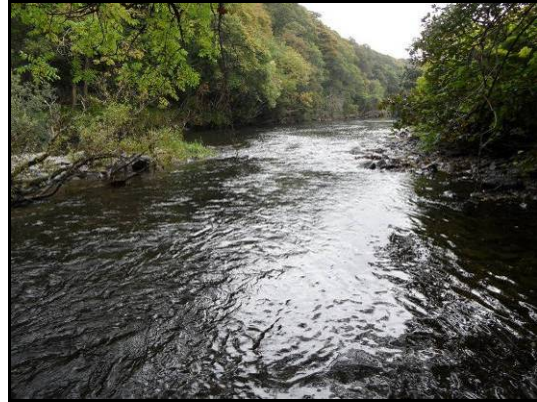
**Plate 34** Site 4 was located approximately 0.8km downstream of the proposed flood relief scheme.

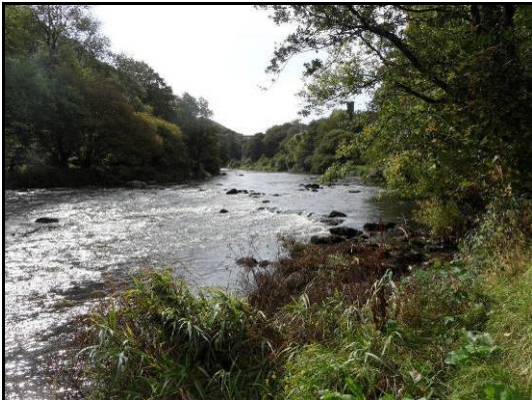
**Plate 35** Site 2 on the River Bandon approximately 1km upstream of Inishannon Bridge (ca. 2km downstream of the proposed works).

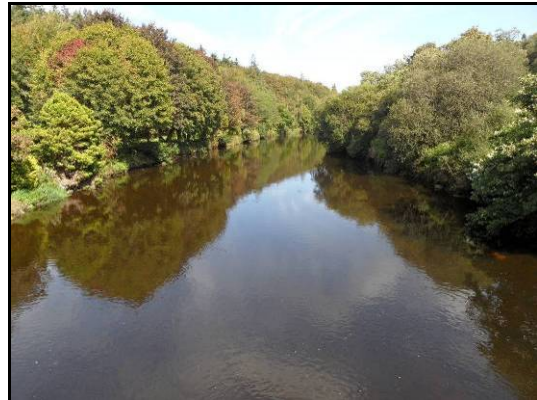
**Plate 36** Site 5 from the Bridge at Curranure. This sluggish stretch of the River Bandon is an important reach for juvenile lampreys.

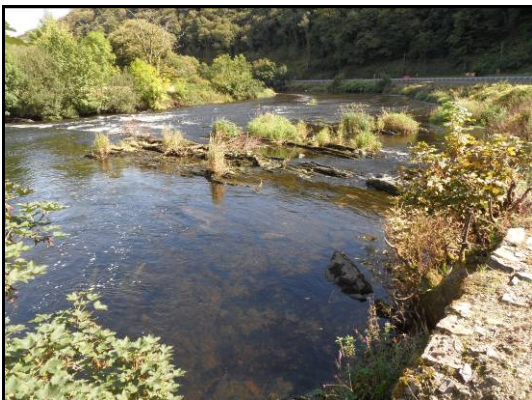
**Plate 37** Site 3 on the River Bandon was located approximately 1.5km downstream of the proposed works.

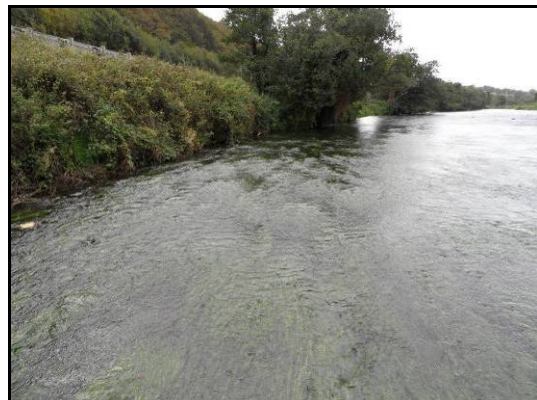
**Plate 38** Site 6 on the Bandon River. This part of the river is an important area for salmon, eel and lamprey and is within the stretch where the flood relief scheme is proposed.

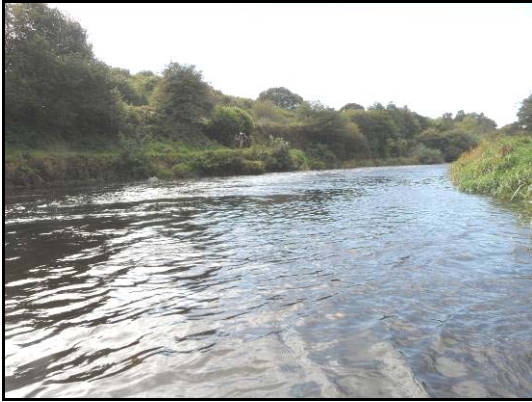
**Plate 39** Site 7 was located within the stretch of the River Bandon that would be affected by the proposed scheme. This area is important for all life stages of salmon, including holding adult fish.

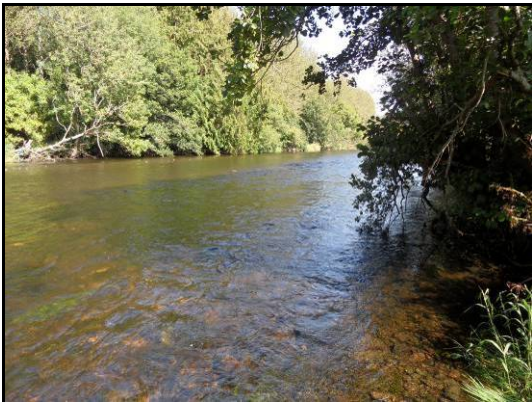
**Plate 41** Site 8 on the Bandon River was located approximately 1 km downstream of the bridge in Bandon within the proposed flood relief scheme.

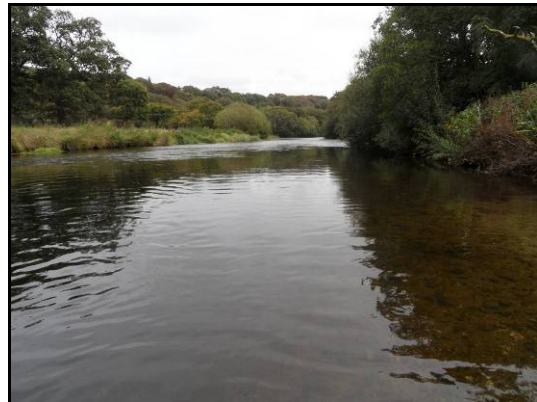
**Plate 42** Site 11 on the Bandon River upstream of the proposed flood relief scheme.

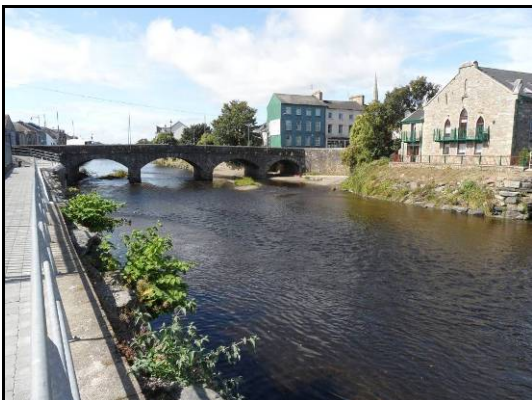
**Plate 43** Bandon River in Bandon at the R589 Bridge (Site 9). Instream works that previously took place along this stretch have diminished the fisheries value of this area.

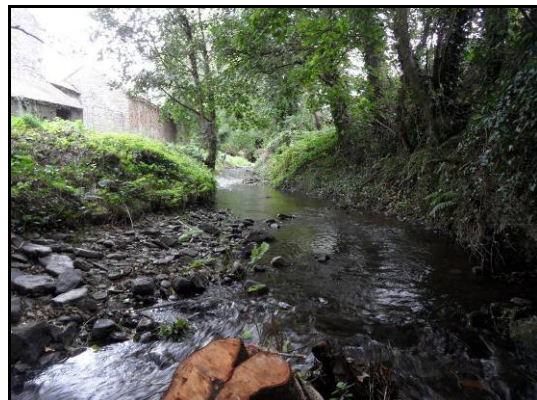
**Plate 44** Site 12 on the Bridewell River. This tributary of the Bandon joins the Bandon River upstream of the proposed flood relief scheme.

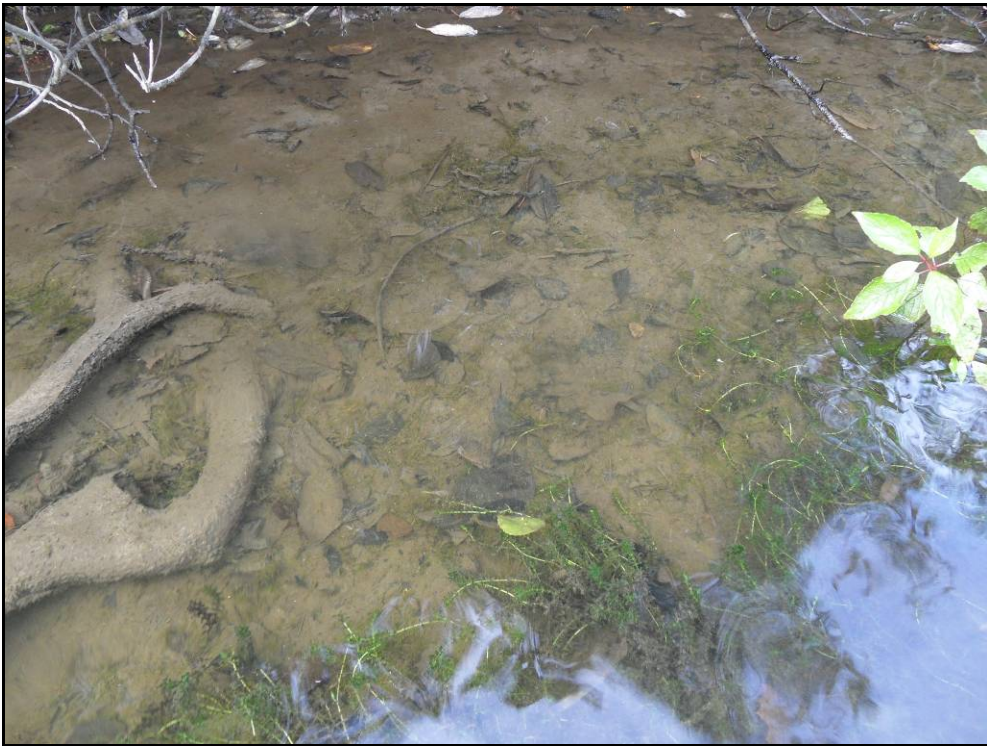
**Plate 45** Deposited silt such as this provides optimal burrowing habitat for juvenile lampreys. Such areas in the lower River Bandon are deemed especially important for river lampreys given that this species is probably restricted to the river downstream of Bandon. .

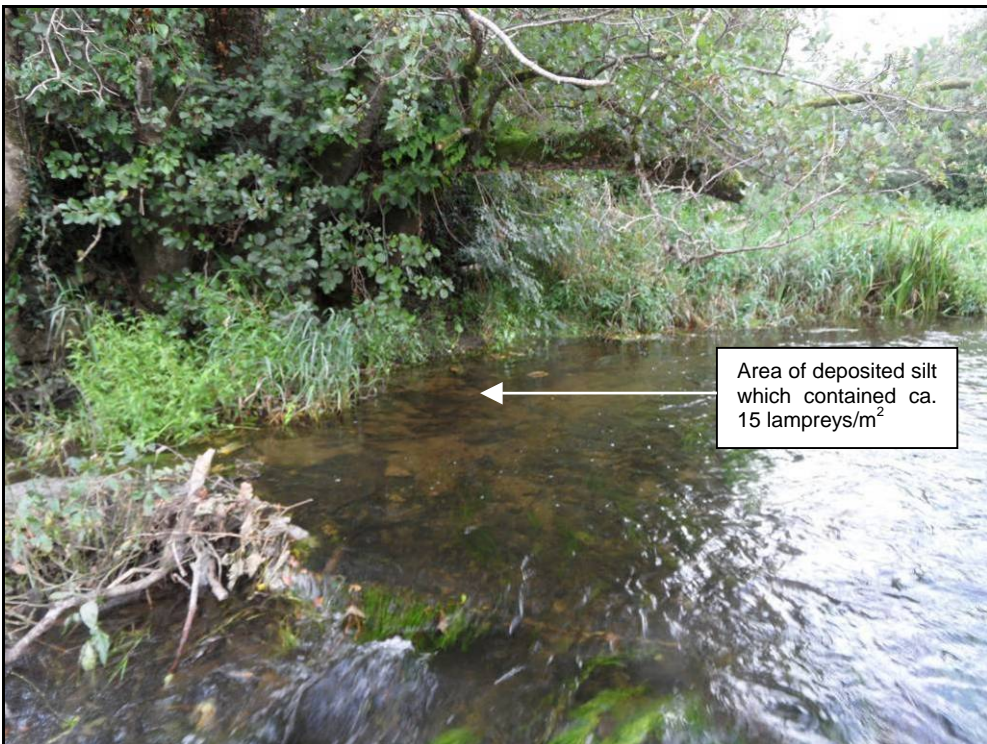
**Plate 46** Lamprey electrical fishing location at Site 3.

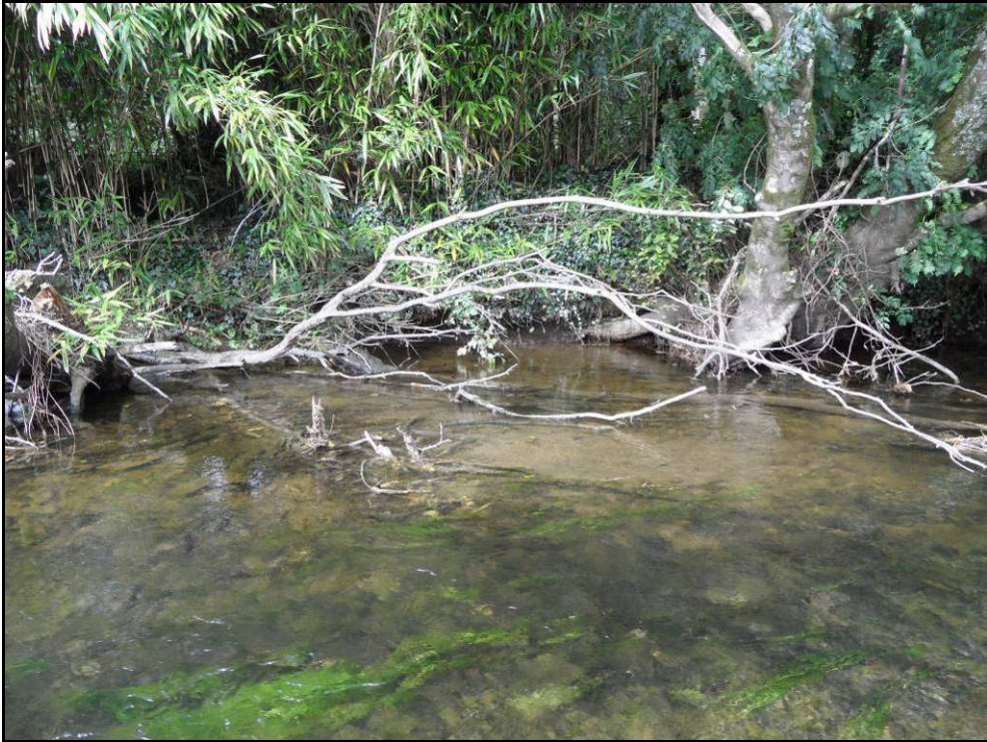
**Plate 47** Lamprey electrical fishing location at Site 8. A total of 103 river/brook lampreys were recorded in 3m<sup>2</sup> of the silt bed shown above. This type of depositing habitat shown occurs at various locations along this part of the river and is likely to hold similar densities of lampreys.

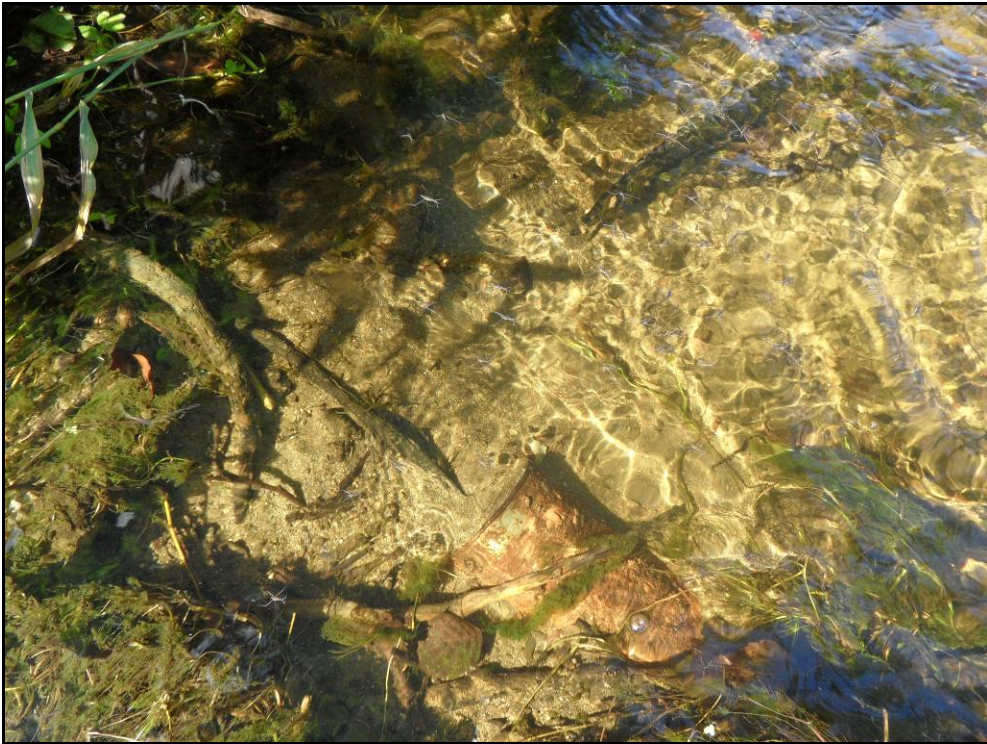
**Plate 48** Optimal habitat for juvenile lampreys occurs at various locations along the verge of the River Bandon. Such habitat is more common along depositing reaches. Shown above is substrate consisting of fine sand and silt at the edge of the river at Site 4.

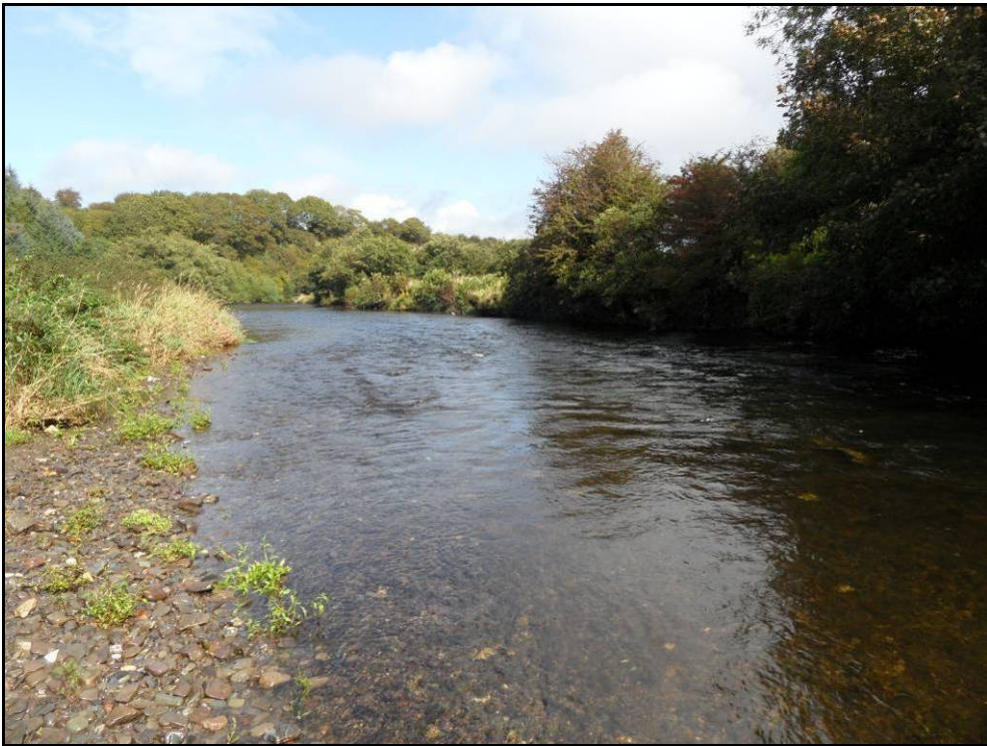
**Plate 49** Salmonid electrical fishing location at Site 7.

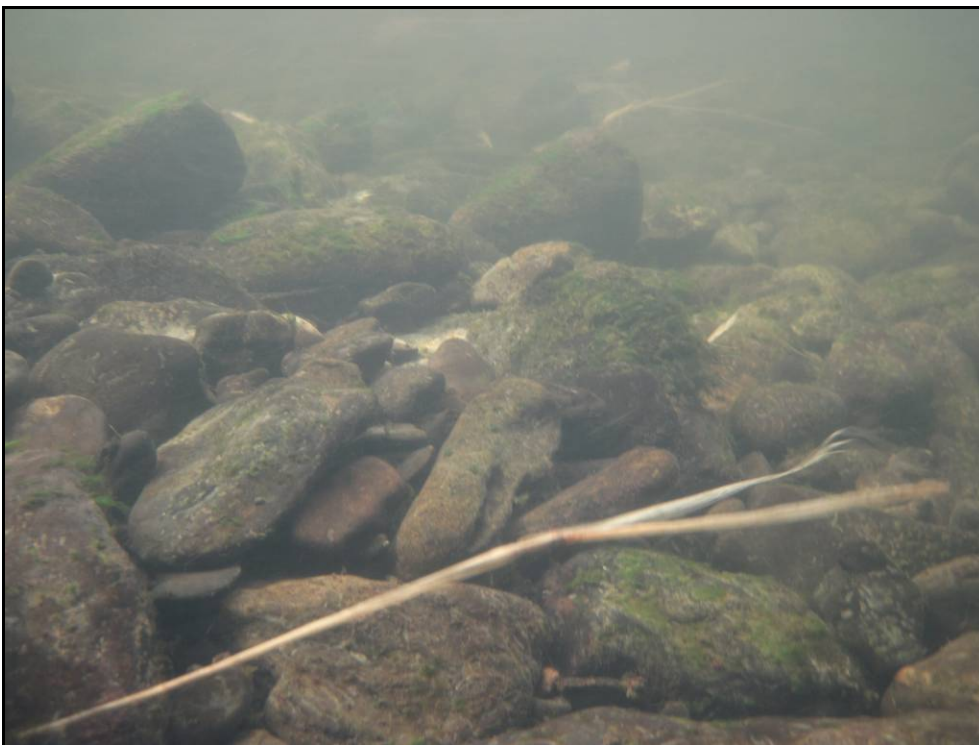
**Plate 50** Underwater view of the substrate at Site 7. This combination of rock and cobble in a fast flowing area provides ideal nursery conditions for young salmon and trout.

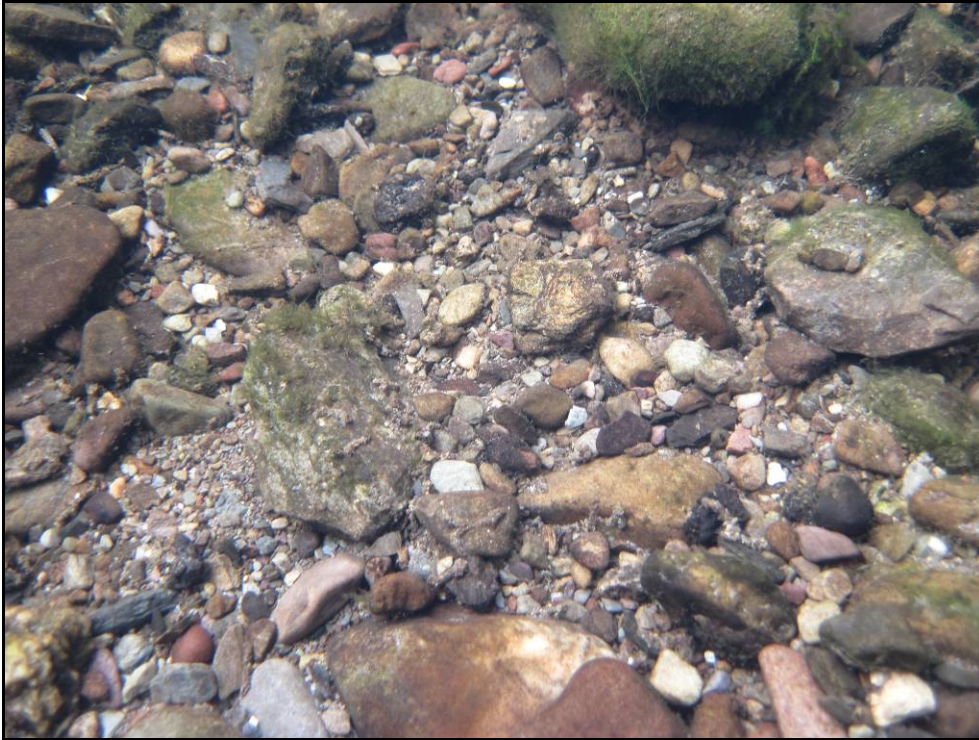
**Plate 51** Substrate in the River Bandon in a glide flow feature upstream of the instream works (photo taken on 23<sup>rd</sup> September 2011).

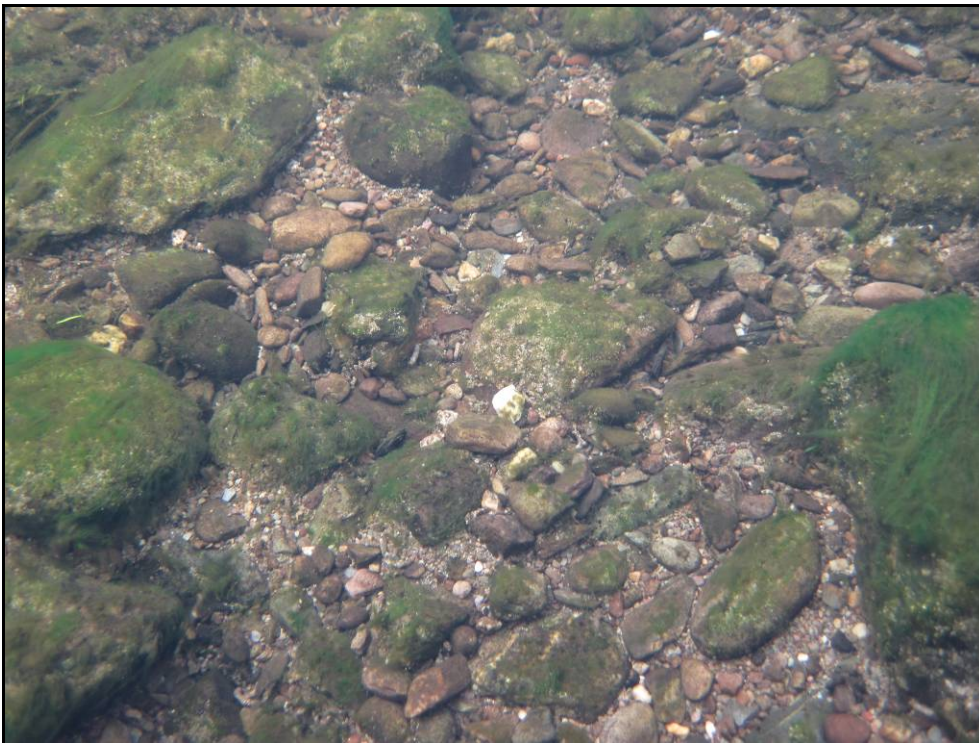
**Plate 52** View of substrate in the River Bandon in a riffled area upstream of the instream works (photo taken on 23<sup>rd</sup> September 2011).

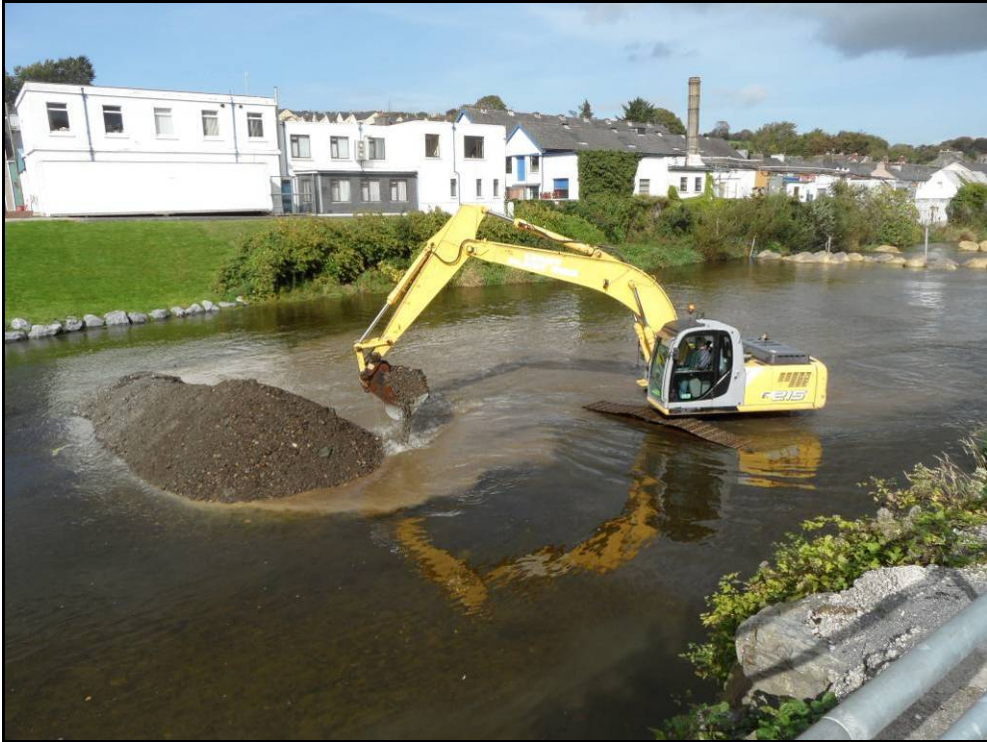
**Plate 53** Instream works that were taking place on the Bandon River on 22<sup>nd</sup> September 2011.

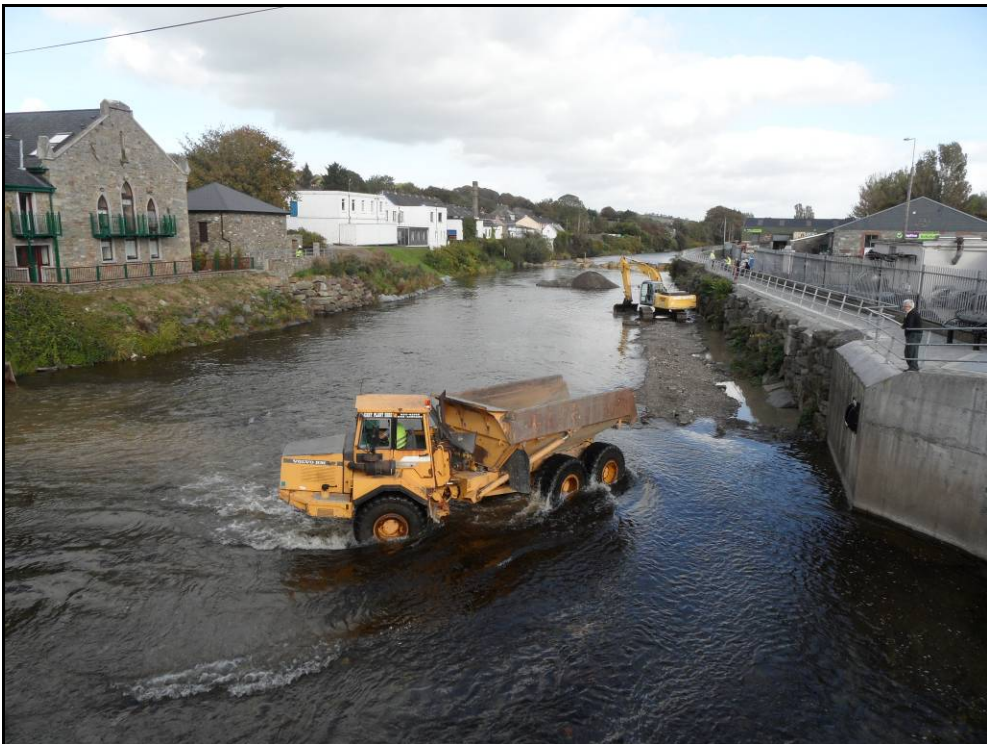
**Plate 54** Instream works that were taking place on the Bandon River on 22<sup>nd</sup> September 2011.

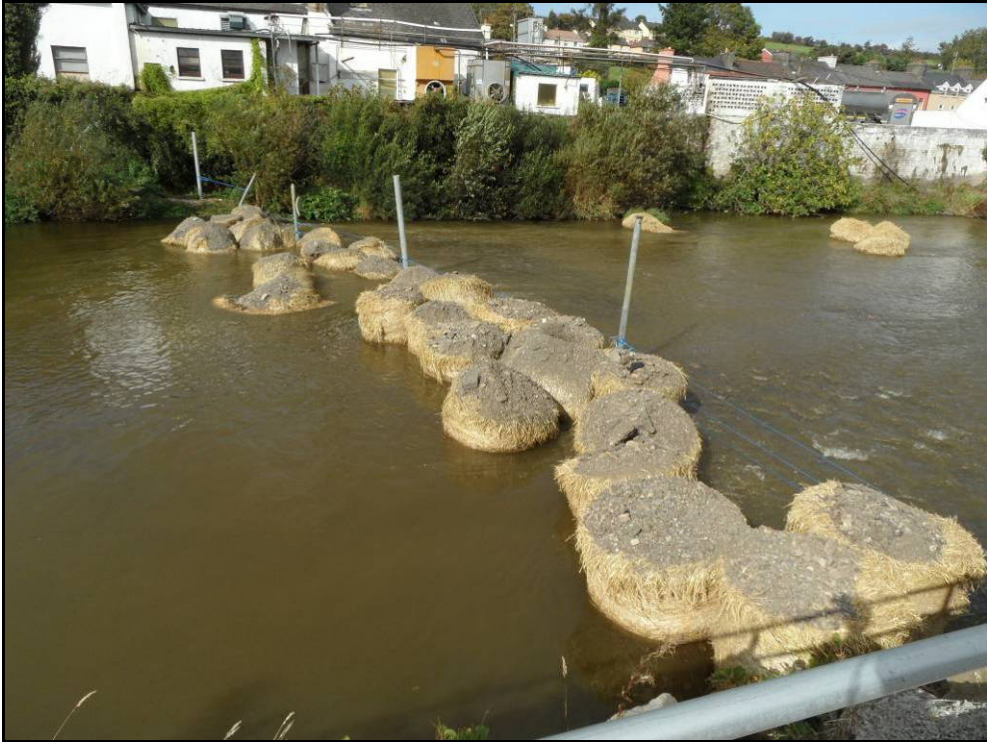
**Plate 55** Ineffective silt control measures being used downstream of the instream works on the River Bandon. Straw bales can be seen floating downstream in the background. The bales have also been topped with silt, which inevitably was also washed downstream.

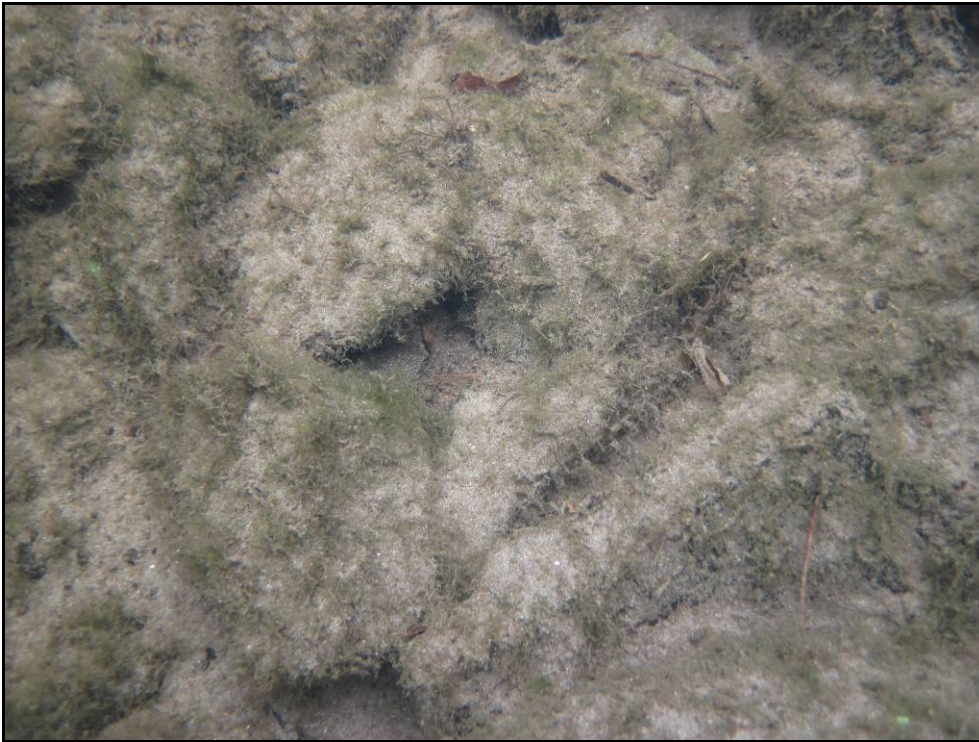
**Plate 56** Siltation on the River Bandon downstream of the instream works within Bandon Town (photo taken on 23<sup>rd</sup> September 2011).

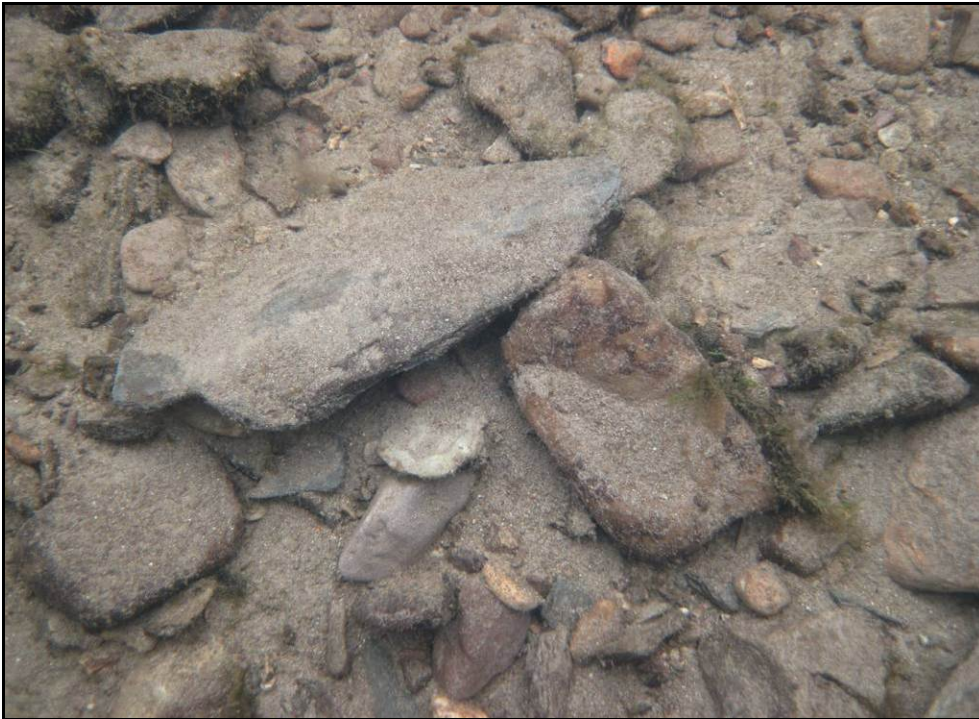
**Plate 57** Siltation on the River Bandon downstream of the instream works within Bandon Town (photo taken on 23<sup>rd</sup> September 2011).

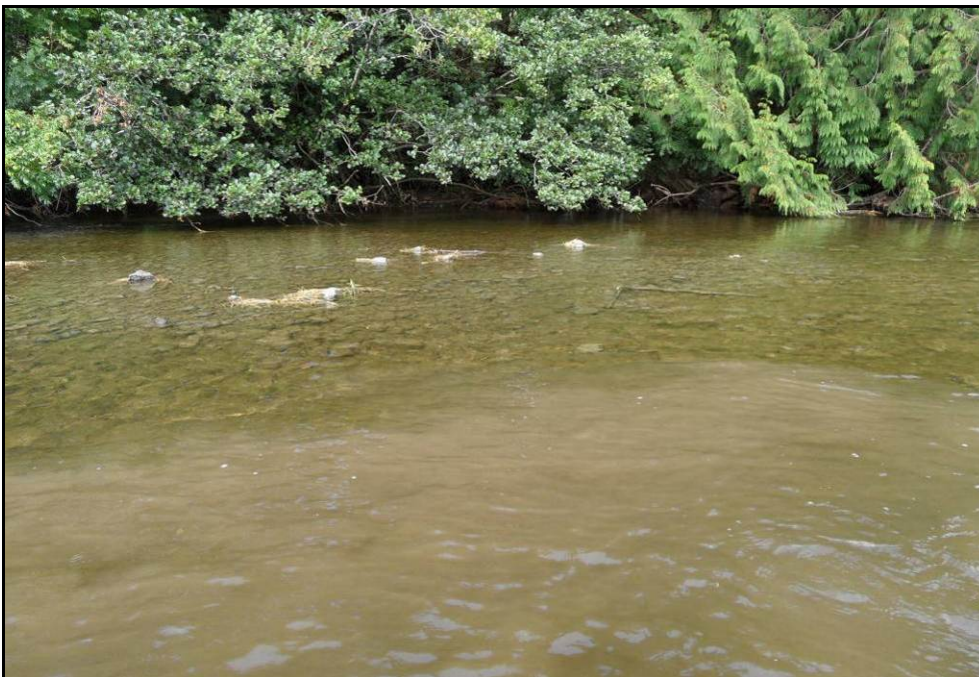
**Plate 58** Plume of silt caused by walking in the River Bandon approximately 1km downstream of the works, illustrating high level of siltation in this area in advance of salmonid spawning season. It is clear from this photo the level of suspended solids pollution experience by section of the river downstream of the instream works. As works also took place during September 2010 it is clear that such works could have affected salmonid production in this stretch and therefore the results of the current survey.

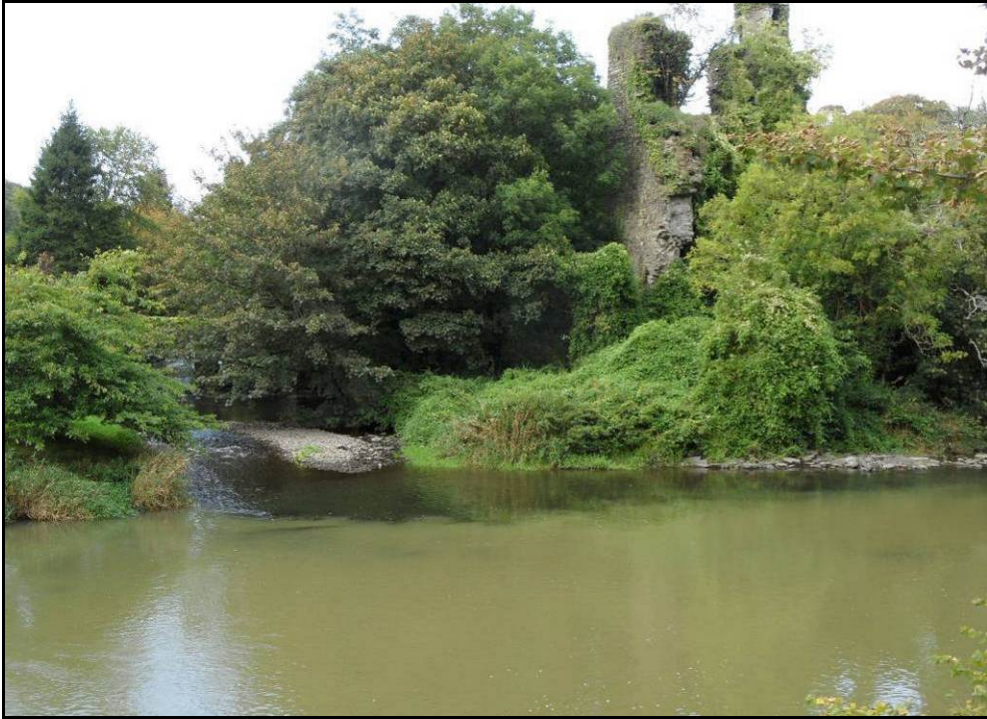
**Plate 59** Confluence of the River Brinny with the River Bandon approximately 5.5km downstream of the instream works in Bandon. It is clear from this photo the level of suspended solids pollution experience by section of the river downstream of the instream works.

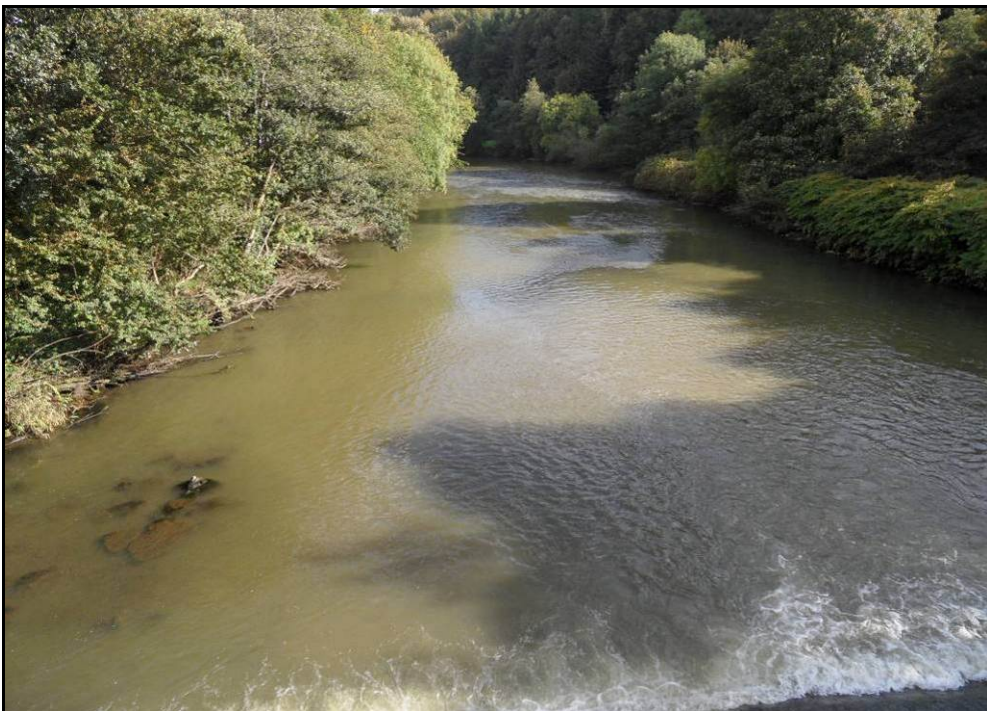
**Plate 60** River Bandon at Inishannon Bridge in the evening of the 22<sup>nd</sup> of September, also showing suspended solids pollution.
