# **STUDY TO IDENTIFY PRACTICAL MEASURES TO ADDRESS FLOODING AT CARNMORE/ CASHLA**

AUGUST 2010

Client	Office of Public Works
Project No.	2138//11/10
Project Title	Clare River Flood Study
Report Title	Study to Identify Practical Measures to Address Flooding at Carnmore/ Cashla

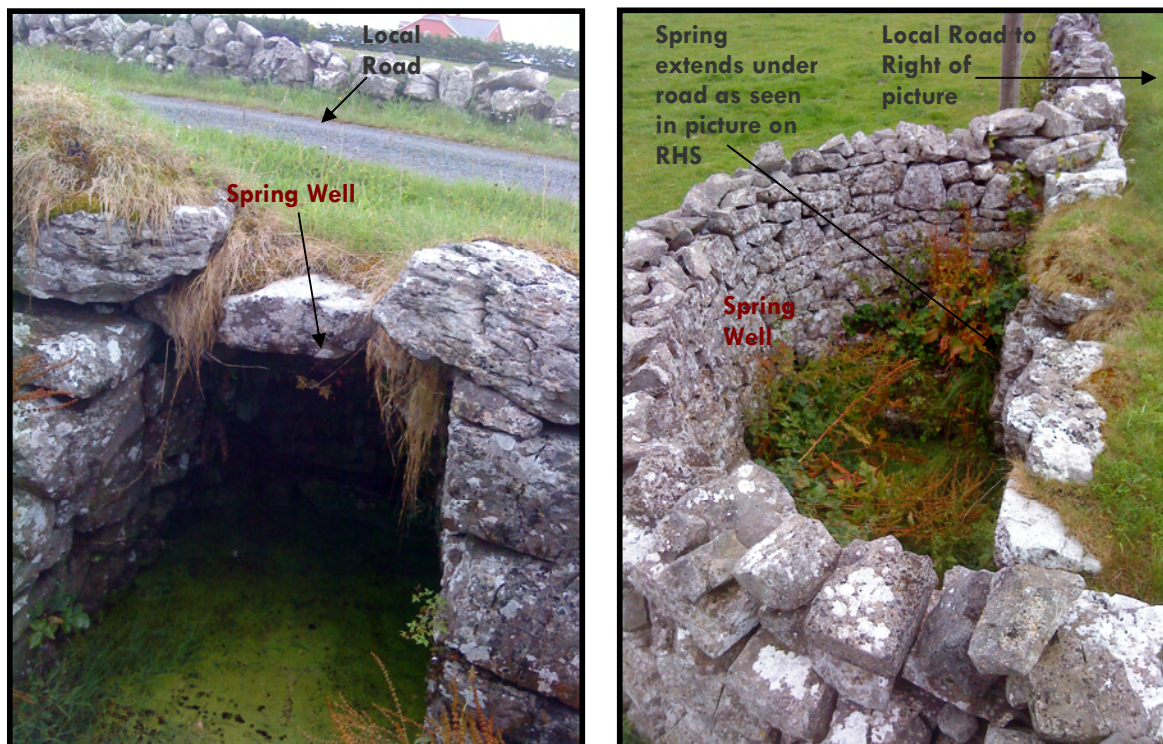
Plate 2.1 Spring Well at Cashla

The whole catchment forms part of a Regionally Important Karstified (conduit) Aquifer. Karst features are located in the vicinity of the catchment, most notably the separate floods/turloughs which have led to the flooding in November 2009, which is the subject of this report. As noted previously, Karstic features in the vicinity of the study area include a shallow well and a seasonal spring at Cashla and caves and souterrains in Carnmore. The shallow Well in Cashla can be seen in Plate 2.1.

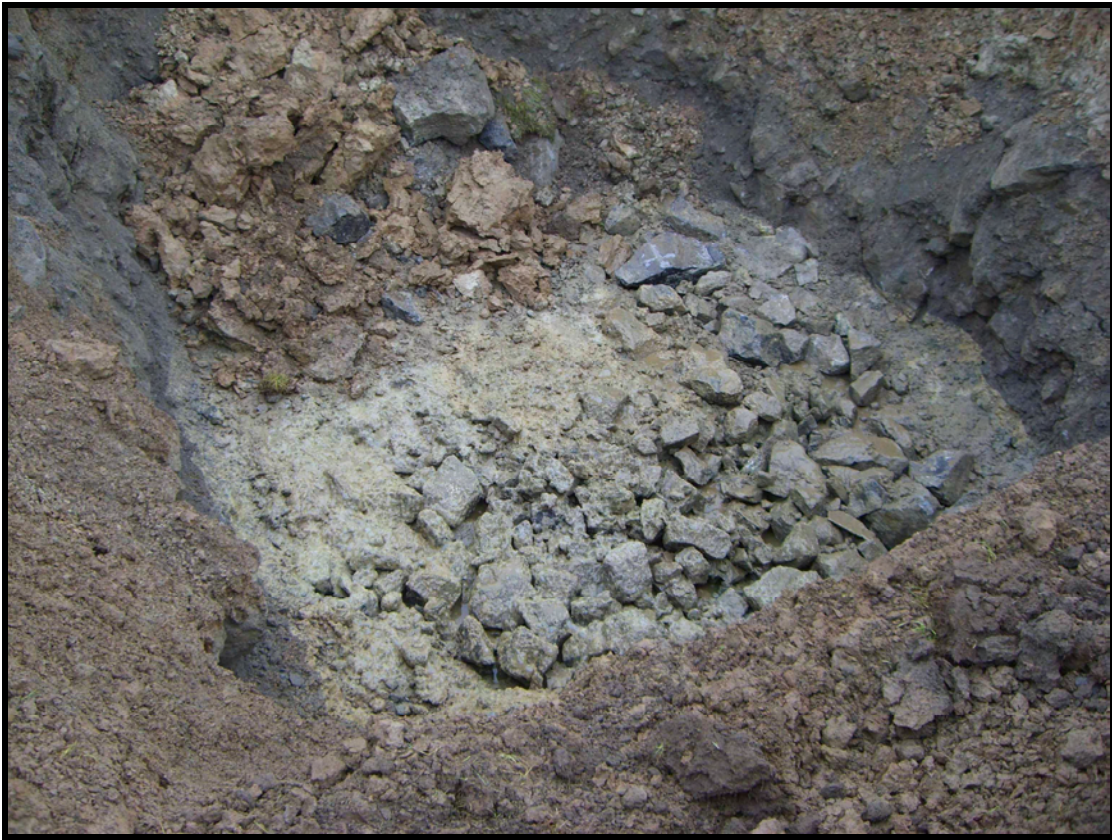
Plate 2.2 Trial Pit No.1, Permeability Test No.2

The first trial pit was dug down to weathered rock and a permeability test was carried out. Following this, the weathered rock was removed and a second permeability test was carried out. A second trial pit was excavated down to the top of a layer of impermeable clay, or 'daub' and a third infiltration test was carried out.

The first permeability test lasted for 50 minutes. In the second permeability test, which was carried out on the bedrock, the water took 11 minutes to dissipate. In the third test, which was carried out on a layer of daub, it is reported that the water took 24 hours to dissipate. The first trial pit was subsequently backfilled with stone and left as an artificial swallow hole. A month later, following a period of rainfall, approximately 10-15 acres of land around the trial hole flooded for 3-4 days.

It should be noted that these permeability tests are not necessarily representative of the overall characteristics of the subsurface layers within the study area. Photographs of the trial pits are shown on Plates 2.2 & 2.3.

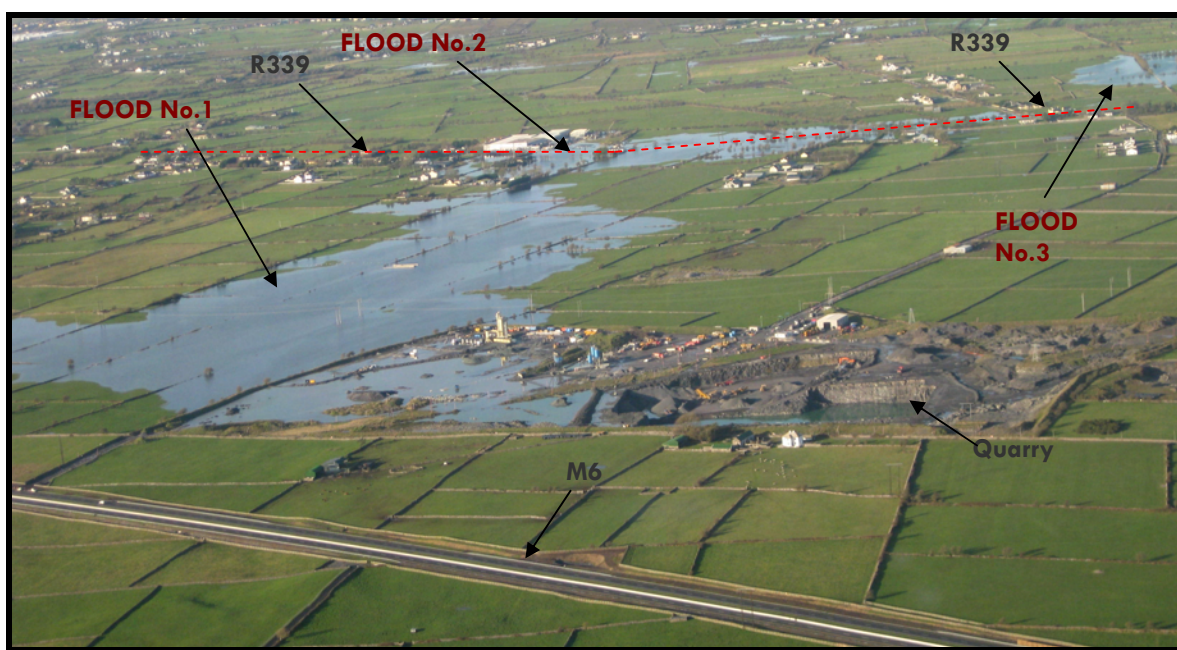
Plate 2.4 Aerial Photography of Flooding in November 2009 (taken from Southeast)

Flood No. 1 is a turlough which originates approximately 1km south of the R339. In November 2009, the turlough expanded to cover an area of approximately 0.5 km<sup>2</sup> and came within 260m of the R339, overflowing into Flood No. 2 during the flood event. A quarry is located at the southeast end of the turlough. Aerial photographs of the flooding support the anecdotal evidence of local residents who contend that flood waters were pumped from the open quarry into the turlough during the flood event. The water level in the quarry can be seen to be lower than that in the surrounding land, in Plate 2.4 for example. The new M6 motorway is routed approximately 200m to the South of Flood No.1. Immediately to the North of the turlough are two houses (House Nos. 9 &10 as shown on Drawing No.001) and farm buildings. House No.9 was in danger of flooding in November 2009. It was not possible to establish timescale for Flood No.1 in November 2009. Given the interconnection between Floods No. 1 & 2, the levels of the two the floods are likely to have equalised prior to the peak flood level, possibly around Saturday 21<sup>st</sup> November 2010. Aerial photography of Flood No.1 is shown in Plate 2.4.
