5 FLORA AND FAUNA

This section of the Environmental Impact Statement (EIS) describes the potential impacts of the proposed Bandon Flood Relief Scheme (FRS) on flora and fauna and has been completed in accordance with the guidance set out by the Environmental Protection Agency in 'Guidelines on Information to be contained in Environmental Impact Statements' (EPA, 2000).

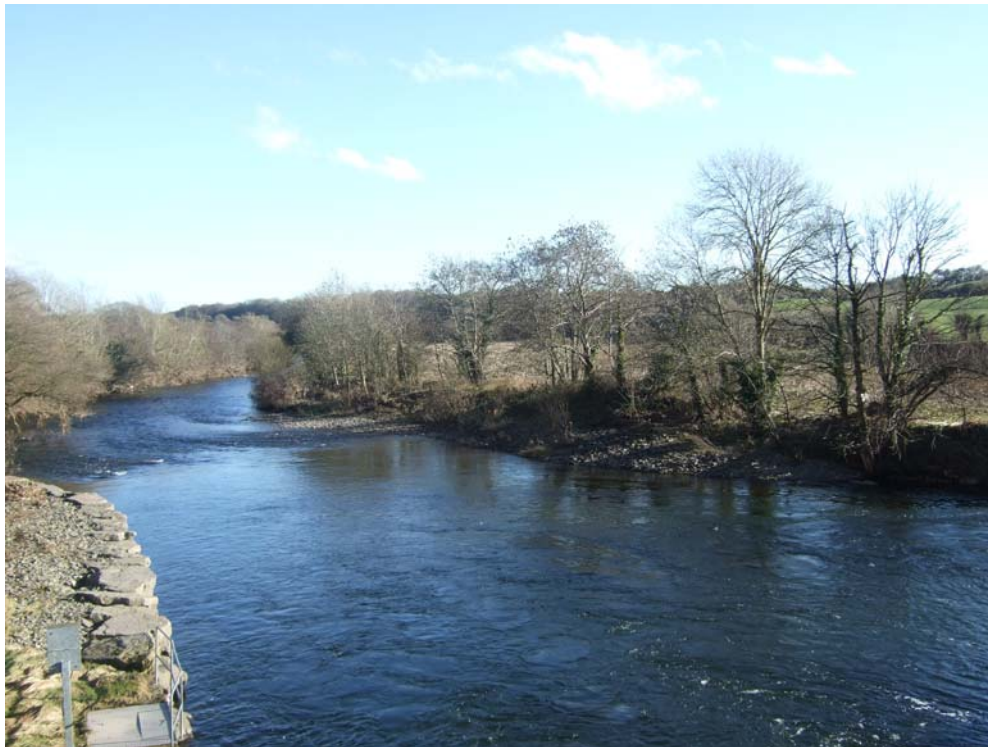
Plate 5.2 Bandon River to the west of the study area, showing the fast flowing river with fringing trees.

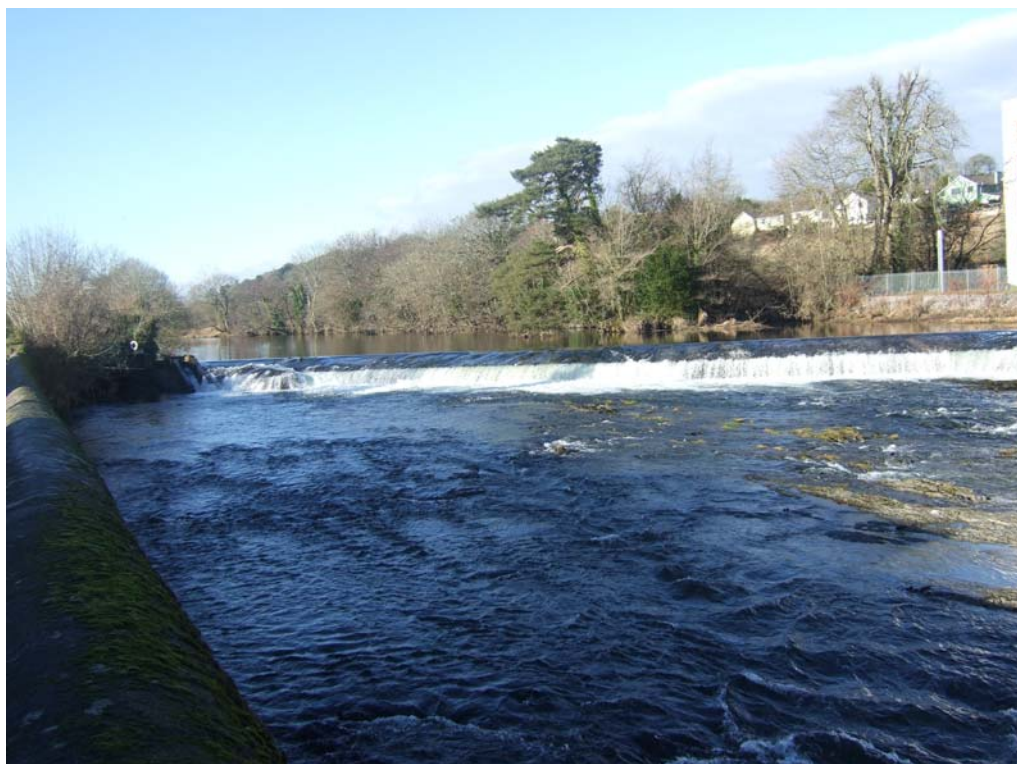
Plate 5.4 Bandon Weir as viewed from downstream

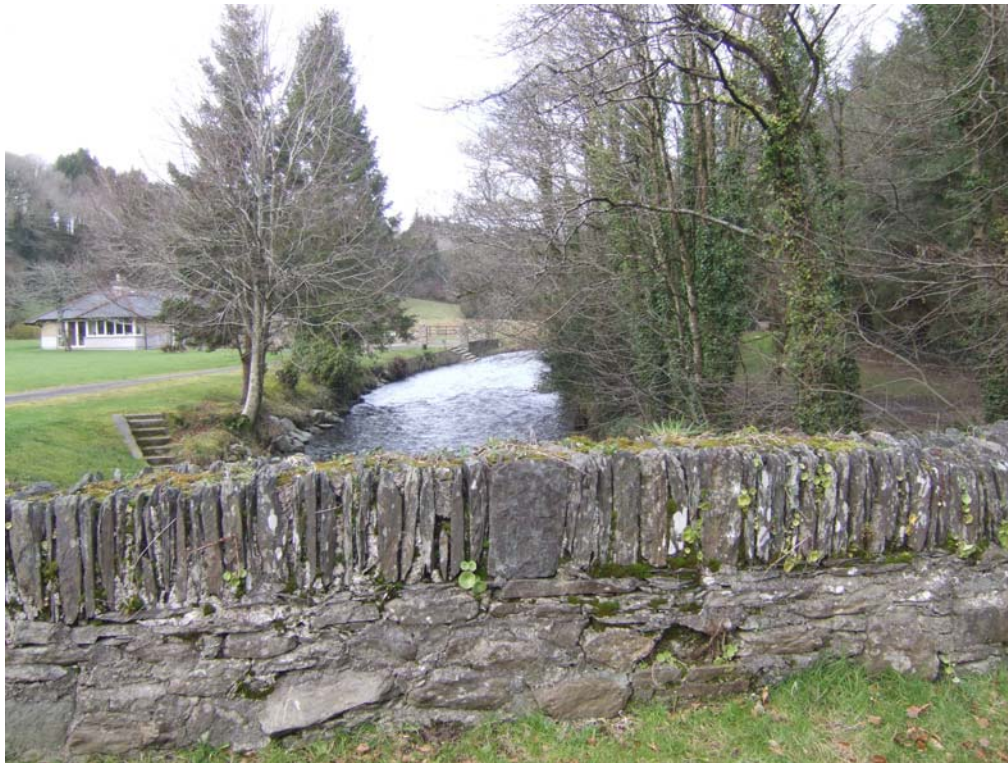
Plate 5.6 Brinny River as viewed facing upstream from Downdaniel Bridge

The Brinny River within the study area flows through a steep wooded valley and discharges to the Bandon River between Bandon Town and Inishannon. It is relatively fast flowing with a stoney/gravelly substrate (Plate 5.6).

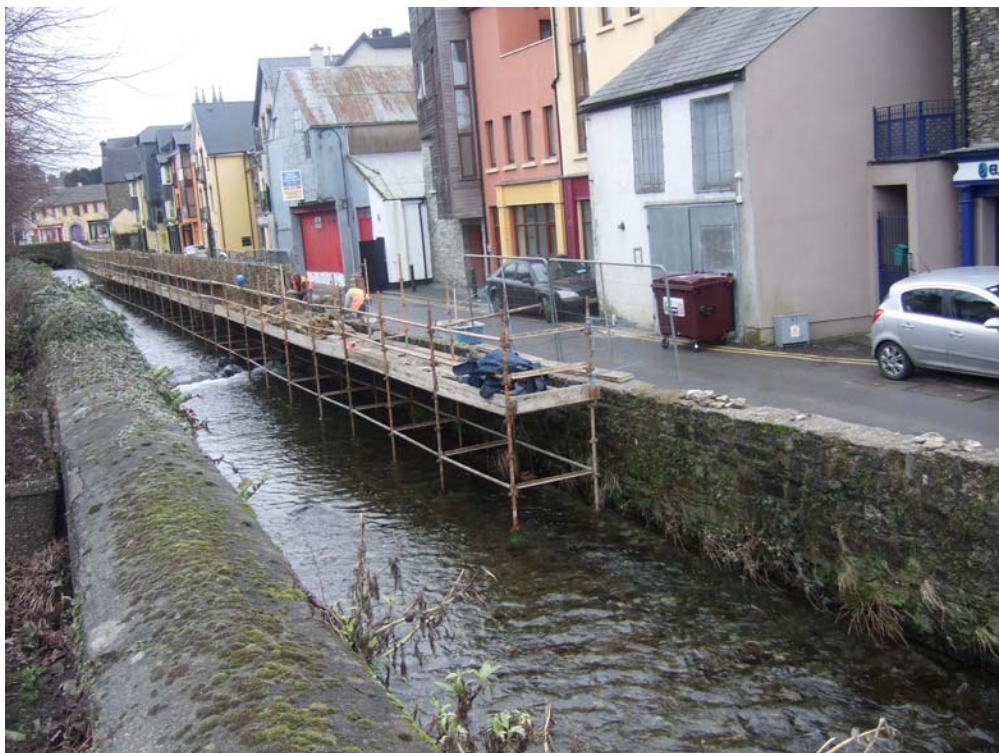
Plate 5.7 Modified channel of the Bridewell River in Bandon Town.

The Bridewell River flows from the south west of Bandon Town into the Bandon River immediately downstream of the bridge in the town. This river flows through more open country than the Bandon River itself with less hills and woodland. The substrate of the river is stony and gravelly. It is extensively culverted within Bandon Town and at Oldchapel (Plate 5.7).

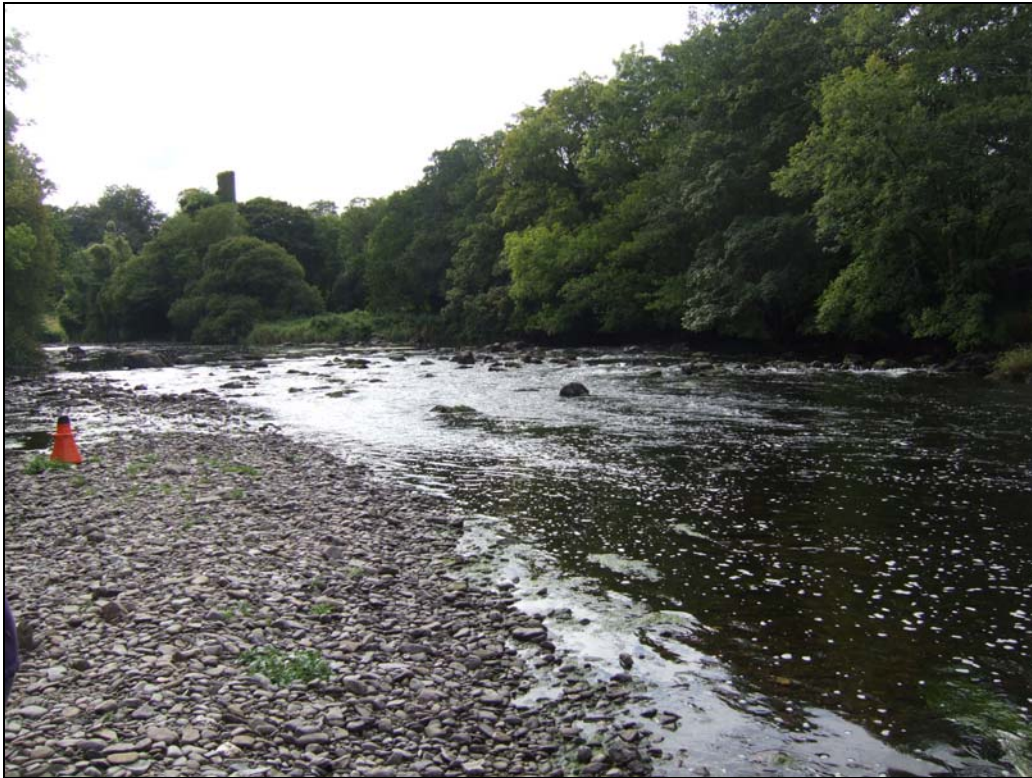
Plate 5.8 Bandon River close to the outfall of the Brinny River and exhibiting the characteristics of an eroding river with fast flows and substrate of large sediments.

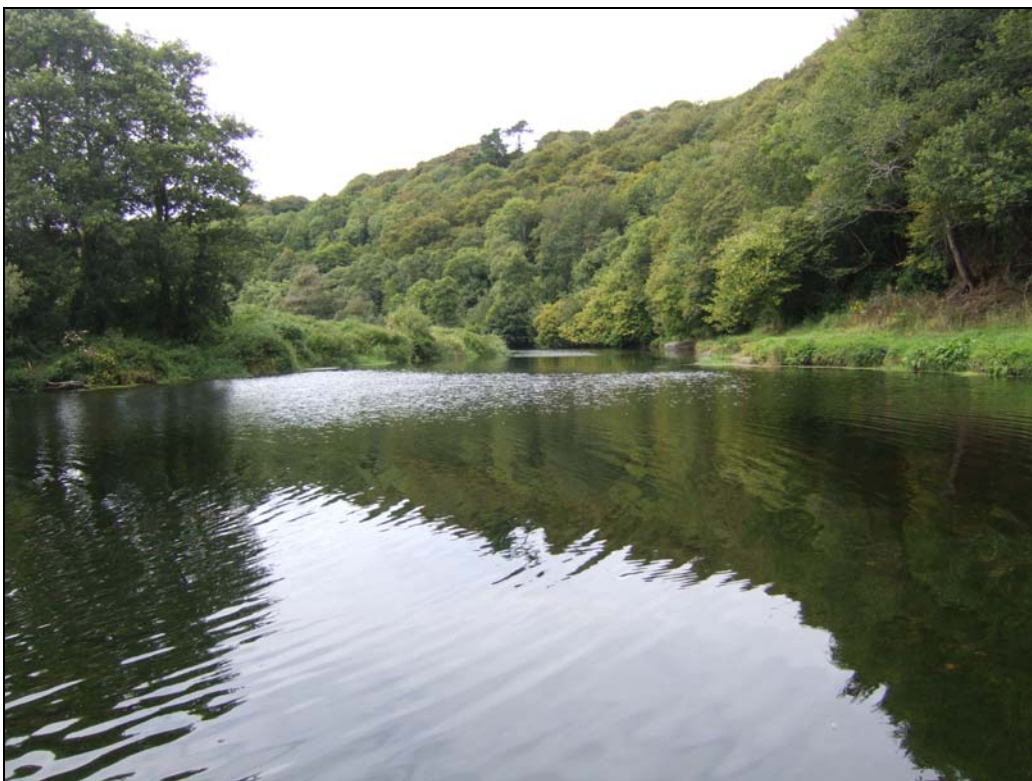
Plate 5.9 Bandon River in deep pool section approximately 500 metres upstream of Inishannon Bridge.

The river itself was variable in form with the majority of sections best classified as an Eroding River (FW1) even though the stretch surveyed was close to the tidal sections at the mouth of the river (Plate 5.8). Over the majority of its course through the study area, the substrate of the river was comprised of larger sediments from boulders to gravels with finer silts and sands only abundant at the edges of the channel and in the deeper pools. There was also exposed bedrock at various locations along the study area. Some of the glides and pools however, were characteristic of a lowland Depositing River (FW2) with finer sediments and slower flows (Plate 5.9).

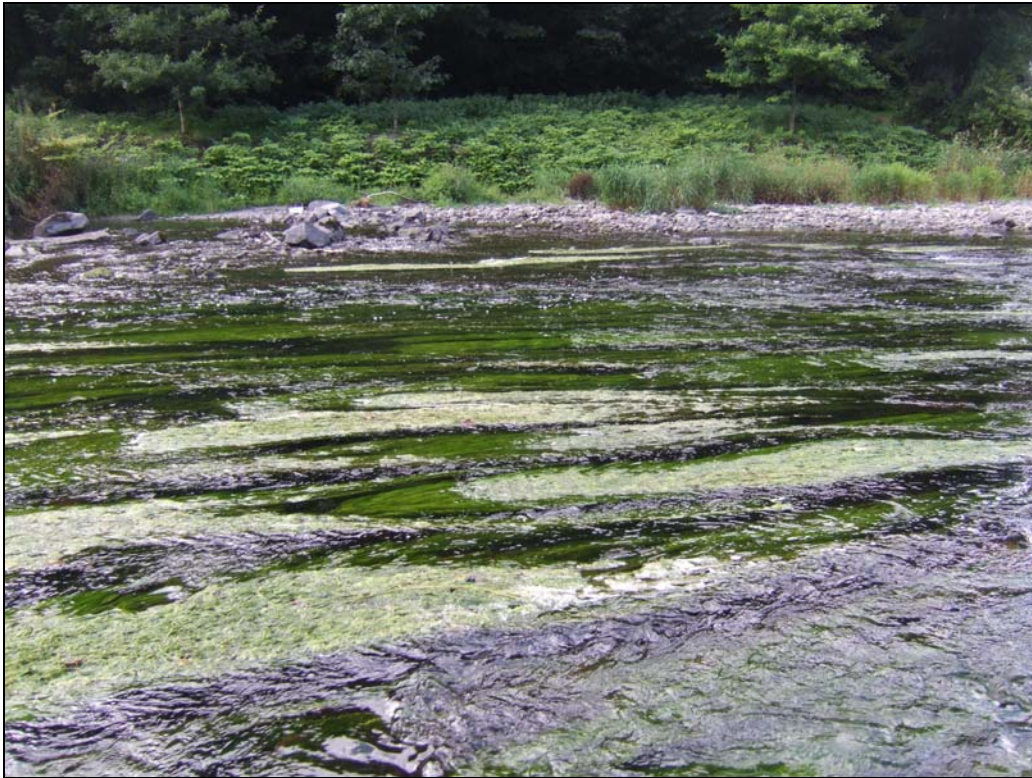
Plate 5.10 Section of the river upstream of the outfall of the River Brinny near Ardnaglug supporting an example of the Annex I Habitat 'Watercourses of plain to mountain levels with the *Ranunculus fluitantis* and *Callitriche-Batrachion* vegetation (3260)'.

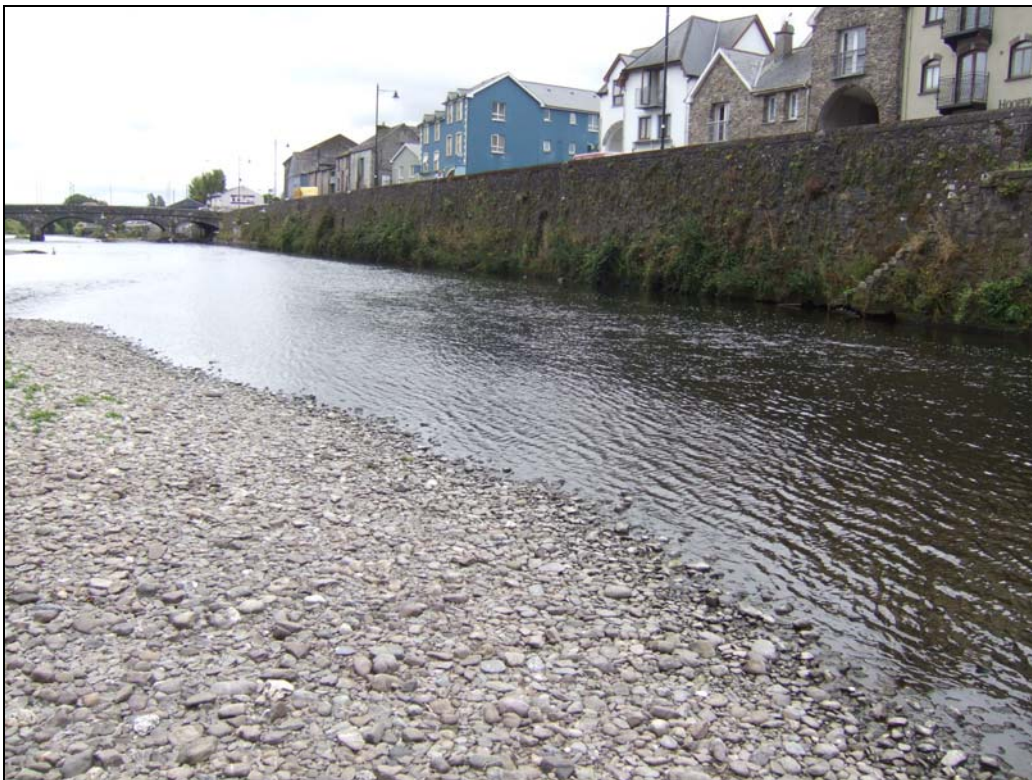
Plate 5.11 Highly managed section of channel in Bandon Town with river wall shown.

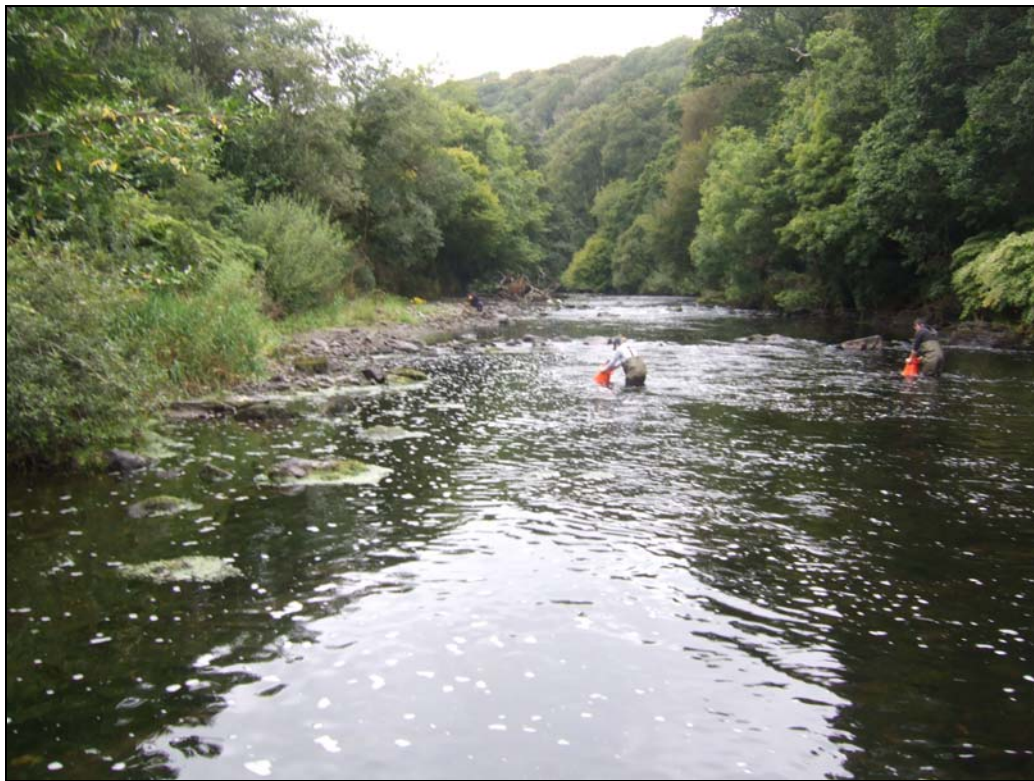
Plate 5.12 Series of pools and riffles upstream of the old railway crossing and showing natural variation in the channel morphology. Natural weirs enhanced to improve the fishery value of the river.

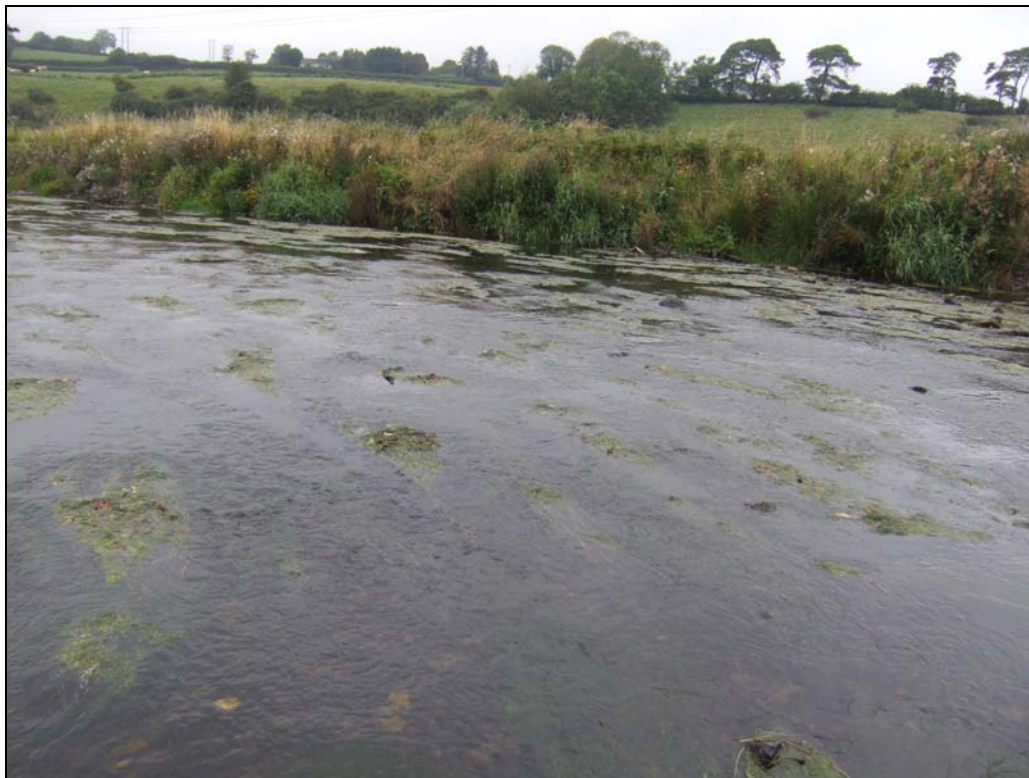
Plate 5.13 Low grassy bank bordering the river where there is an adjacent floodplain to the north near Ballyangley. Note also the presence of the Annex I Habitat 'Watercourses of plain to mountain levels with the *Ranunculus fluitantis* and *Callitriche-Batrachion* vegetation (3260)'.

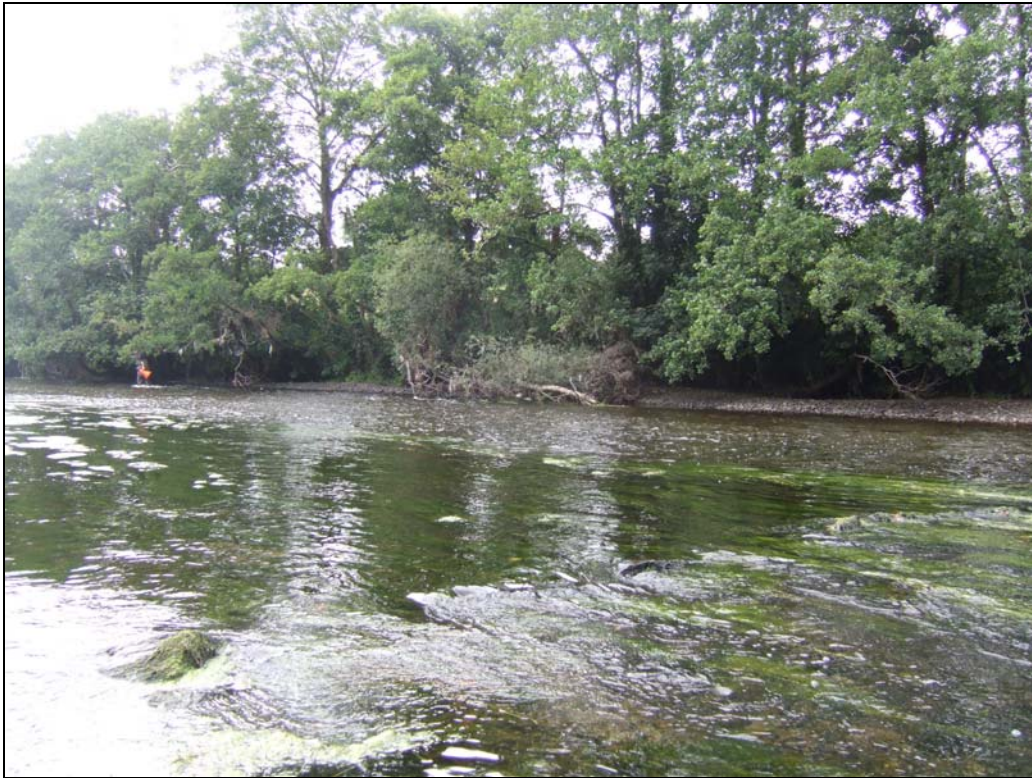
Plate 5.14 Alder Tree Line on northern bank of the river just downstream of the previous plate near Ballyangley.

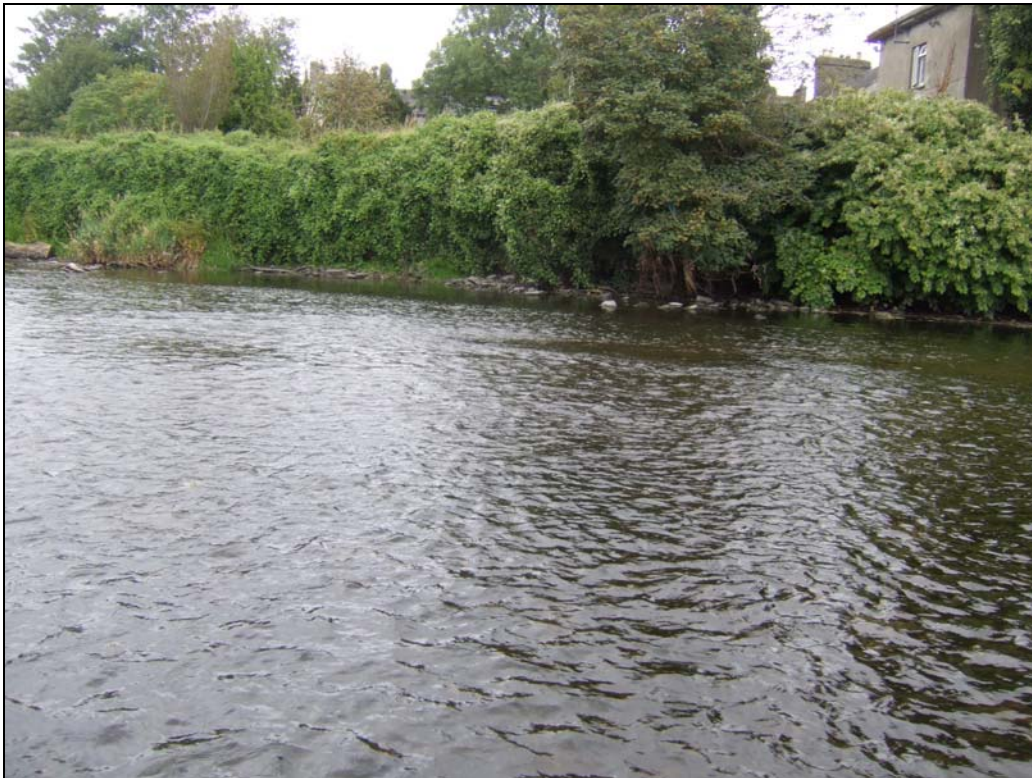
Plate 5.15 Invasive species Traveler's Joy and Japanese Knotweed on the river bank within Bandon Town

The banks of the river within the study area comprised of various habitats. In areas downstream of Bandon Town and at the southern end of the study area, the river is surrounded by the flat grasslands of the floodplain, the banks were generally quite low (approximately 2-3 metres above bed level) and supported either grassy vegetation that was typically dominated by Reed Canary Grass (*Phalaris arundinacea*) and Nettle (*Urtica dioica*) (GS2) (Plate 5.13) or supported Tree Lines (WL2) with Alder (*Alnus glutinosa*), Willows (*Salix spp.*), Hawthorn (*Crataegus monogyna*) and Ash (*Fraxinus excelsior*) (Plate 5.14). A tree line of Lombardy Poplar was located close to the left bank downstream of the town. In some areas the banks supported scrubby vegetation including bramble and bracken scrub. Areas of bramble scrub were recorded downstream of the town on the right bank along with native and non-native tree species such as Cypress (*Cupressus sp.*). In many sections of the study area, there is growth of invasive species including Traveler's Joy (*Clematis vitalba*), Himalayan Balsam (*Impatiens glandulifera*), Japanese Knotweed (*Fallopia japonica*) and Himalayan Knotweed (*Persicaria wallichii*) (Plate 5.15).

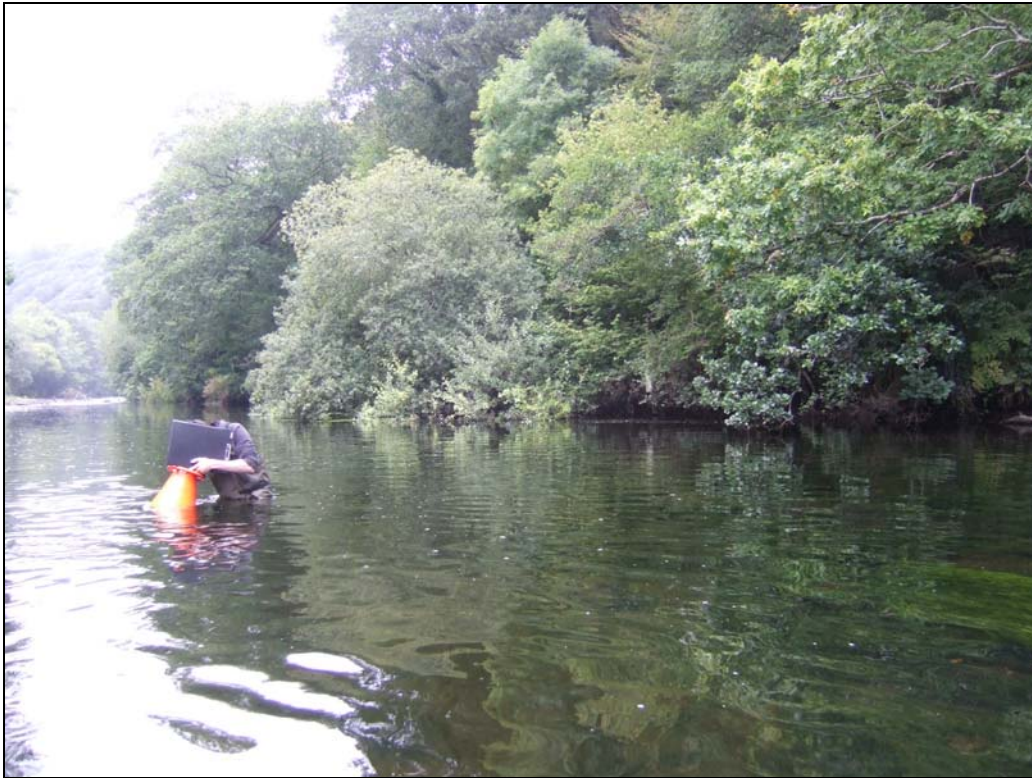
Plate 5.16 Woodlands on the river bank within the NHA in the middle section of the study area. Note the trees encroaching into the river channel.

Where the surrounding lands are steeper, the banks are often surrounded by woodlands and scrub. This is the case in much of the pNHA in the mid section of the study area and on the opposite bank from the Bandon town sewage treatment plant. The woodlands are mainly best classified as Mixed Broadleaved Woodland (WD1) with a dominance of Ash, Beech (*Fagus sylvatica*), Sycamore (*Acer pseudoplatanus*) and Oak (*Quercus Spp.*). In some areas where woodlands and tree lines are located along the banks, the trees grow out over the water with some fallen trees obscuring the channel (Plate 5.16). There is a small

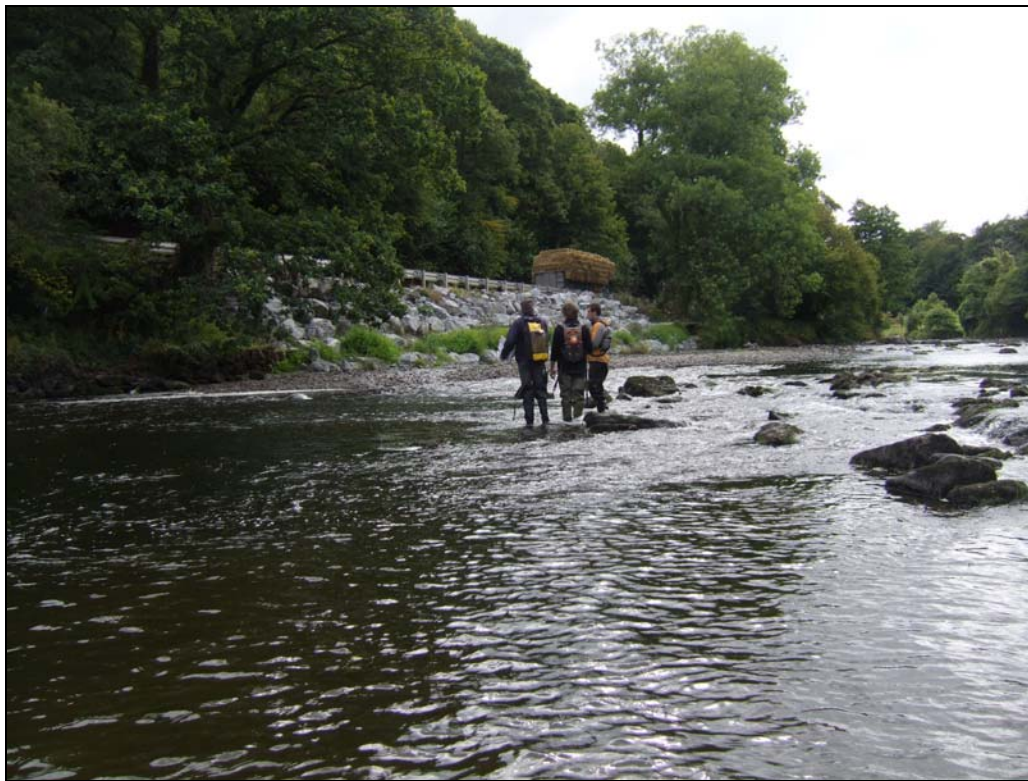
Plate 5.18 Section of the Bandon River at a location where the road is located close to the river and where rock armour has been employed to stabilise the bank.

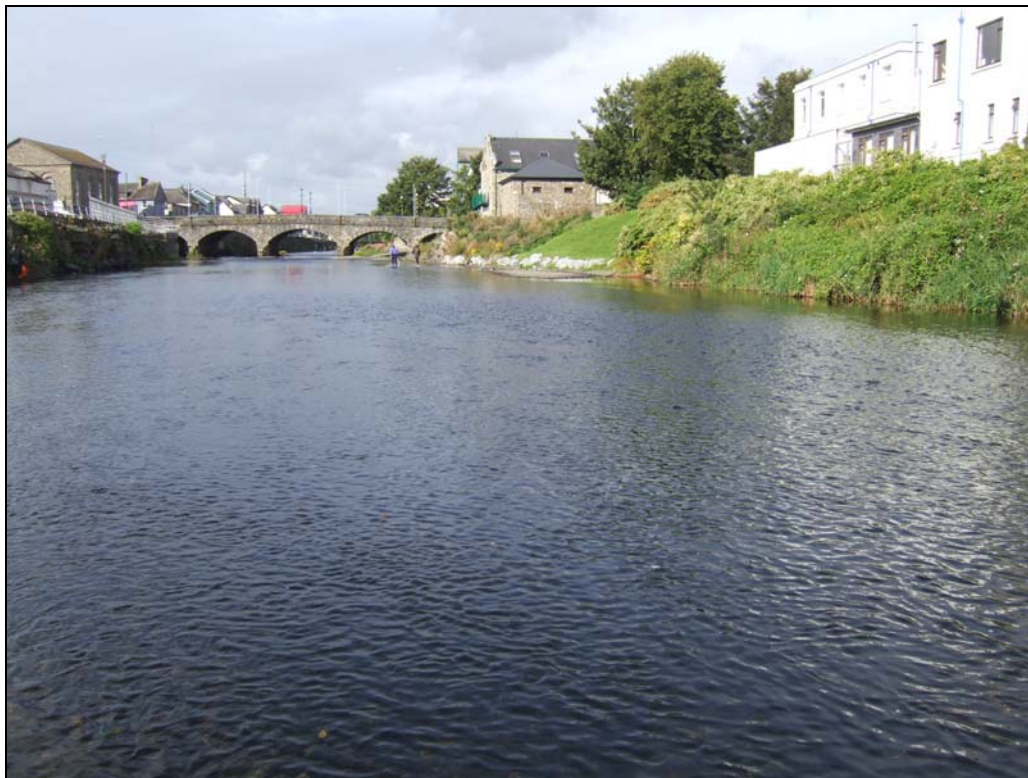
Plate 5.19 Bandon River Immediately downstream of Bandon Bridge showing the overgrown and urban nature of the banks.

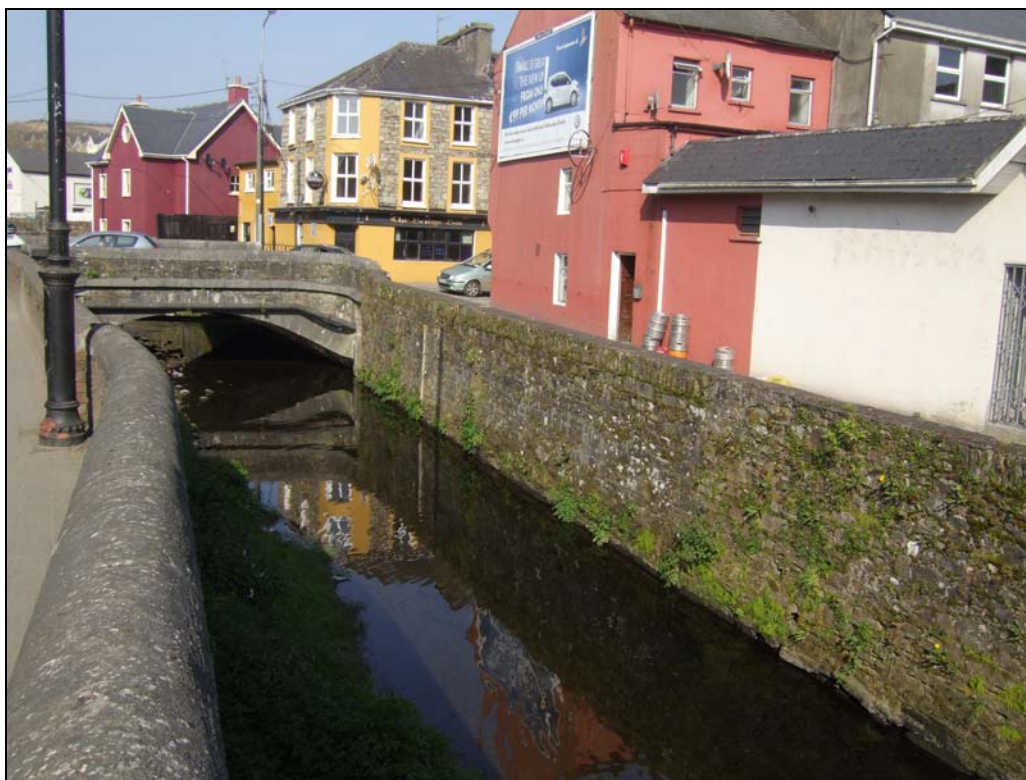
Plate 5.20 Bridewell River within Bandon Town

The Bridewell River, which flows into the Bandon River immediately downstream of the main road bridge is surrounded by vertical walls and is extensively culverted within the town area. The substrate of this river is comprised of boulders, cobbles and gravels (Plate 5.20). The Mill Stream, which flows into the Bandon River approximately one kilometre downstream of the town and is culverted near the confluence with the Bandon River and again approximately 250 metres upstream. Between the two culverts the stream supports a gravelly substrate. The downstream sections of this stream are bordered by vegetation including Alder and Willow with grassy vegetation (Plate 5.2.1). Behind these bankside habitats are industrial gravelly yards on both banks. Continuing upstream, the stream passes a sewage treatment plant that is associated with a livestock mart and continues with the left bank adjacent to the mart car park before entering under a culvert beneath a minor road and emerging as a heavily shaded channel among trees alongside the Mart Building. The trees in this area are dominated by Elm (*Ulmus sp.*) with some Willow and Sycamore. From here, the stream enters a stone culvert of approximately 100 metres in length before emerging as a small stream with a gravelly substrate and in-stream vegetation including Water Crowfoot and Fools Watercress (*Apium nodiflorum*). This section of channel is surrounded by agricultural fields and supports bankside treelines that are dominated by Alder.

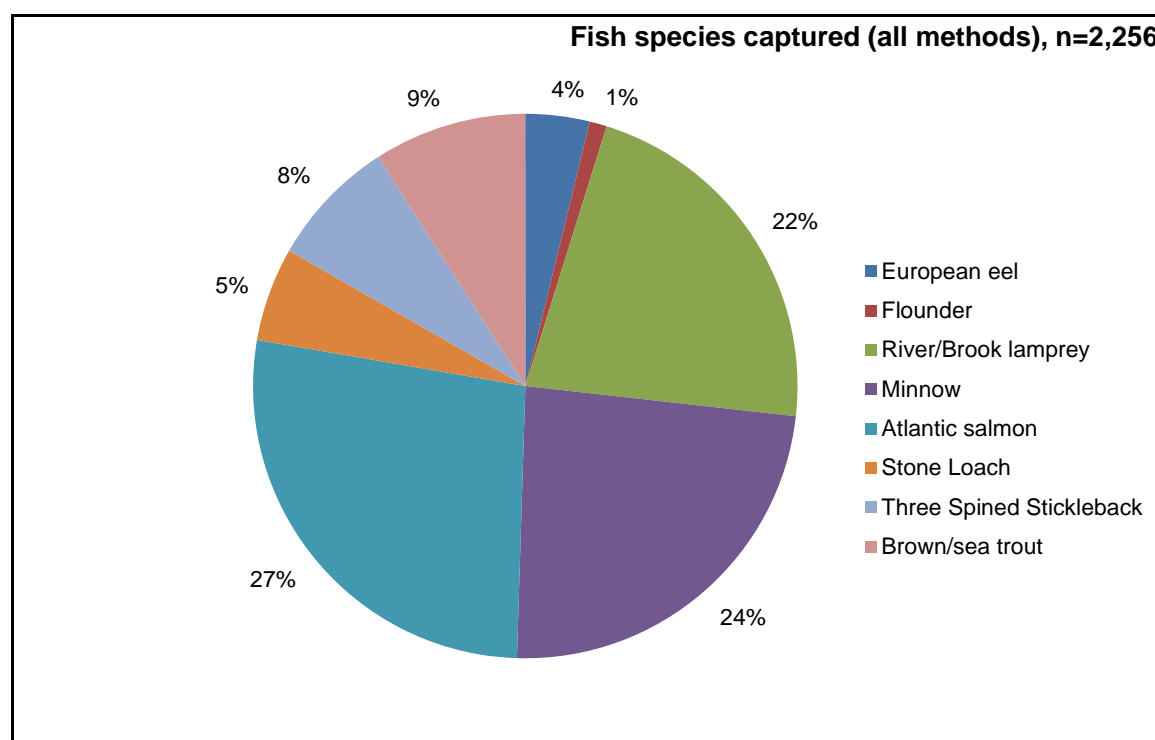
Figure 5.4 Fish species compositor (all methods combined) for the September 2011 fish stock assessment on the Bandon River.

Over the 12 sites surveyed a total of 1,605m² of habitat was surveyed for juvenile salmonids; 60m² was surveyed for European eel; while a total of 36m² of suitable habitat was surveyed for lamprey. The current survey also included 240 sweep net samples within the study area. The survey resulted in the capture of 2,256 fish in total, comprising eight species. The most common species recorded was Atlantic salmon *Salmo salar*, followed by minnow *Phoxinus phoxinus*. Additional fish species recorded include three-spined stickleback *Gasterosteus aculeatus*, stone loach *Barbatula barbatula*, European eel *Anguilla anguilla* and flounder *Platichthys flesus*. The relative abundance of all species recorded during the current survey is shown in Figure 5.4.

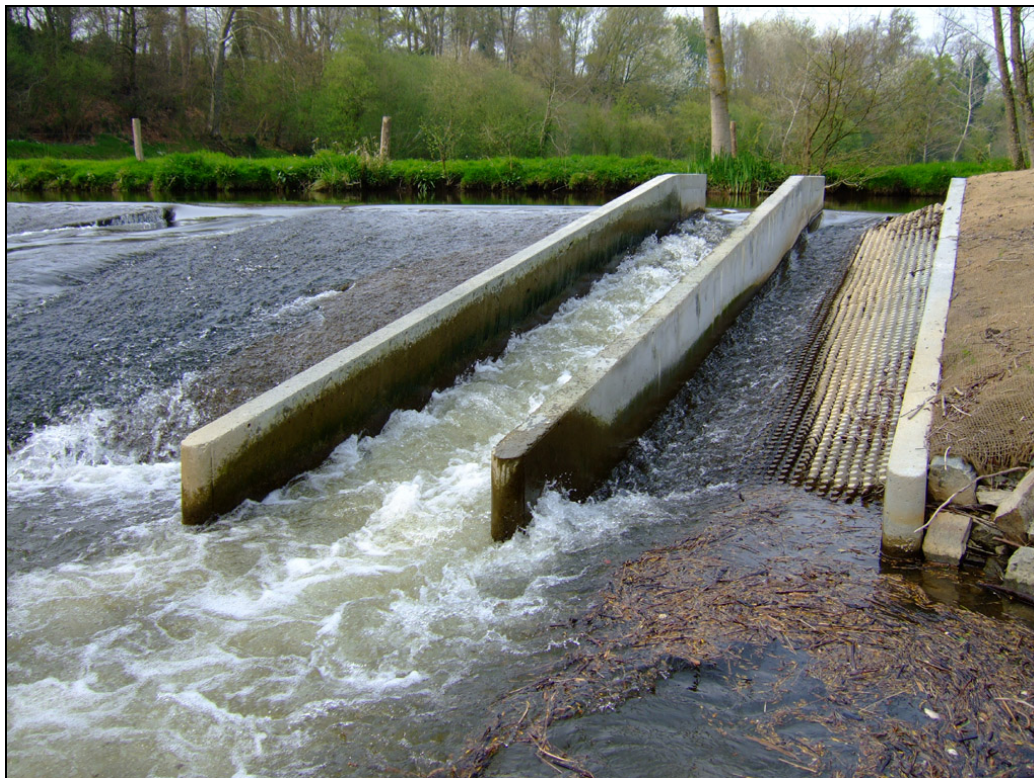
Plate 5.22. Fish Ladder with Lamprey Access to the side. Similar to that which will be installed on the Bridewell River and Mill Stream.

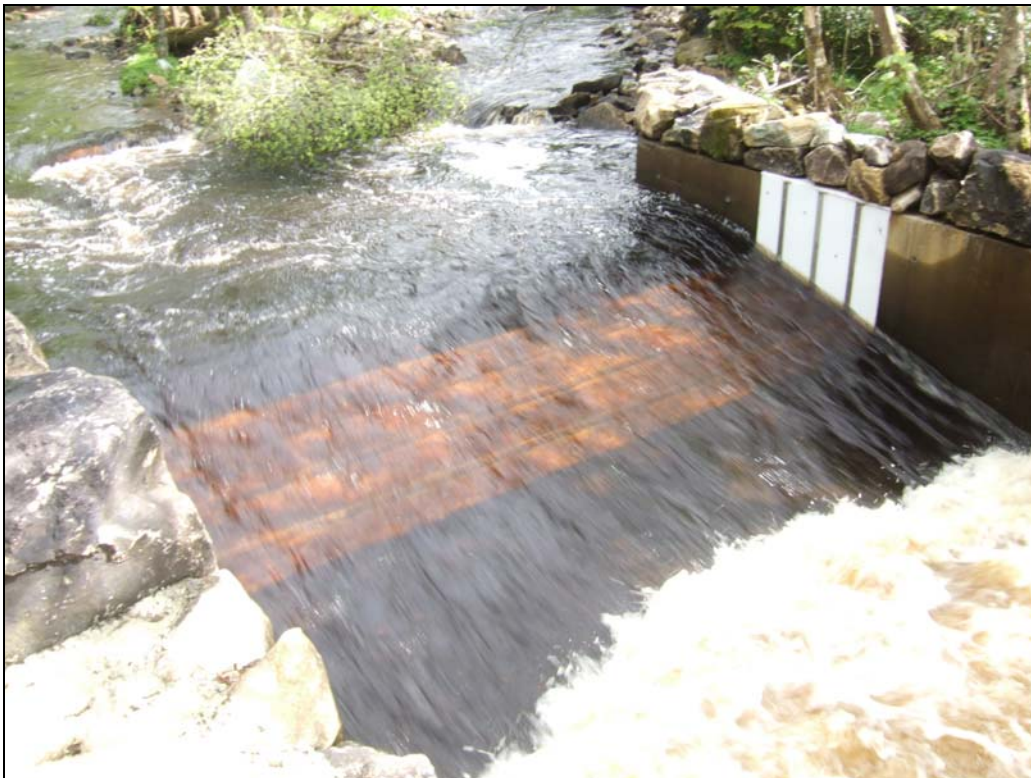
Plate 5.23. Fish Counter in use on the Owenboliska River, Oughterard, Co. Galway.

A fish Counter will be constructed at the top of the rock ramp. This will be constructed with guidance from the IFI and will allow for the passage of Lamprey over the weir. This may require a small section of matting (as in the plate above) at the edge of the counter. It will be five metres in width to cover the entire top of the rock ramp. It will consist of a series of electroplates that register fish movement over the weir. It will also be fitted with a camera to verify records. It will be constructed at a low gradient of no more than 1:5 and if possible nearer 1:10 to facilitate easier passage for fish. There will be a depth of water of at least 0.15 metres on the counter at dry weather flow. A similar counter in use by the IFI on the Owenboliska River is shown in Plate 5.23.
