SERIES OF ECOLOGICAL ASSESSMENTS ON ARTERIAL DRAINAGE MAINTENANCE No 5

Ecological Impact Assessment (EcIA) of the Effects of Statutory Arterial Drainage Maintenance Activities on Water Courses of Plain to Montane levels with Aquatic Vegetation (*Floating River Vegetation*)

**Office of Public Works
Environment Section
West Region Drainage Maintenance
Headford
Co. Galway**

**Ecological Impact Assessment (EcIA) of the Effects of
Statutory Arterial Drainage Maintenance Activities on
Water Courses of Plain to Montane Levels with Aquatic
Vegetation (Floating River Vegetation).**

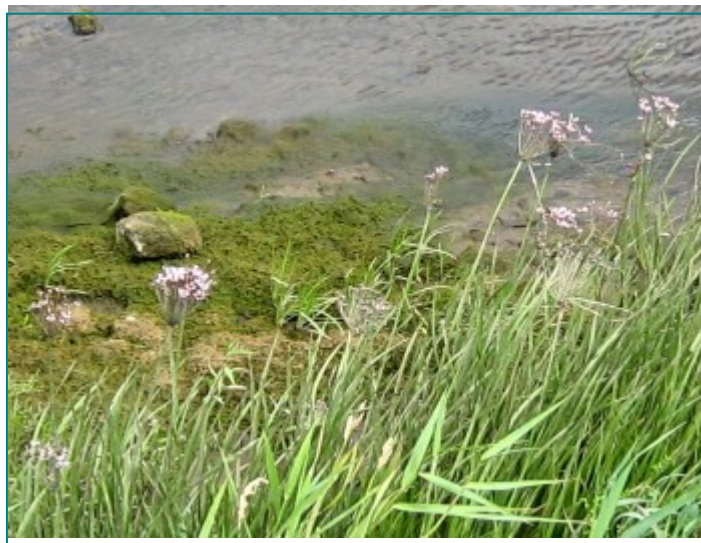
Fig. 1 Flowering rush (*Butomus umbellatus*) on the banks of the River Suir.

A selection of habitats was observed within the River Suir survey square. Interestingly stone walls classified as stone walls and other stonework (BL1) habitats were frequently noted in association with rivers in this square. Also recorded along the banks of the River Suir in the town of Carrick-on-Suir was the presence of flowering rush (see section 2.1) along the river bank. Habitats designated as Water courses of plain to montane levels with the *Ranunculion fluitantis* and *Callitriche-Batrachion* vegetation is occasionally associated with bank communities of flowering rush (EUNIS website).

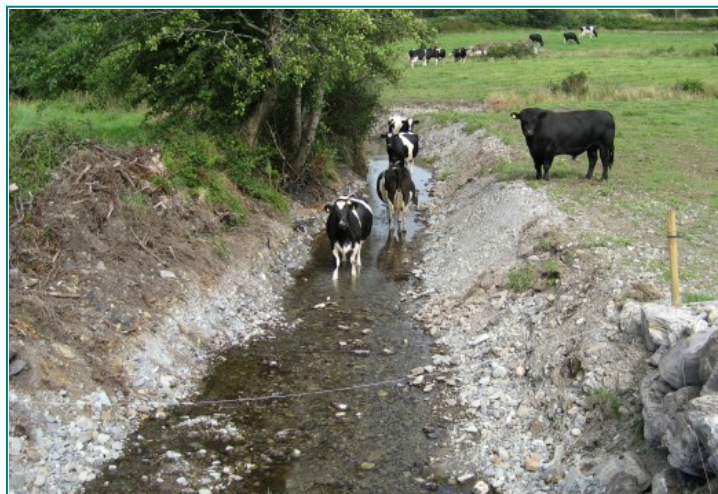
Fig. 2 Cattle accessing a recently maintained watercourse (**NOT** Office of Public Works channel).

For most watercourses surveyed cattle had unhindered access to the water. In one case cattle were seen paddling in shallow water. The channel in question was not a maintainable channel nor was it directly within a Special Area of Conservation (SAC) but the water level was low and four head of cattle were present in the water at the same time. It does illustrate the level of nutrient loading of some watercourse, which in turn can lead to excessive plant growth within aquatic environments (Fig. 2).

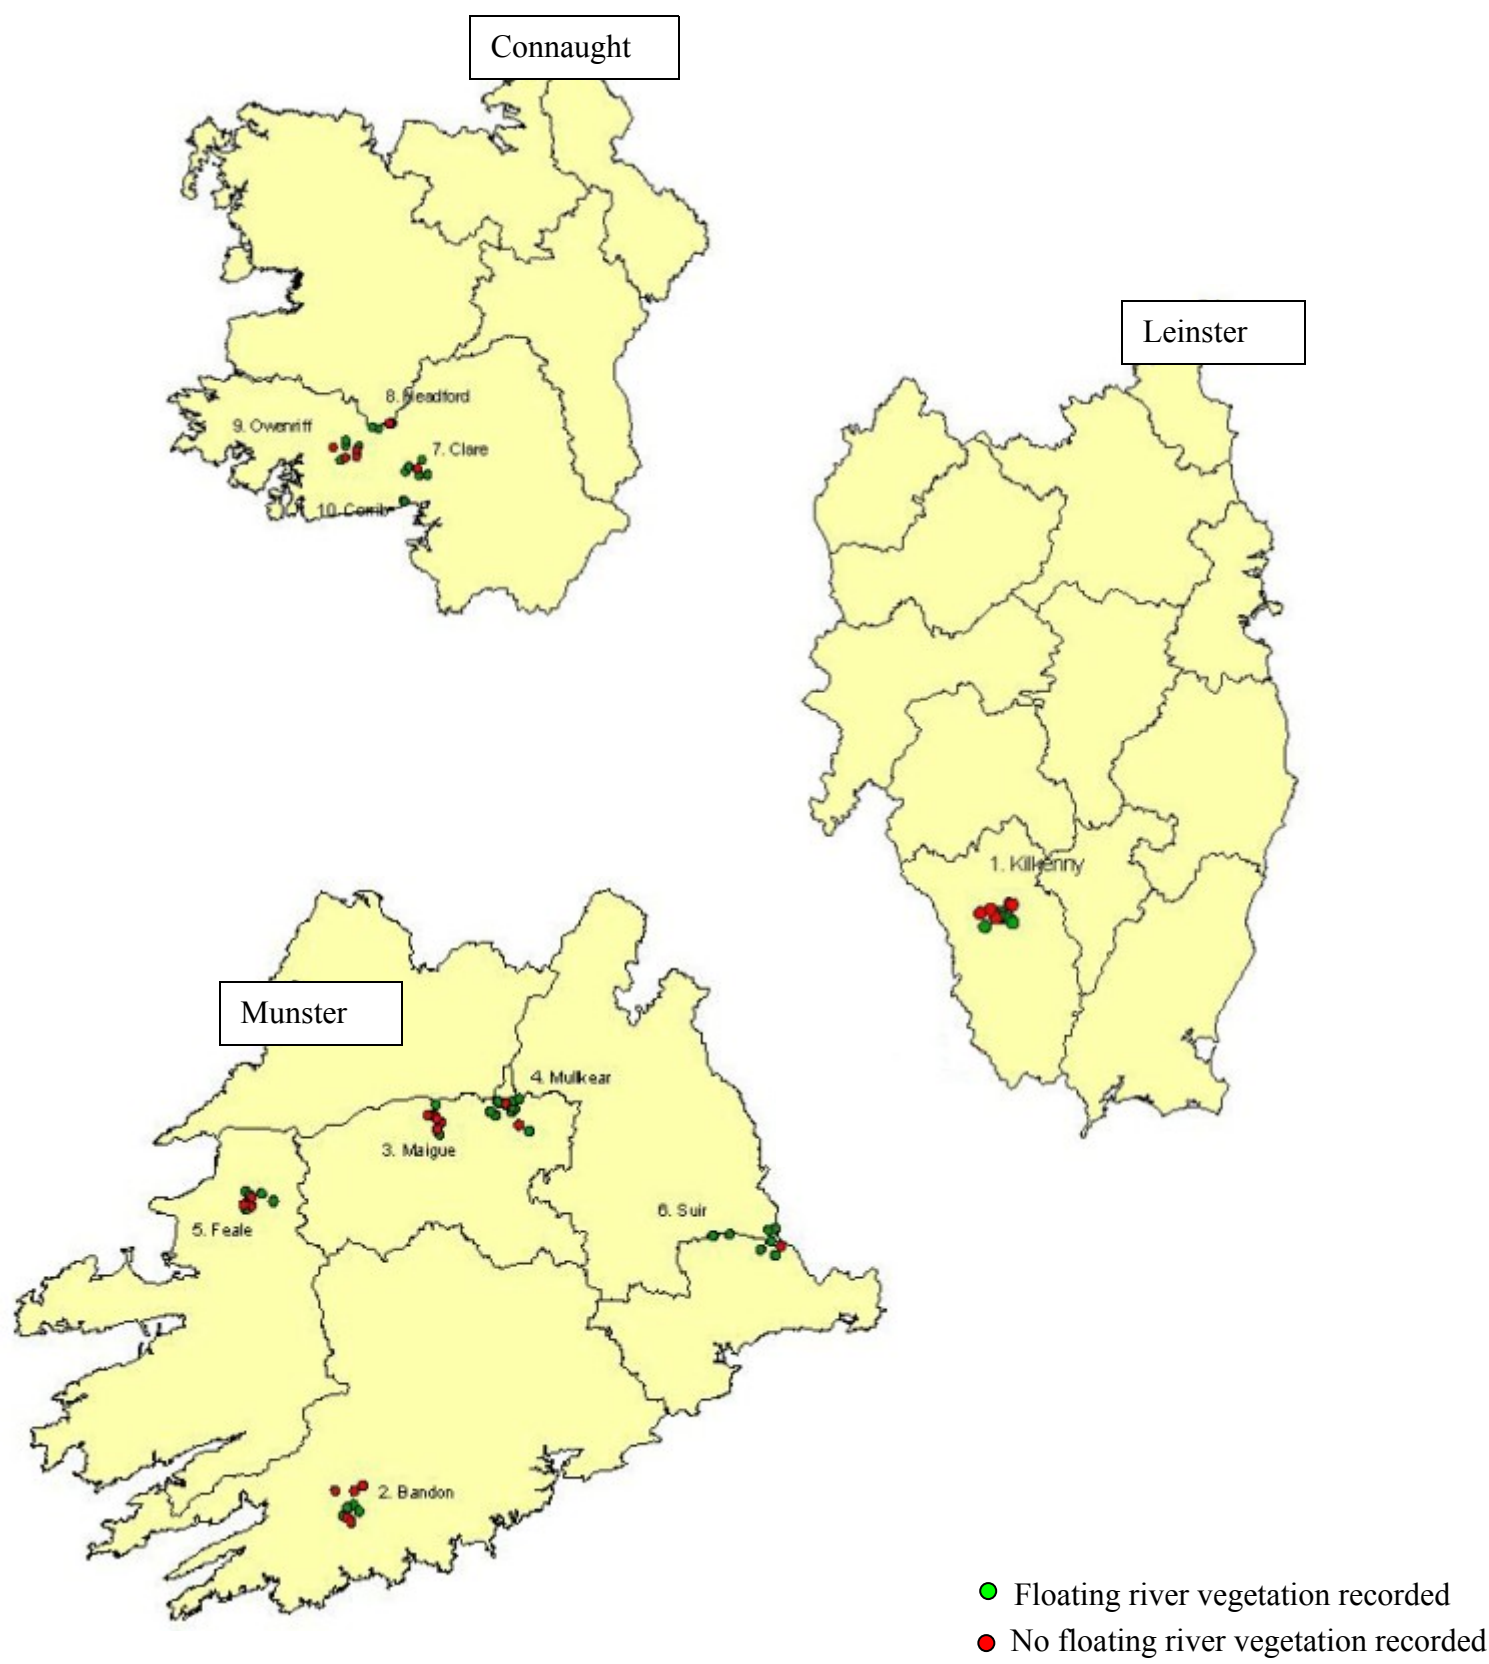
Fig. 4 Distribution of floating river vegetation recorded in each province surveyed

A collective map of the provinces of Munster, Connaught and Leinster providing a more detailed overview of the presence or absence of floating river vegetation is illustrated in Fig. 4. De-

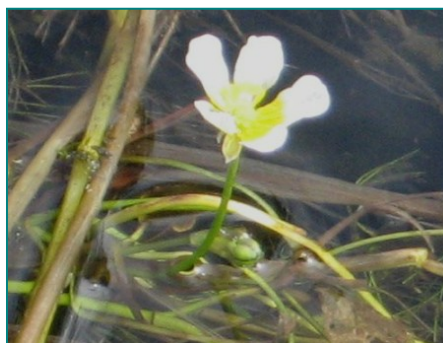
Water Parsnip, *Berula erecta*

- Found frequently in maintained drainage ditches.
- Along rivers in areas with silt or mud deposits - in the middle of rivers or at the waters edge.
- Prefers shallow slow flowing or still water.
- Flowers August to September - small white flowers that form a white ball shape.
- Can be easily mistaken for Fool's Watercress, which is often found in same habitat.
- Smells of carrots when leaves are crushed.

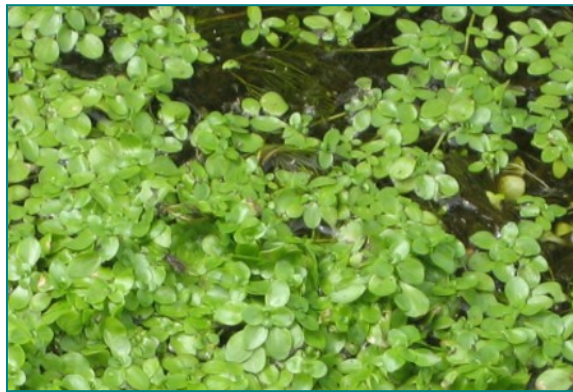
Pondweed, *Potamogeton* species

- Most varied distribution of all the species in terms of water depth.
- Pondweed was the only floating river vegetation recorded in deep waters.
- Broadleaved pondweed was the most frequently observed pondweed species.
- Flowering structures were evident on deep-water species between August to September.
- Not all pondweed species had floating leaves; some species remained completely submerged.
- Evidence of reproduction by vegetative means – mechanical shearing of rooted stem.

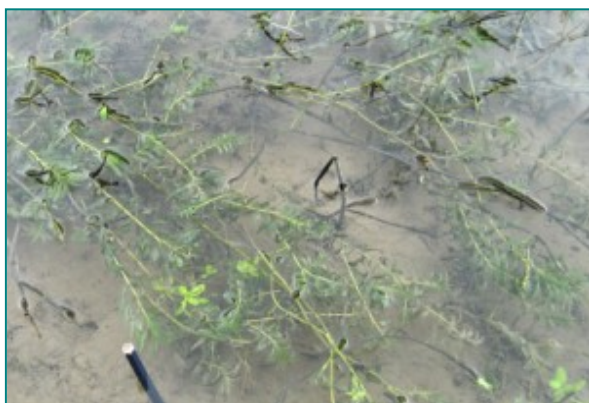
- Wavy leaves are oppositely paired along the stem
- Dark green leaves contrast with light green / white stems
- New leaf growth appears as a tuft of leaves at the tip of the stem
- All leaves are submerged
- Coloniser of fine mud sediments
- Can develop as a dark green mat close to the water surface.

Fig. 6 Photograph on the left *G.densa* in its natural habitat (with starworts in bright green). On the right a stem of *G.densa* beside frog spawn. Note the opposite paired wavy leaves.

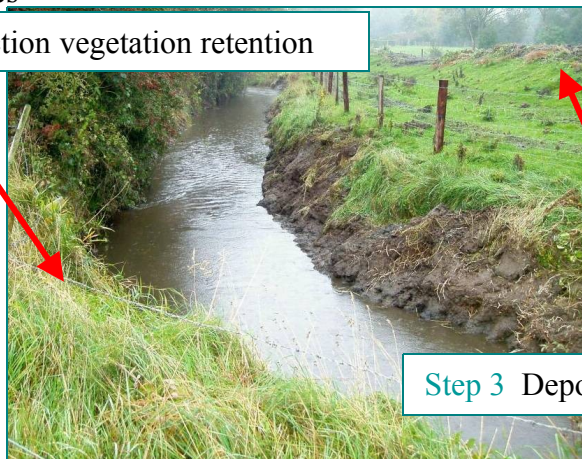
Step 1 Bank protection vegetation retention

1. Protection of channel bank slopes

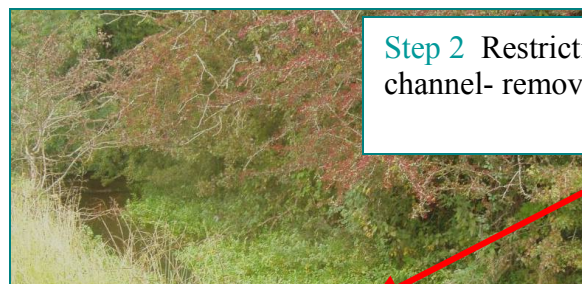
Step 2 Restriction of maintenance to channel- removal of instream vegetation

2. Restriction of maintenance to the wetted channel

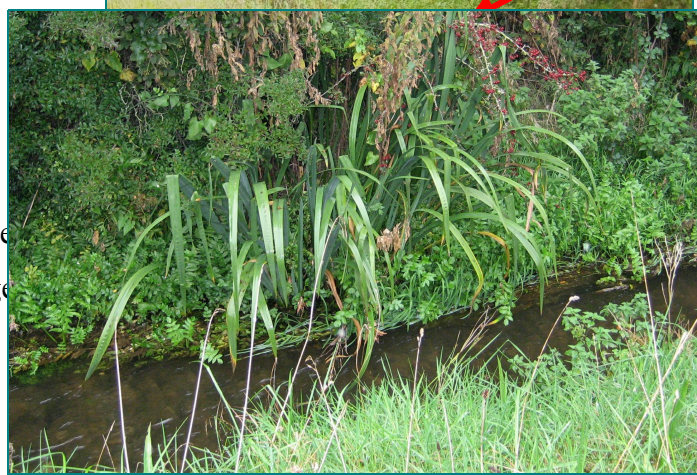
Step 4 Selective vegetation removal i.e. Bulrush

4. Selective removal of vegetation

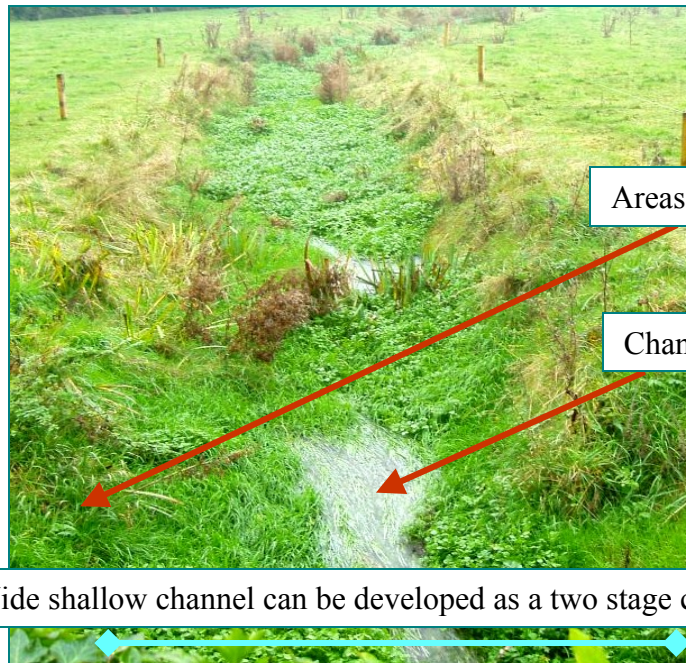
Areas of reduced flow

Channel with flow

Wide shallow channel can be developed as a two stage channel

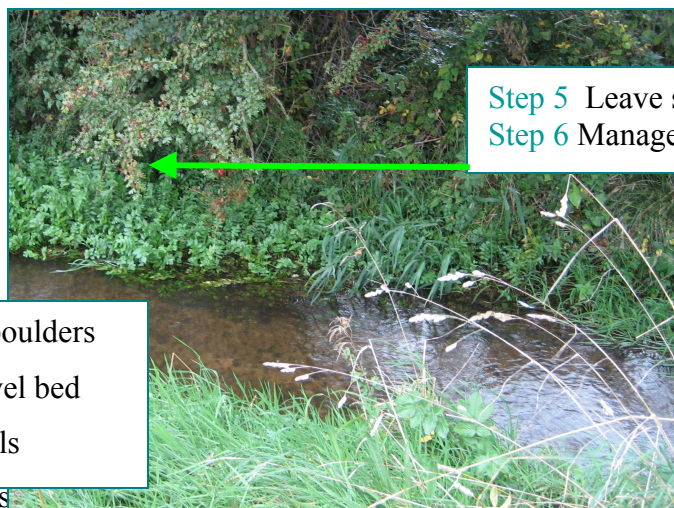
Step 5 Leave section untouched or
Step 6 Management of trees

Step 8 Placement of boulders
Step 9 Loosen of gravel bed
Step 10 Excavate pools

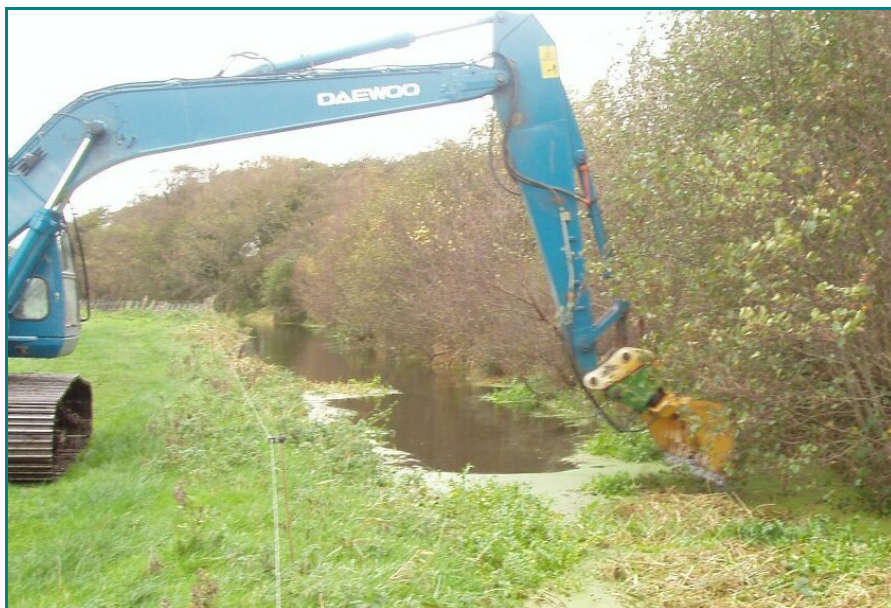
Three types of maintenance regimes are employed by the Office of Works to manage aquatic vegetation. The first is by channel maintenance, removal of deposited silt and aquatic vegetation under the 10-step Environmental Drainage Maintenance (EDM) programme (section 4.1). Secondly, using a hydraulic excavator with a weed cutting blade attached, ideal for channels with suitable access for large machinery and not too wide to prevent the bucket reaching the opposite bank.

Fig. 7 Weed cutting bucket operated by a hydraulic machine (photo courtesy Office of Public Works)

The removal of silt deposits from channels brings about the removal of nutrient enriched soils and root material of aquatic vegetation. Through the removal of vegetation and root material the growth capacity of plants is reduced. Extraction of root and aerial material also reduces the quantity of plant biomass degraded in watercourses during winter months. Therefore the Phosphate and Nitrogen quantity released into the water column as a consequence of plant tissue breakdown results in less nutrient availability for the following season growth. In such cases the drainage maintenance regime may be spread out over a couple of years.

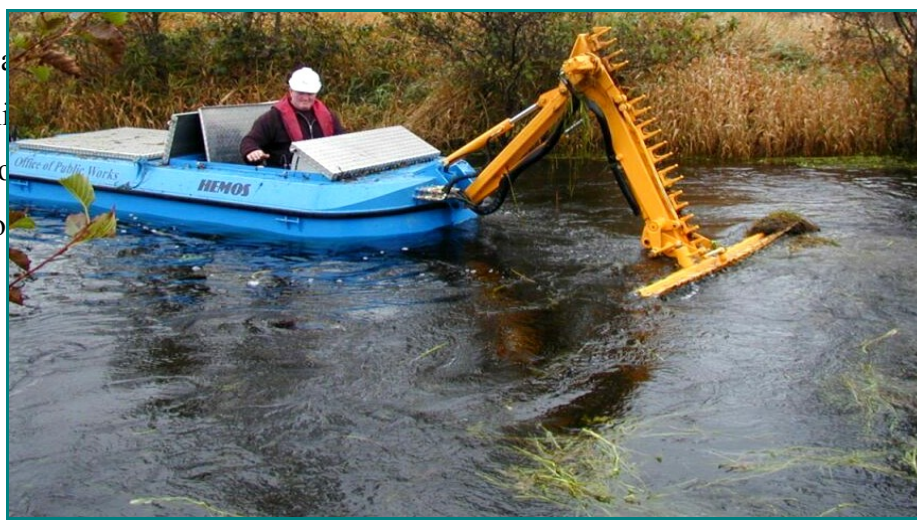
Thirdly, a boat-mounted hydraulic excavator is used in narrow channels, which endeavours to clear the vegetation completely.

Fig. 8 Weed cutting blade operated from a boat (photo courtesy Office of Public Works)

Aquatic vegetation cut using the weed cutting boat brings about a slightly different dynamic. The weed is cut above the channel bed but unlike the weed cutting bucket of the hydraulic machine, the boat bucket is not designed to collect cut vegetation. Some or all of the cut vegetation therefore floats on the water surface until it re-enters the water column through degradation of plant material or sinks to the bottom channel bed. All nutrients are not removed from the water column and are therefore readily absorbed by the regrowth. As weed cutting occurs in the summer months when water levels are lowest and the oxygen capacity of the system is reduced (compared to winter months), therefore the uncollected cut vegetation could be favouring opportunistic aquatic flora.

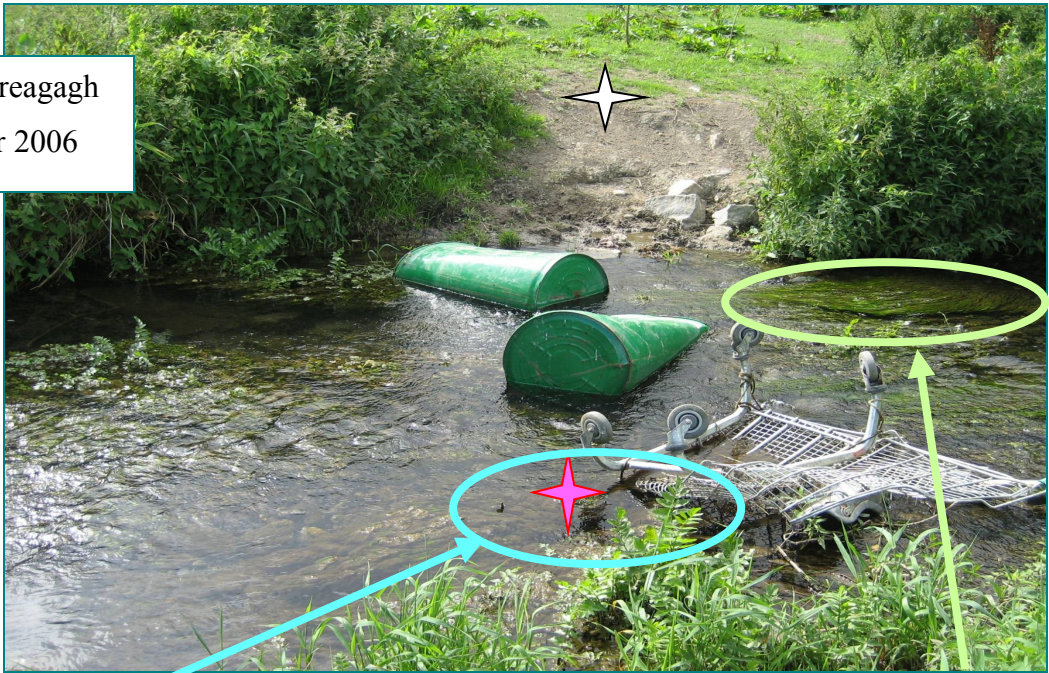
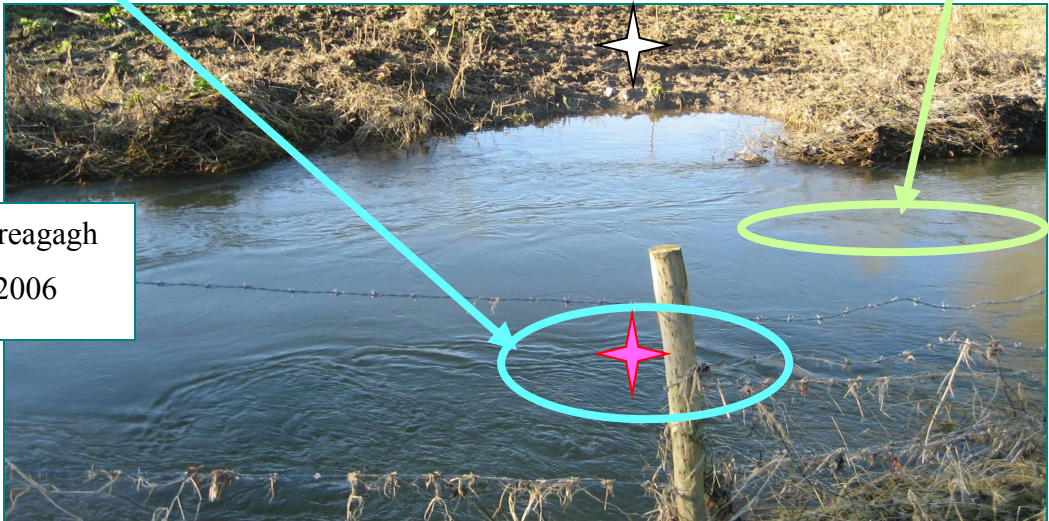
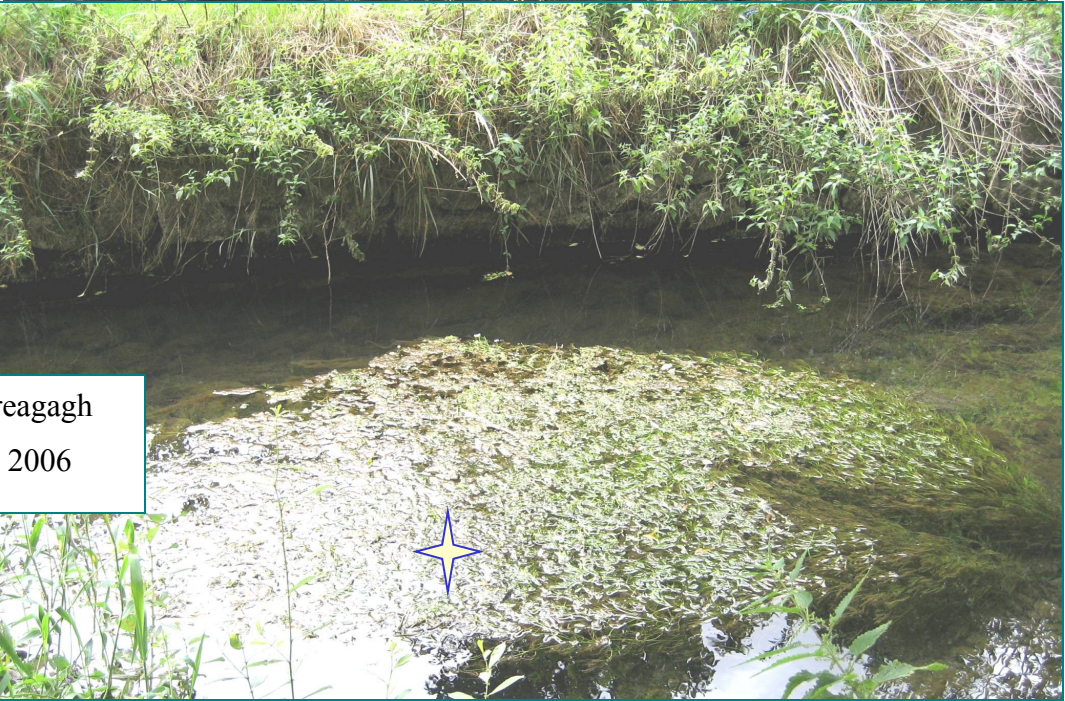
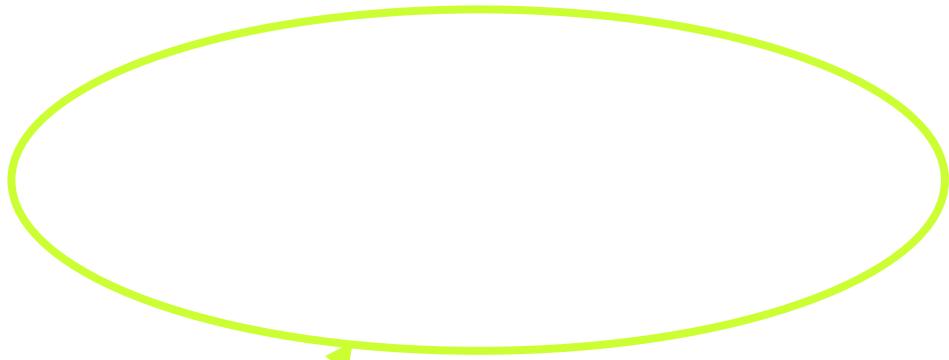
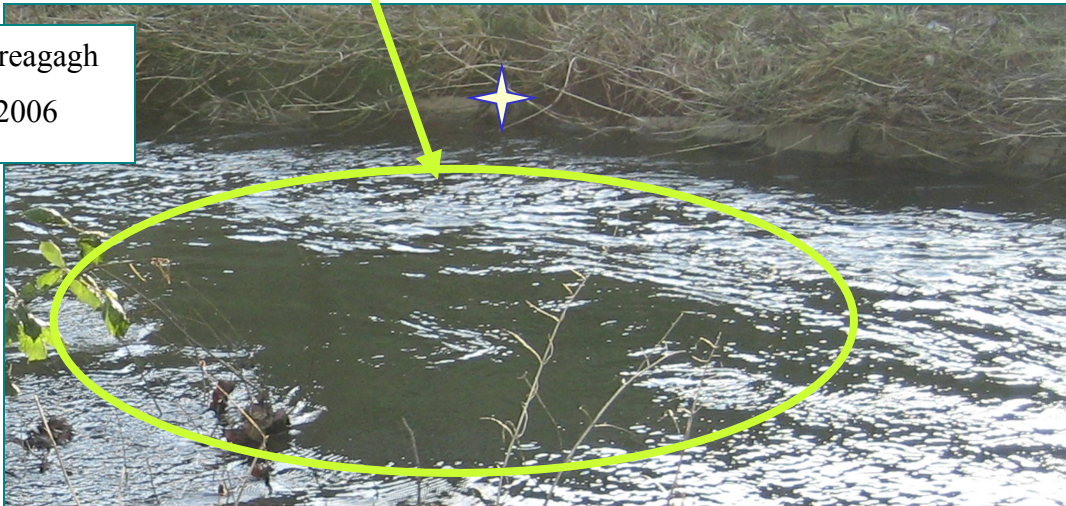
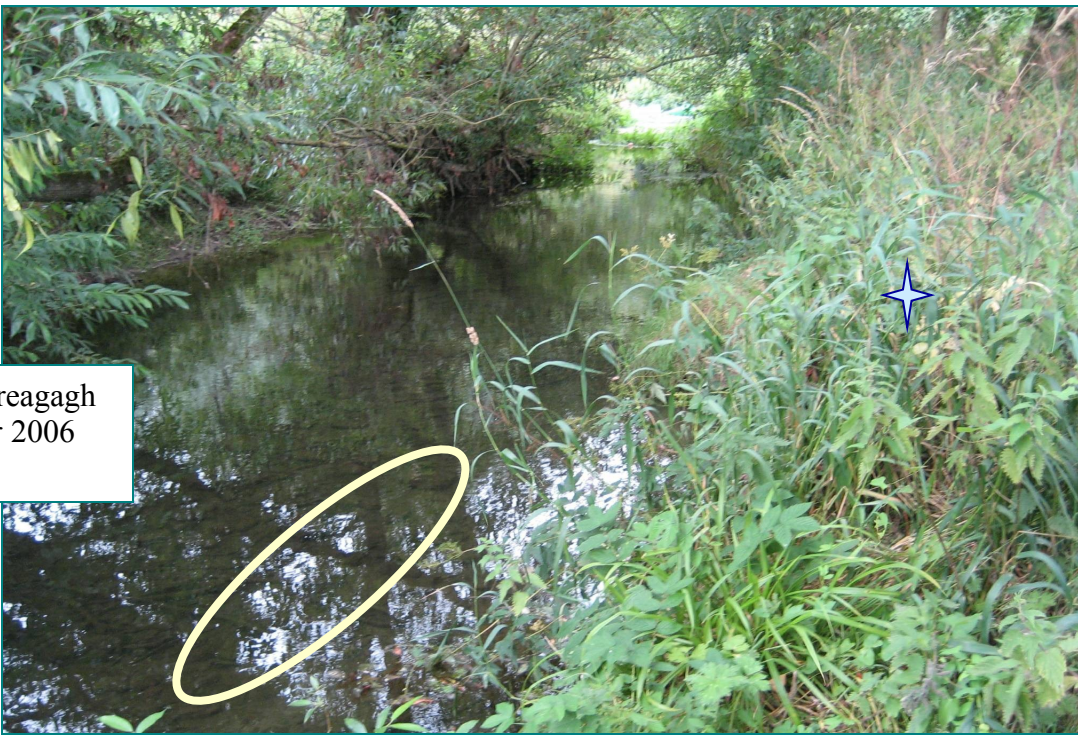
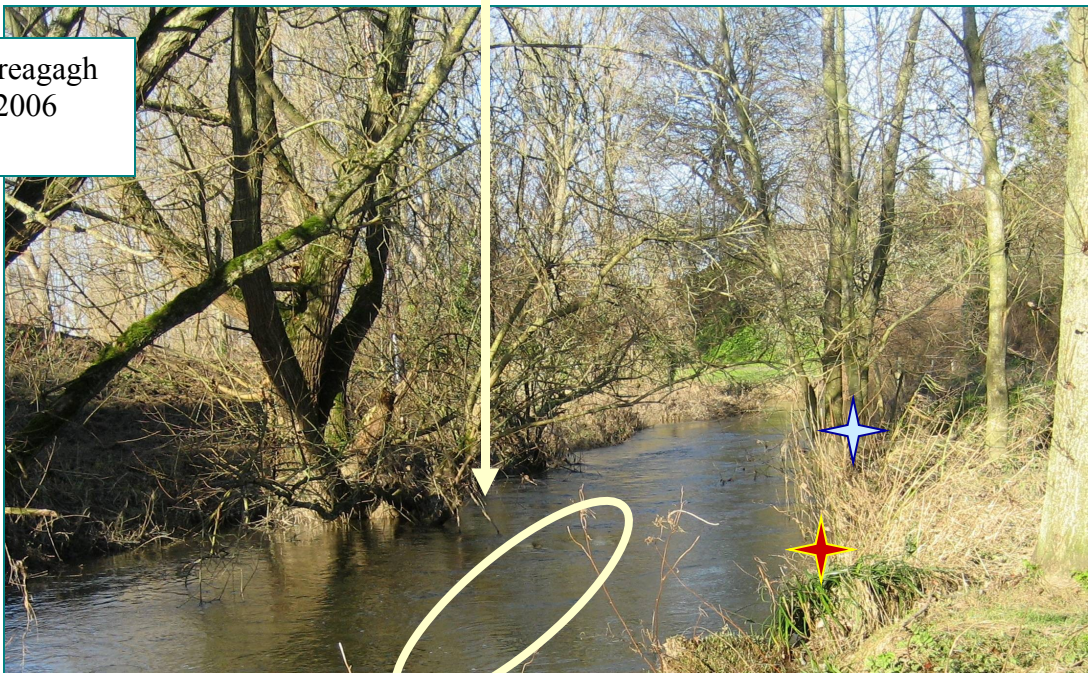
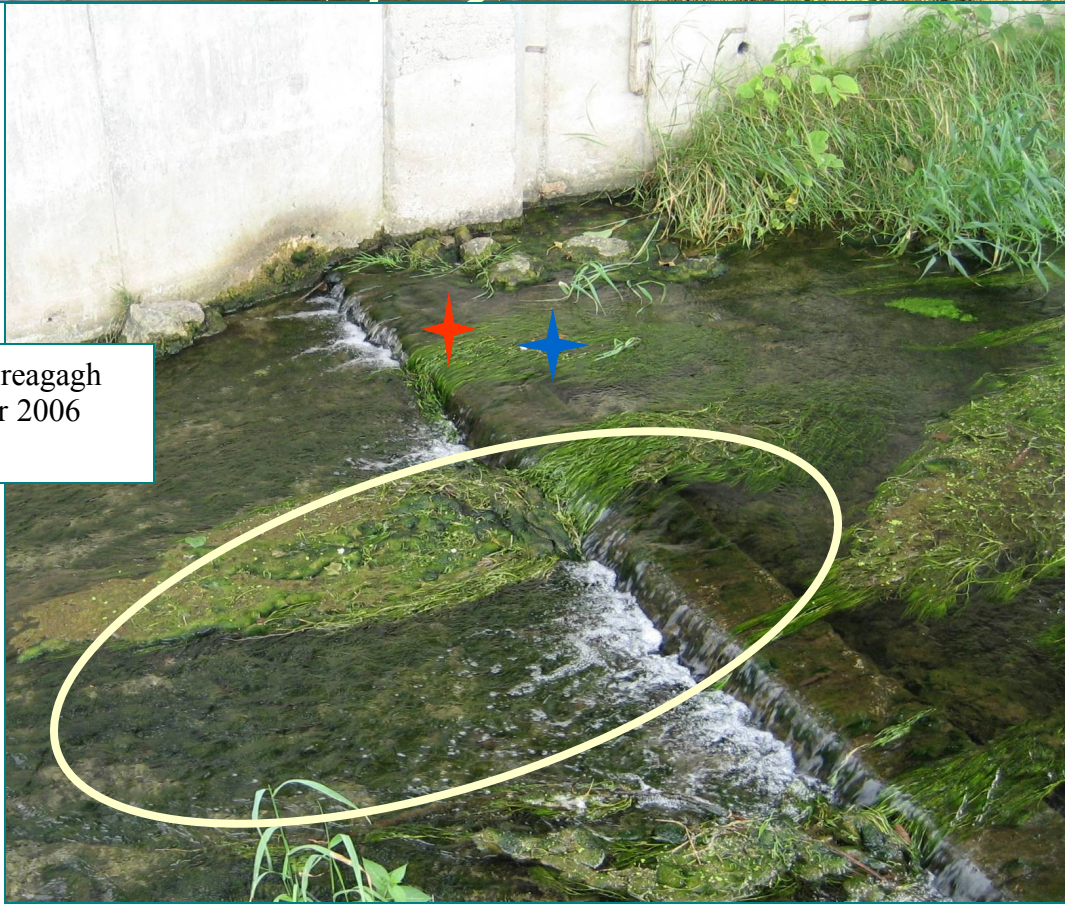
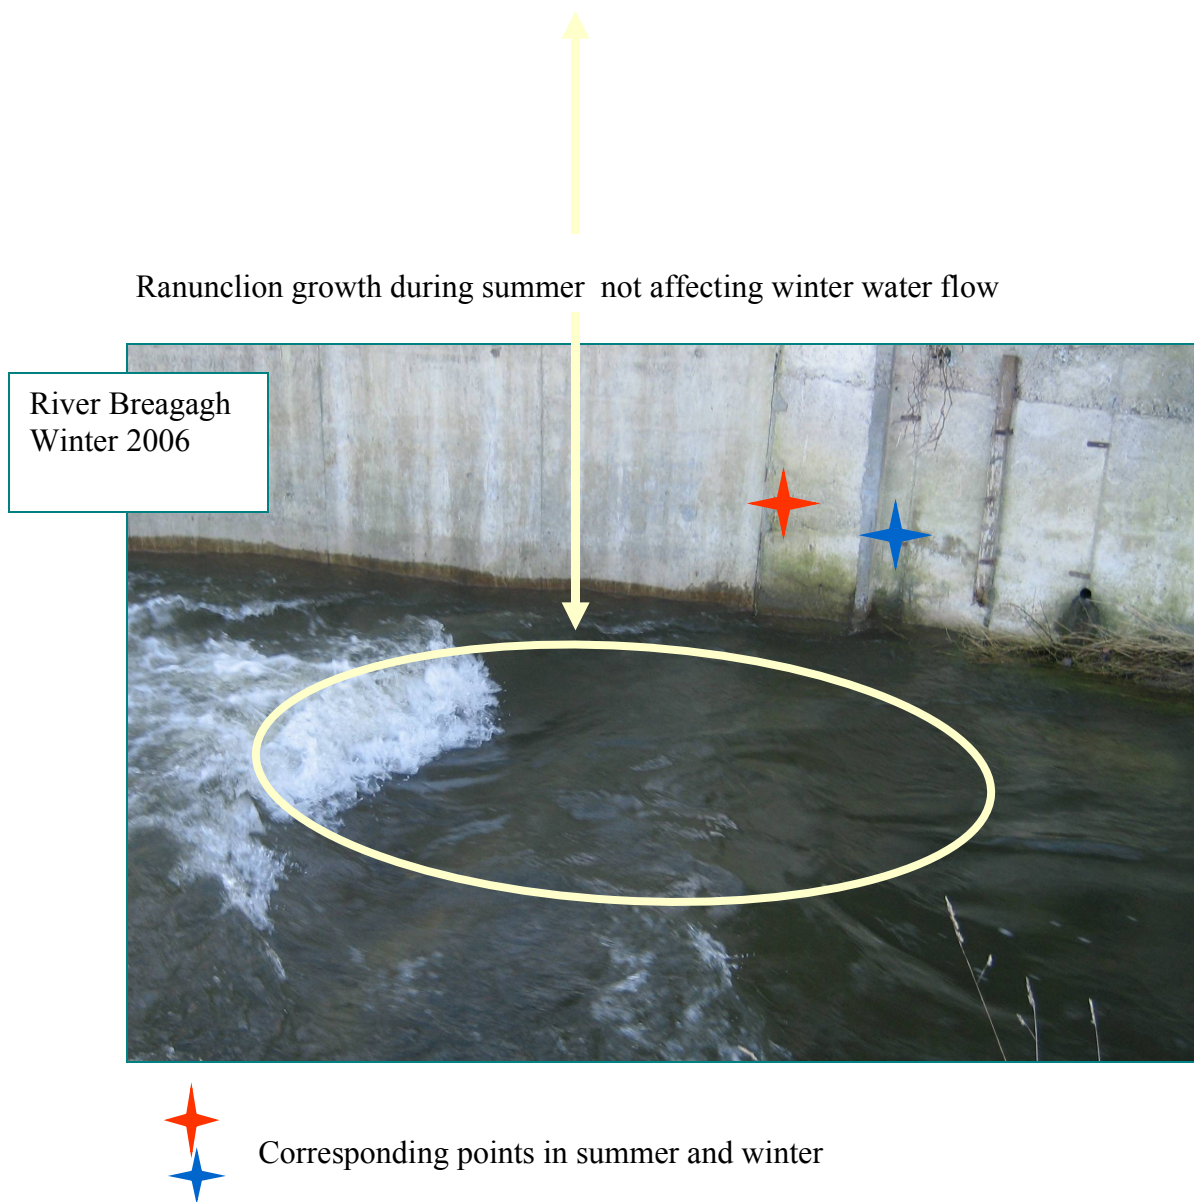
River colonised by Water Parsnip growth

River colonised by Ranunculation growth

✧ Corresponding points in summer and winter

Absence of floating river vegetation during summer months due to excess shading

Fig. 10 Effect of floating river vegetation growth on winter water flow on the River Breagagh (Site 5) survey site.

A comparison between summer flow and winter flow suggests that the location of some floating river vegetation may interfere or change flow capacity at higher water levels. Fig. 21 shows photographs of the River Breaghagh in Kilkenny during the summer with floating river vegetation

Water crowfoot adjacent to the weir does not appear to interfere with winter flow. Further upstream the eroded riverbank that supported water parsnip is totally submerged. Its location is illustrated by a series of vortices evident on the water surface. An alternative situation is occurring on the bend of the river, the area supporting the water crowfoot during the summer months is depicted as an area of minimal energy flow. Whether the vegetation has adapted to a section on the river where the flow has differed due to some environmental dynamic or that the vegetation has exerted a regime on the water flow is not entirely clear. It is likely that a difference in flow dynamic has enabled the colonisation of floating river vegetation and consequently the presence of the plant growth is facilitating further change in the surrounding environment (Fig. 10) which, if unmaintained would result in silt build-up and replacement by different plant species over time. In
