# SERIES OF ECOLOGICAL ASSESSMENTS ON ARTERIAL DRAINAGE MAINTENANCE No 8

## Ecological Impact Assessment (EcIA) of the Effects of Statutory Arterial Drainage Maintenance Activities on Turloughs (EU Code 3180)

**Version: 1107**

# **Ecological Impact Assessment of the Effects of Statutory Arterial Drainage Maintenance Activities on Turloughs**

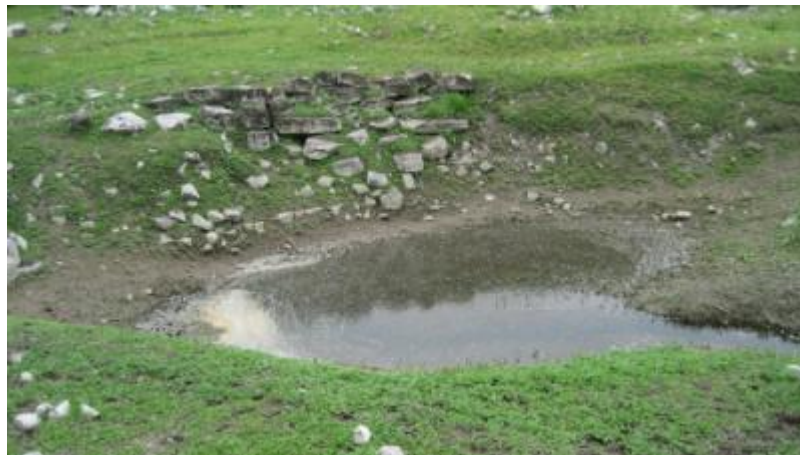
Fig. 11 Swallow hole to the west of the Shrule Turlough (July 2007).

Sand deposition was observed in the swallow hole on the Corrib side of Shrule Turlough. The increase in the size of the swallow hole collecting basin and decreased flow of water within the basin appears to facilitate the deposition of particulate matter. This phenomenon might also be true of other Office of Public Works drainage channels that benefit the drainage of peatlands which flow into Turloughs. Access to swallow hole would be needed to confirm deposition of any external particulate matter.

Arterial drainage maintenance has influenced the Turlough regime. At the Shrile Turlough, the appearance of the swallow hole has changed (Goodwillie, 1992, personal communication from OPW staff). Arterial drainage work has focused on increasing the water storage capacity around the swallow hole rather than interfering with the swallow hole mechanics. Consequently, a rather large hollow identifies the swallow hole to the west. The swallow hole to the east is marked by a debris collection grill and an arc of stones enclosing the swallow hole (which were removed from the swallow hole area).

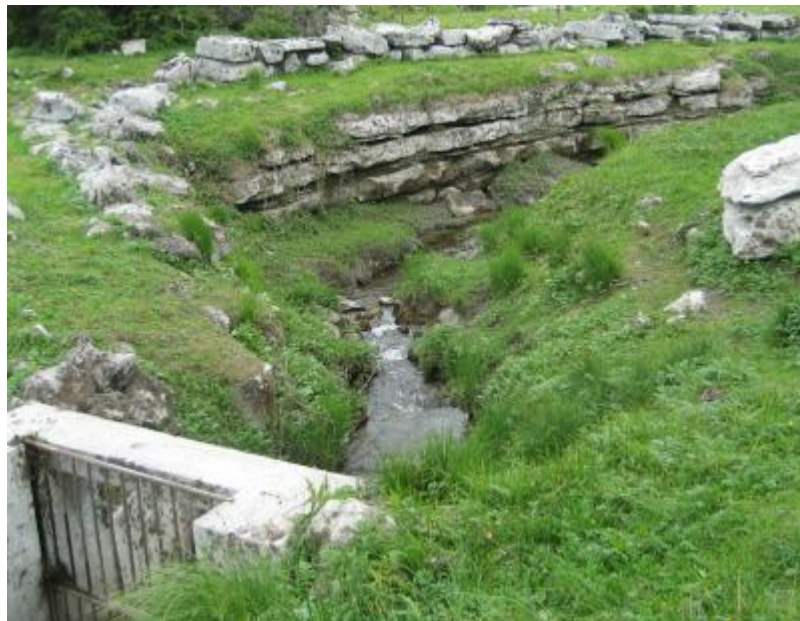
Fig. 12 Swallow hole to the east of the Shrule Turlough (July 2007).

Irreversible damage caused in Turlough habitats are associated with large schemes undertaken in the mid 70s. Engineering works undertaken at Shrle Turlough involved the removal of large sections of limestone rock to enlarge the swallow hole basins. The deposition of fine sediment material in a swallow hole basin at Shrle may need to be assessed in the short to medium term. Whether the deposition of sandy material is a consequence of a larger swallow hole basin is debatable and beyond the scope of this report.

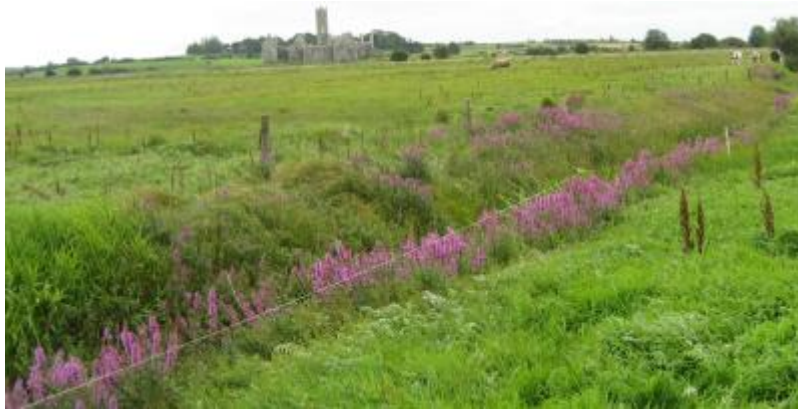
Fig. 13 Floral diversity on the banks of an Office of Public Work channel (August 2007).

During the course of the survey arterial drainage channels supported a different flora to that of the surrounding Turlough environment. For the most part this was due to the different land management regime observed. Office of Public Works channels were often protected by fencing preventing livestock from accessing the channel area. As a result the channel banks were colonised by tree and plant species. The drainage channel at Rosstaff Turlough was colonised with Heath Orchids in July and Purple Loosestrife in August, which contrasted with the surrounding grazed agricultural grassland. The slow colonisation of marl at the Belcare Turlough supports insectivorous plants.

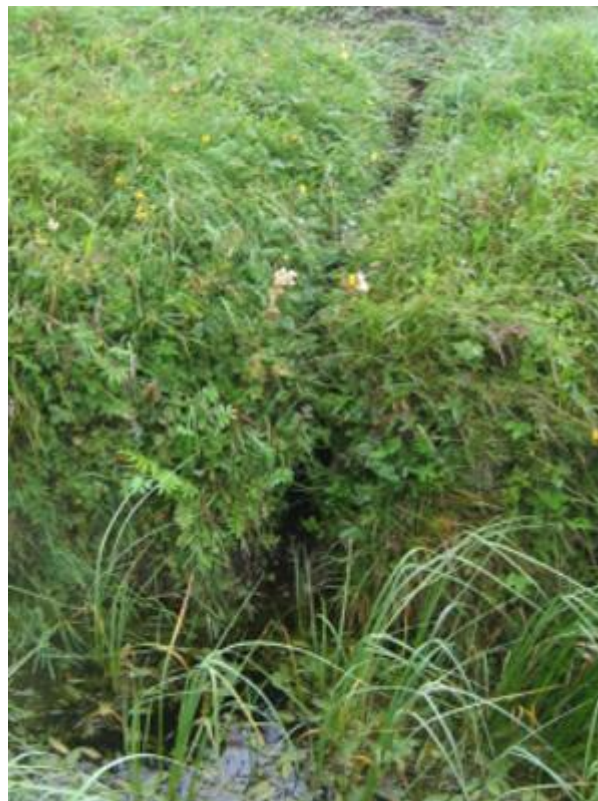
Fig. 14 A hare burrowed channel cut into the side of a drainage channel (August 2007).

Channel width and depth within Turlough habitats has an impact on mammals and birds. Fenced sections of arterial drainage channels supporting rushes were often preferred by birds such as mallard ducks and kingfisher. However, channel width and depth can on occasion negatively impact on terrestrial mammals traversing dry Turlough lands.

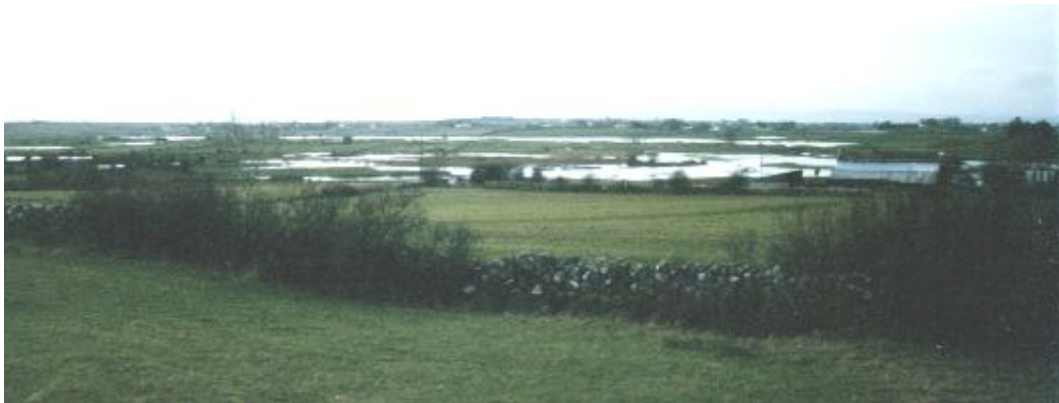
Fig. 15 The extent of flooding near Shrule November 1999 (courtesy Office Public Works).

In the absence of Turlough flood management, flooding caused by Turloughs has made roads impassable and left communities stranded. A report in a local paper the Western People on the 10<sup>th</sup> October 2007 publicised the flood relief work undertaken at the Thomastown Turlough. According to the article the worst flooding was experienced in the area in late 2006 and early 2007 when four to five houses were cut-off due to flood waters. Similarly, flooding caused by the Shrule, Belclare and Killoower Turloughs has also been reported in local newspapers. In the case of Shrule Turlough, local access roads adjoining the Turlough have been impassable for two to three months at a time.

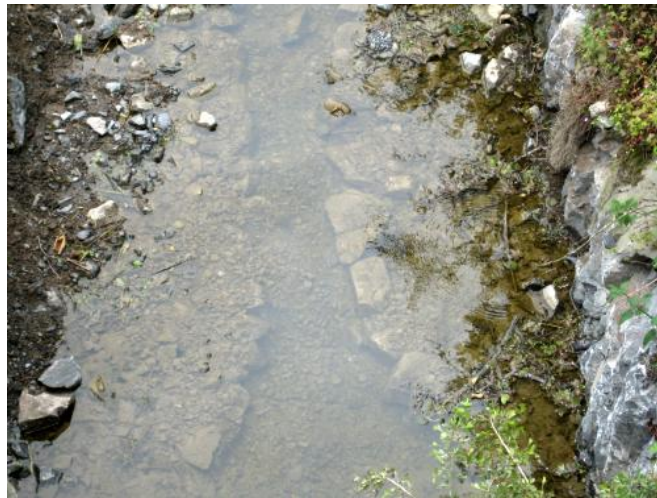
Fig. 16 Deflectors placed at the base of a bridge of the Clyard Turlough complex (July 2007).

Although Turlough habitats are classified as freshwater environments not all Turloughs surveyed would be capable of supporting fish populations during summer months. However, Turlough habitats fed by large streams can support fish populations. Photographed below are two different types of deflectors which have been installed in an Office of Public Works drainage channel at the edge of a Turlough habitat. This is in compliance with Step 10 of the Environmental Drainage Maintenance Programme and undertaken in consultation with the Western Regional Fisheries Board.

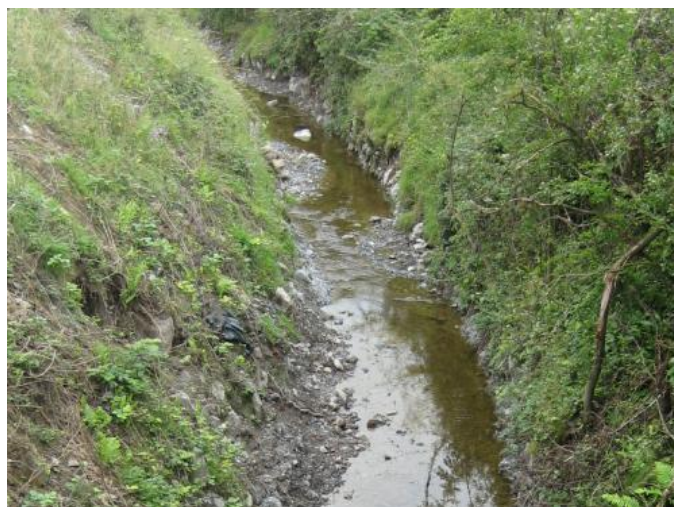
Fig. 17 Alternating deflector series on the Clyard Turlough complex (July 2007).
