OFFICE OF PUBLIC WORKS

REVIEW OF THE SOUTH GALWAY FLOOD STUDY REPORT

ENGINEERING PROPOSALS FOR THE REINSTATEMENT OF CULVERTS ON THE N18 AND THE PROVISION OF NEW CULVERTS ON MINOR ROADS AT KILTARTAN

FEASIBILITY OF AN OVERLAND CHANNEL FROM COOLE TO KINVARRA

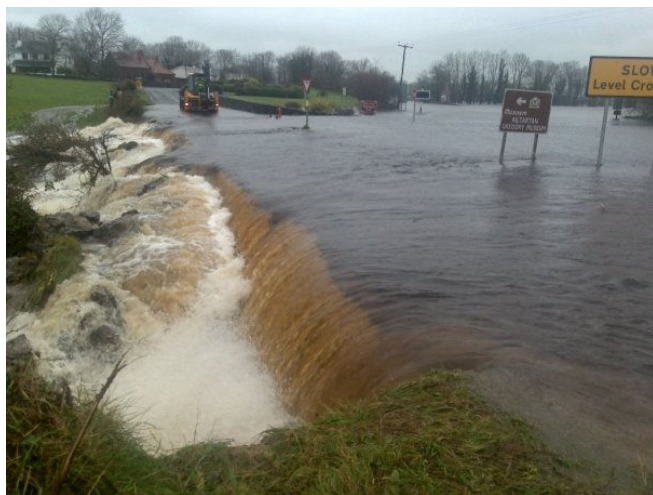
Figure 1.1 : Flood Waters crossing over the N18
& Railway crossing at Kiltartan
November 2009 Floods

As can be seen in Figure 1.1, waters flooded the N18 at Kiltartan as well as a significant section of the adjacent Limerick to Galway railway. The church at Kiltartan was flooded and a number of houses became isolated and surrounded by flood waters. 2 to 3 feet of water which is equivalent to 0.6m to 0.9m, were reported on the local road from Kiltartan to Raheen :

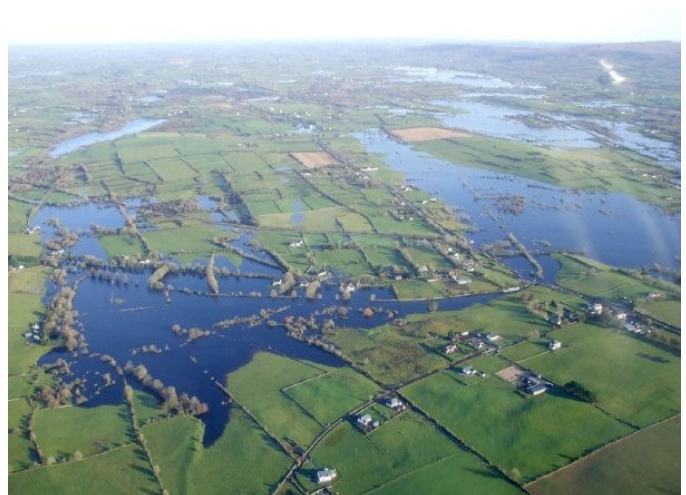
Figure 1.2 : Kiltartan Aerial Photograph
November 2009 Floods

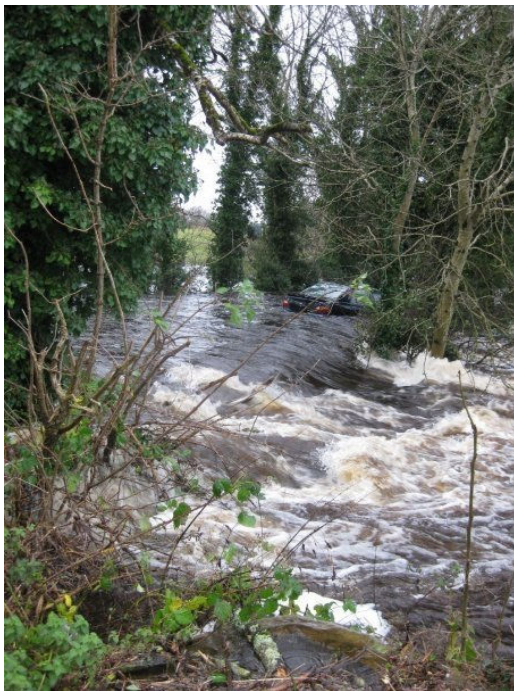
*Figure 1.3 : Kiltartan to Raheen local Road –
Flood level 14.5 to 15.0mOD approximately
November 2009 Floods*

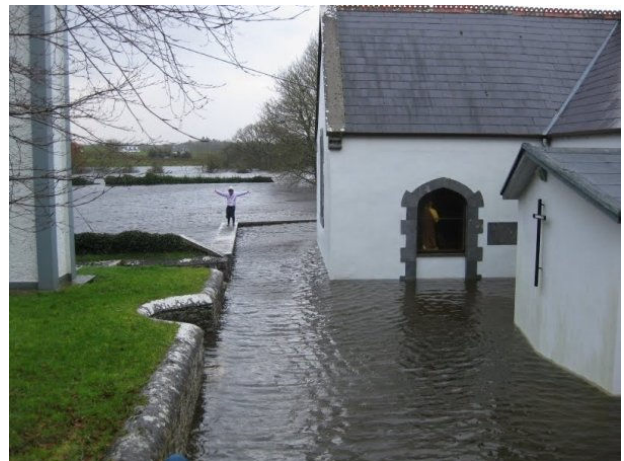
*Figure 1.4 : Kiltartan church (FFL @
14.25mOD) – Flood level 14.5m to 15.0mOD
approximately
November 2009 Floods*

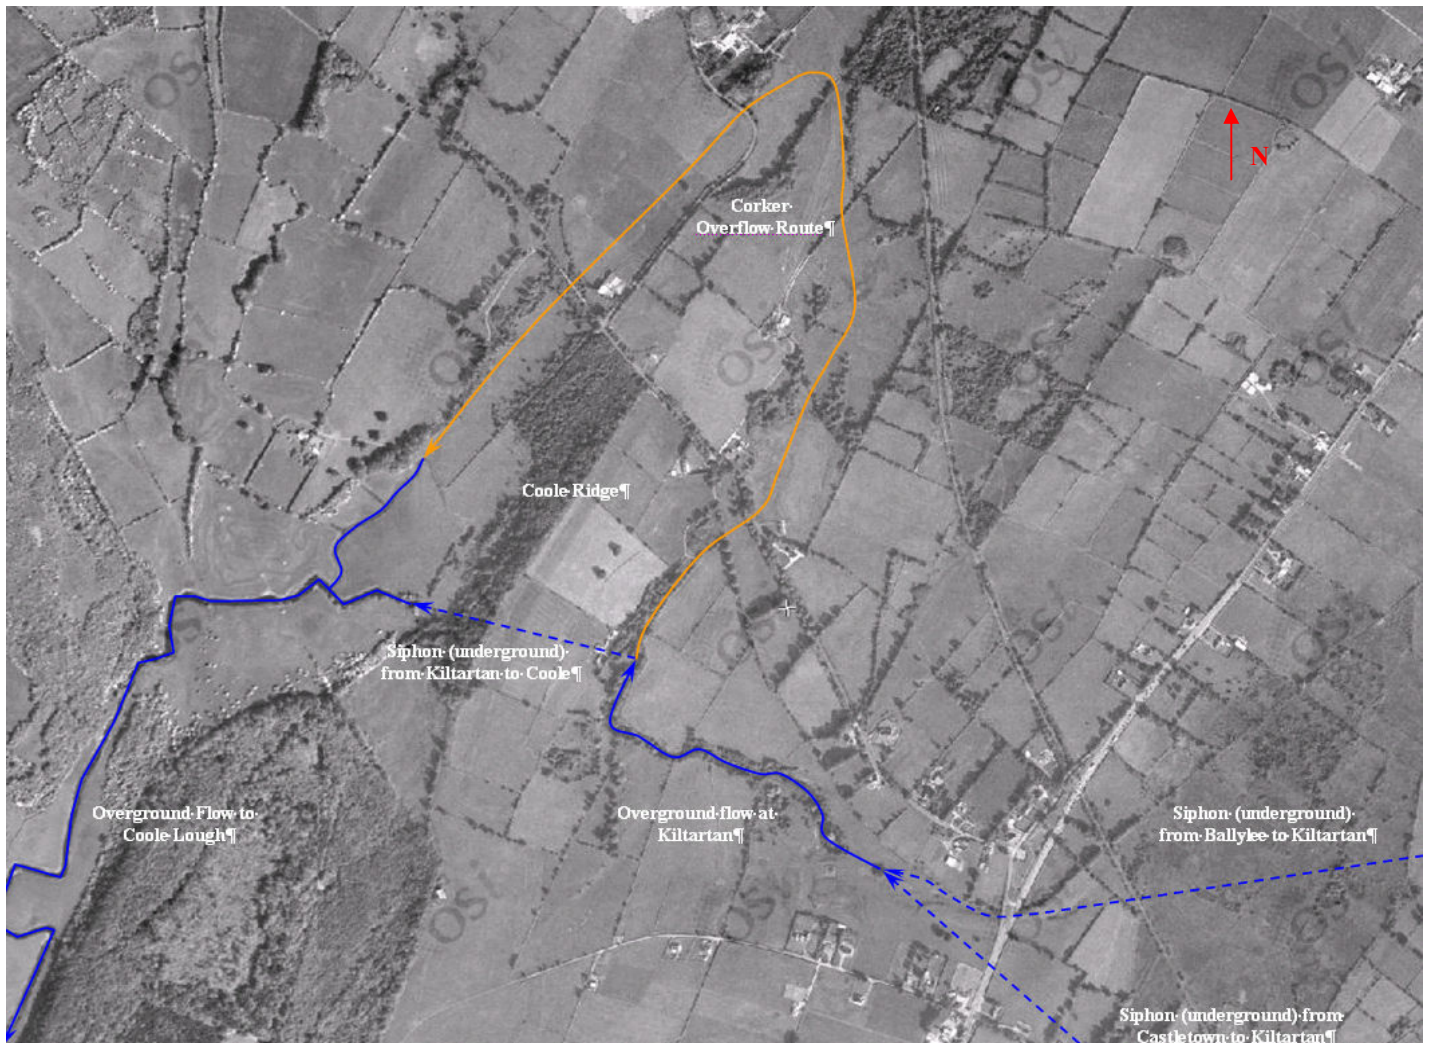
Figure 2.1 : Kiltartan schematic

3. The head differential between Coole Lough and the main sink hole at Kiltartan (known as Pollomuiiri) decreased significantly which subsequently reduced the capacity of the underground system from Kiltartan to Coole
4. Water levels rose at Kiltartan and water found its way through a natural winter “overflow” channel at Corker.

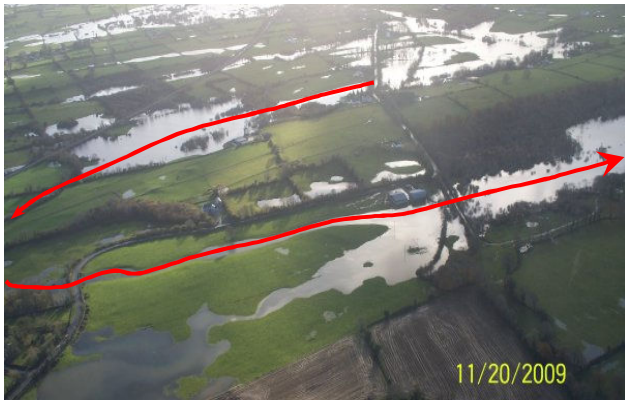
*Figure 2.2 : Corker overflow
November 2009 Floods*

During the November 2009 floods, underground systems gradually decreased in flow capacity in response to reduced head differentials. Flood waters tended to flow overground as illustrated in the following aerial photos :

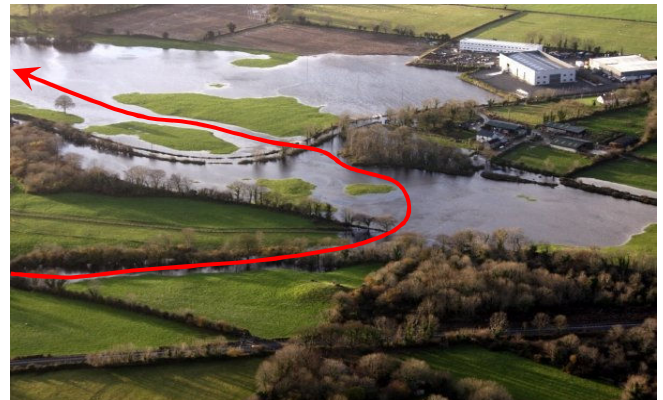
*Figure 2.3 : Corker overflow
November 2009 Floods*

As a significant proportion of the flow is over ground under extreme flooding conditions, it is deemed satisfactory to generate design flows using traditional methods, for the purpose of culvert sizing only in the Kiltartan area.

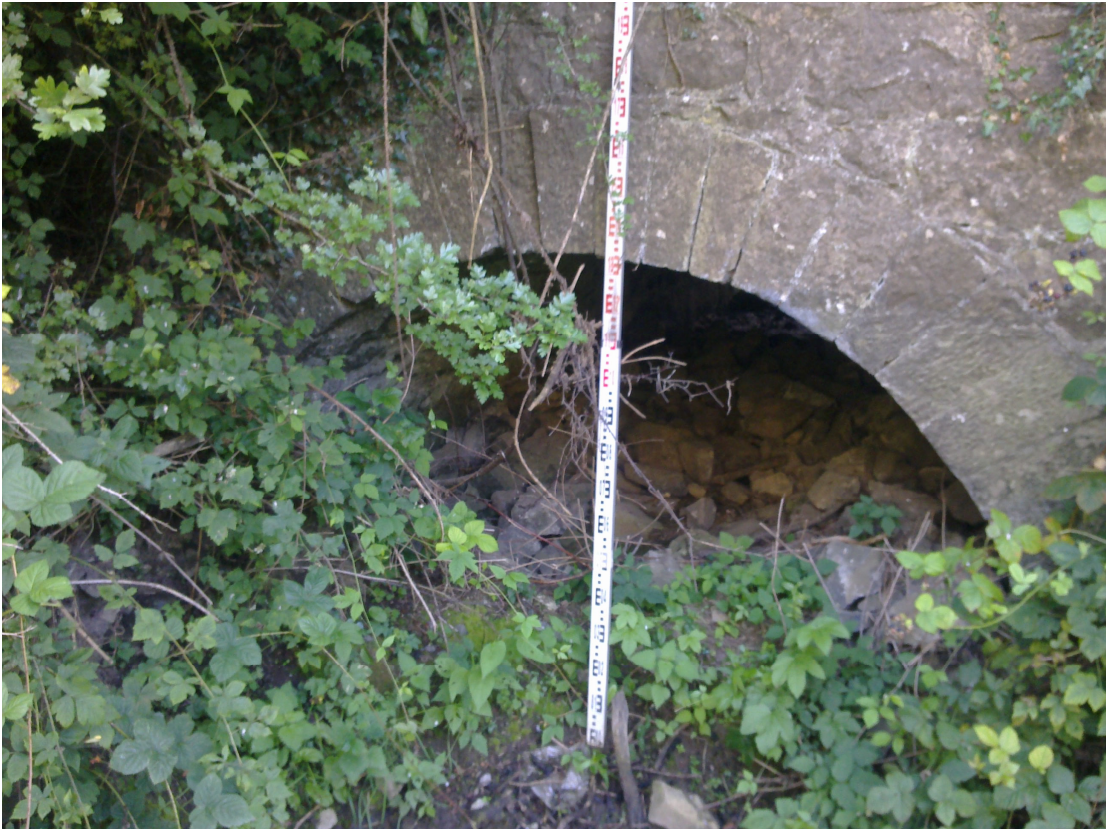
*Photo No.14 – Looking downstream to the arch bridge on the Corker overflow route
Refer to Drawing No. 4721/K/02 for the exact location*

Photo No.14 above shows that the bridge is partially filled with debris accumulated over the years. A number of boulders are also currently blocking the downstream end of the bridge. Cleared from any debris, the bridge is approximately 1.5m high by 2.0m wide which gives a maximum wetted area of approximately 2.35 m². It is estimated that under gravity conditions, the flow transfer capacity through this bridge is approximately 30 m³/s. In November 2009, the bridge was surcharged as water reached the level of the Kiltartan to Raheen Road.

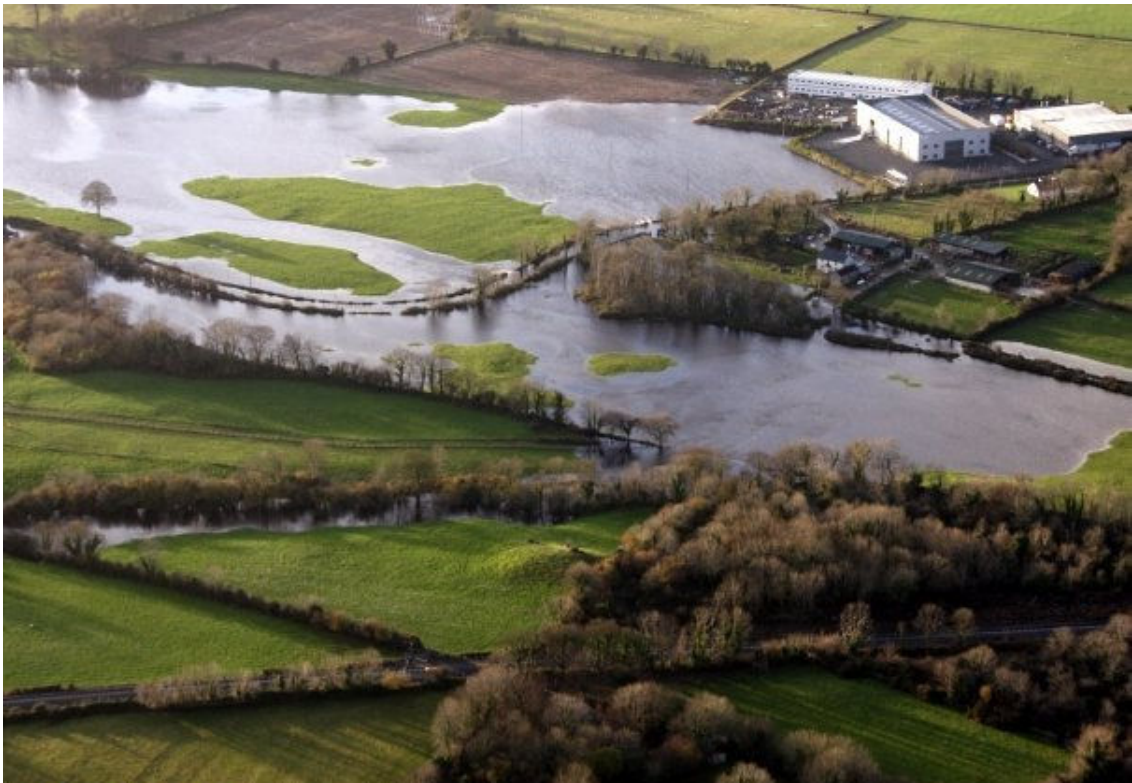
*Figure No.3.1 – Corker overflow – Water flowing over the Kiltartan to Raheen Road
Road levels at this location 12.90mOD – Flood levels estimated to be 13.0 to 13.5mOD
approx.*

This means that flows in November 2009 along the Corker overflow (at the downstream end) could have been higher than 30 m³/s going through the bridge and even higher overall as a significant proportion of the water bypassed the bridge and flowed over the Kiltartan to Raheen Road as shown in Figure 3.1 below.

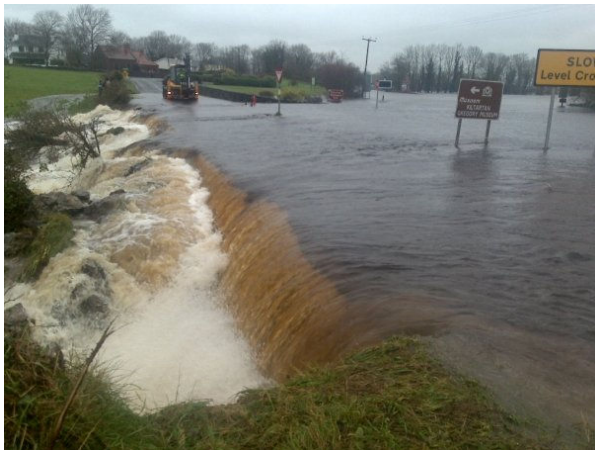
*Figure No.4.1 – N18 at Kiltartan
November 2009 floods*

During the November 2009 floods, it became apparent that the existing culvert underneath the N18 road at Kiltartan was blocked and consequently flood waters rose above the level of the N18. As a result, the N18 was closed for a number of days as well as the adjacent Limerick to Galway railway. It is estimated that water levels above the N18 reached 18.2mOD.

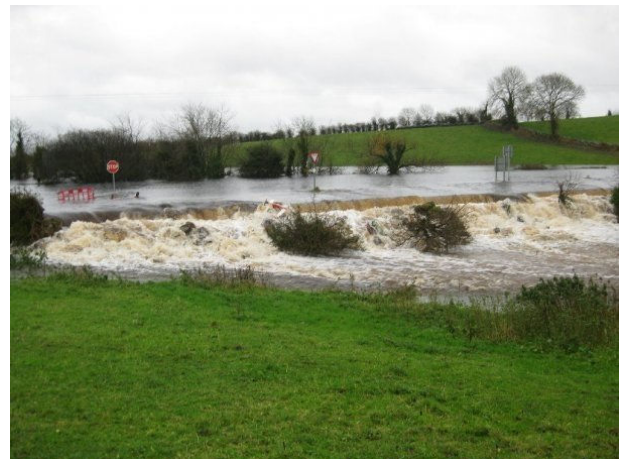
*Figure No.4.2 – N18 at Kiltartan
November 2009 floods*

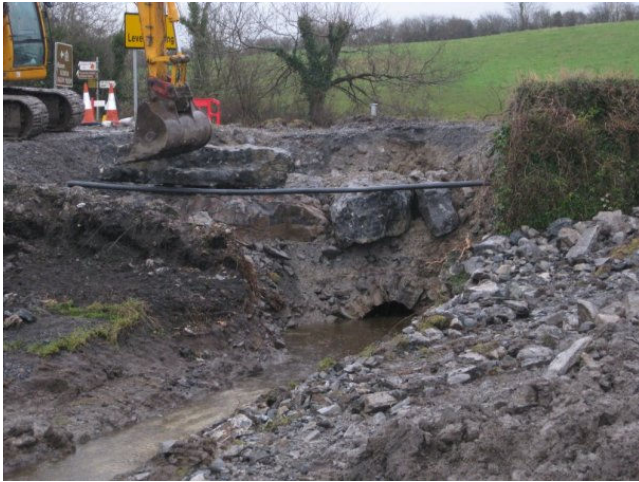
*Figure No.4.3 – N18 at Kiltartan
 Emergency Works
 November 2009 floods*

As part of emergency works in November 2009, the old stone culvert crossing the N18 was identified.

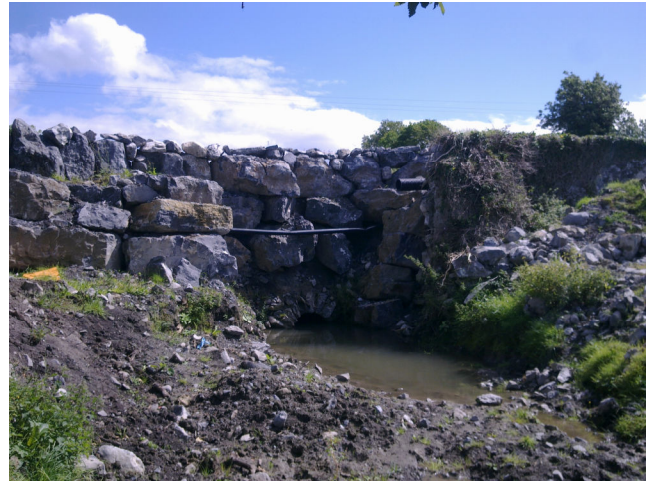
*Figure No.4.4 – N18 at Kiltartan
 Partially unblocked culvert
 August 2010*

As can be seen in Figure No. 4.4, the culvert is still partially blocked. From detailed observations and measurements of the accessible part of the culvert, the size of the culvert can be estimated to be approximately 2.5 metres in width at the base and 1.5 metres high. A culvert of these dimensions is capable of conveying a capacity of 20 m³/s. However, this is less than the 30m³/s identified in Section 3.4 which is the estimated overground flow of the existing arch bridge on the Corker overflow. In addition, the culvert is in poor structural condition and may have sustained further damage from the flow of flood waters in November 2009.

It is therefore proposed to construct a new pre cast concrete culvert under the N18 to replace the existing old culvert which is under capacity and in poor structural condition. It is proposed that the pre cast concrete culvert be 3m wide and 2.0m high with associated pre cast splayed wing walls at the upstream and downstream ends.

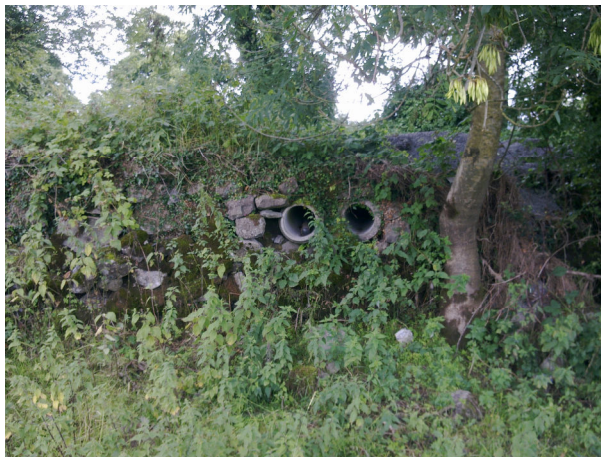
The local Kiltartan to Raheen road was raised following the 1995 flood event and 2 No. 150mm diameter pipes were placed as shown in Figure No. 4.5 below :

Figure No.4.5 – Upstream end of Corker overflow – 2 No. 150mm diameter pipes crossing the Kiltartan to Raheen road

It is proposed to construct a new pre cast concrete culvert to replace the existing 150mm dia. pipes which are significantly under capacity. It is proposed that the pre cast concrete culvert be 3.5m wide and 1.5m high with associated pre cast splayed wing walls at the upstream and downstream ends.

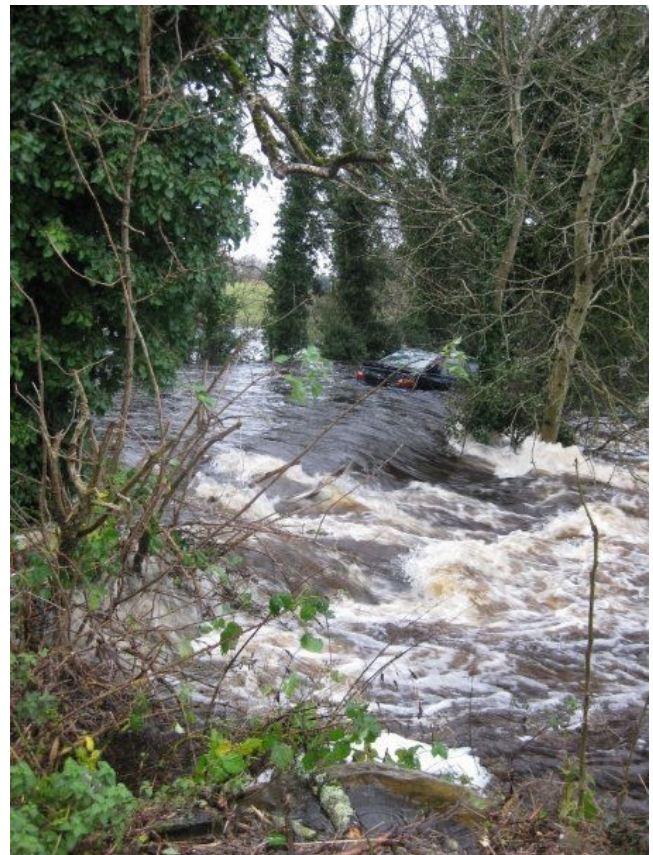
Figure No.4.6 : Same location as adjacent

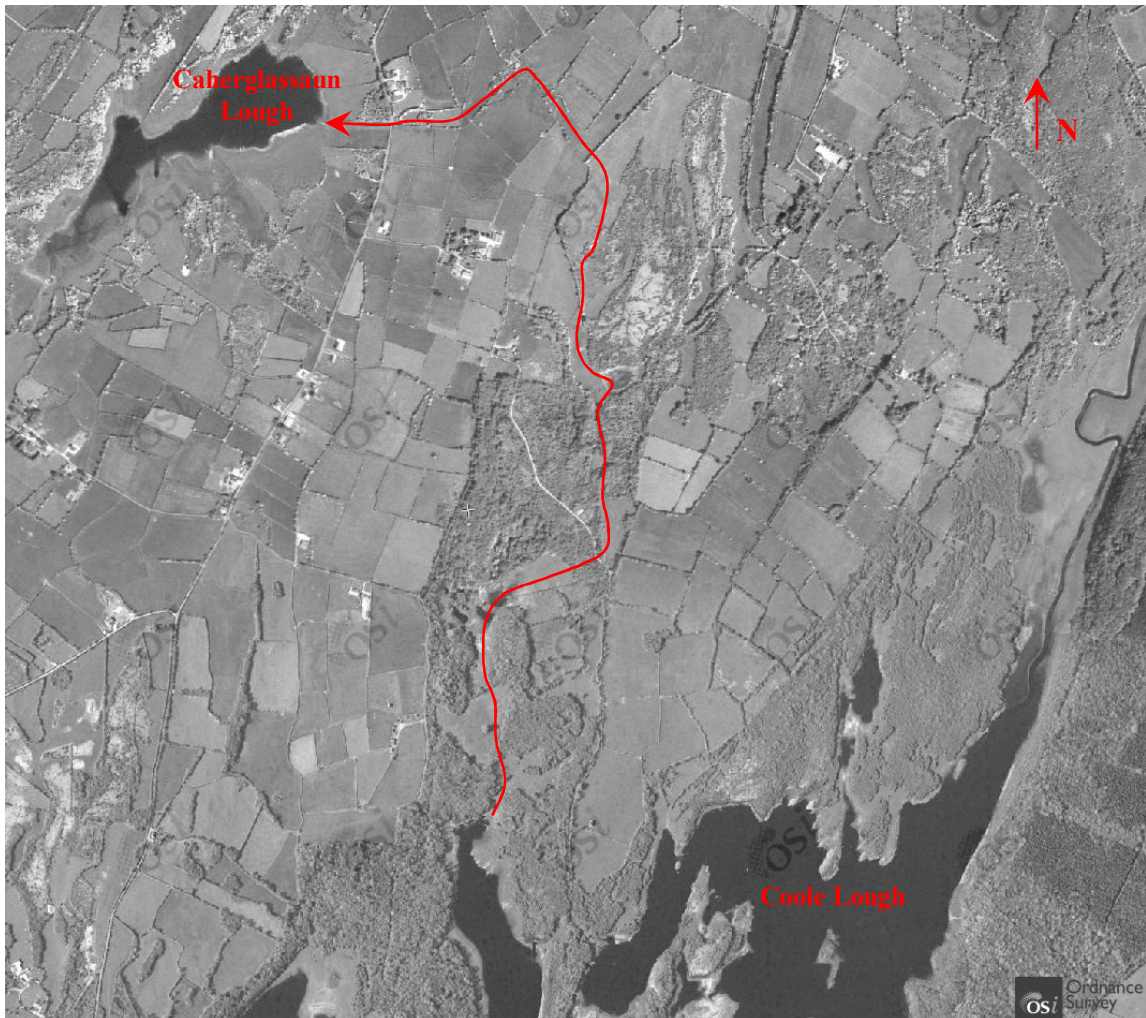
Figure No.5.1 – Coole to Caherglassaun natural overflow

As can be seen in Figure 5.1 above, the route of this natural overflow follows low lying areas in a north westerly direction. It is technically feasible to improve the capacity of this natural route as described in the 1998 South Galway Flood Study Report. This would involve minor excavation works to lower ground levels upstream from the road crossing (northern end of the alignment only) as well as the construction of a culvert under the road to Cahermore and an additional culvert under an agricultural access road as shown on Drawing No. 4721/K/07.

As can be seen above, excess water from Coole Lough overflowed to Caherglassaun Lough following the route detailed under Section No.5.3 – Figure 5.1. This natural channel

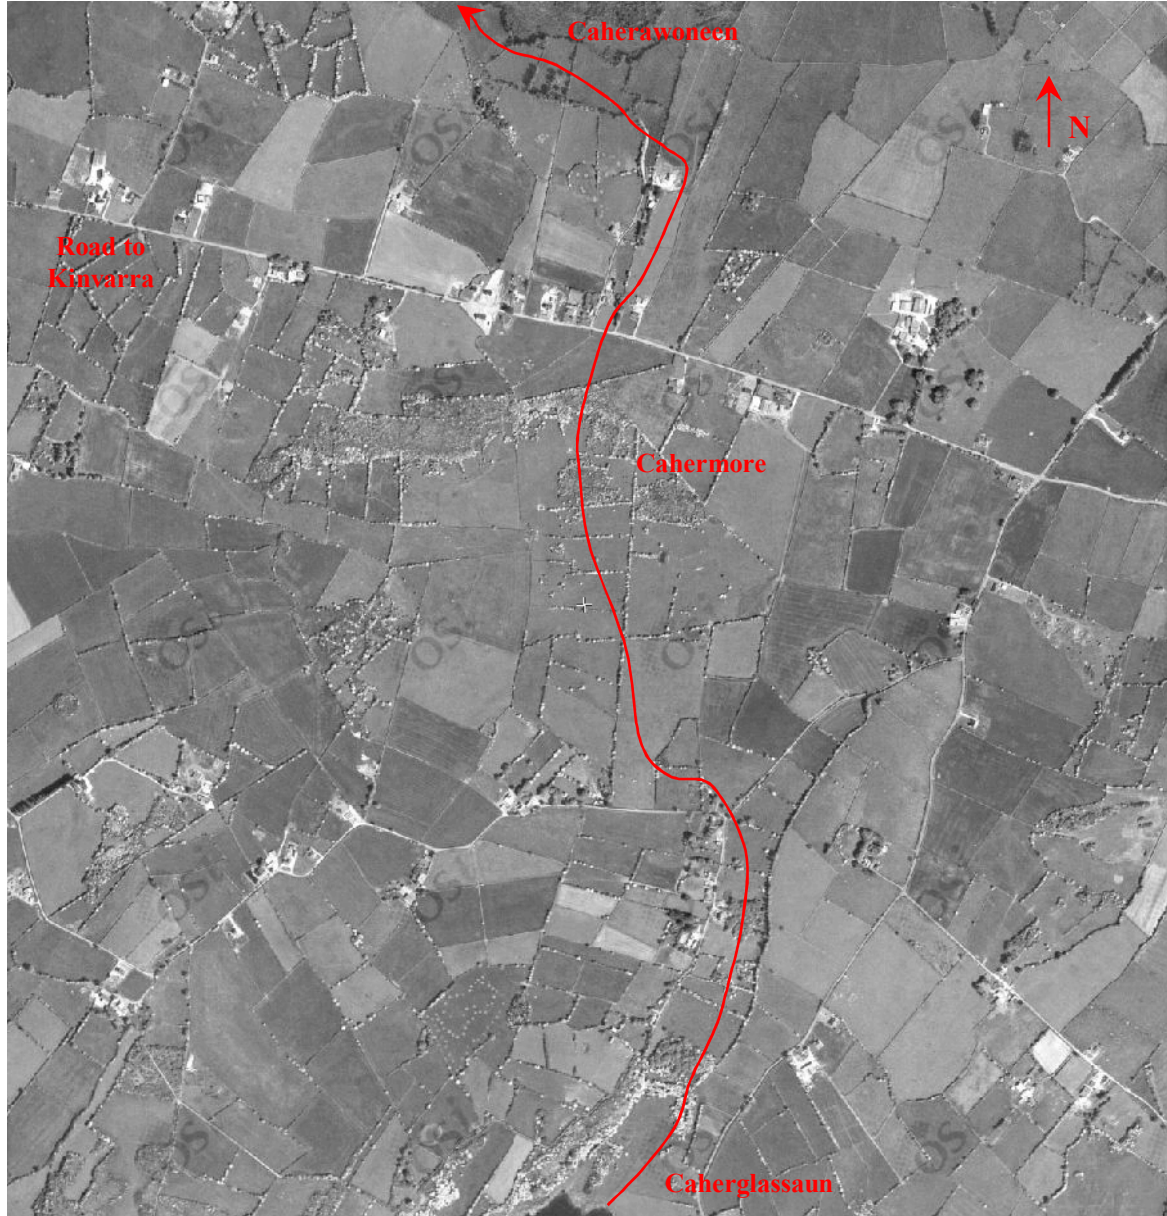
The upstream part of the possible overland flood overflow channel between Caherglassaun and Caherawoneen via Cahermore is set out in Figure 5.2 as follows :

Figure No.5.2 – Possible Caherglassaun to Caherawoneen via Cahermore overland flood overflow channel

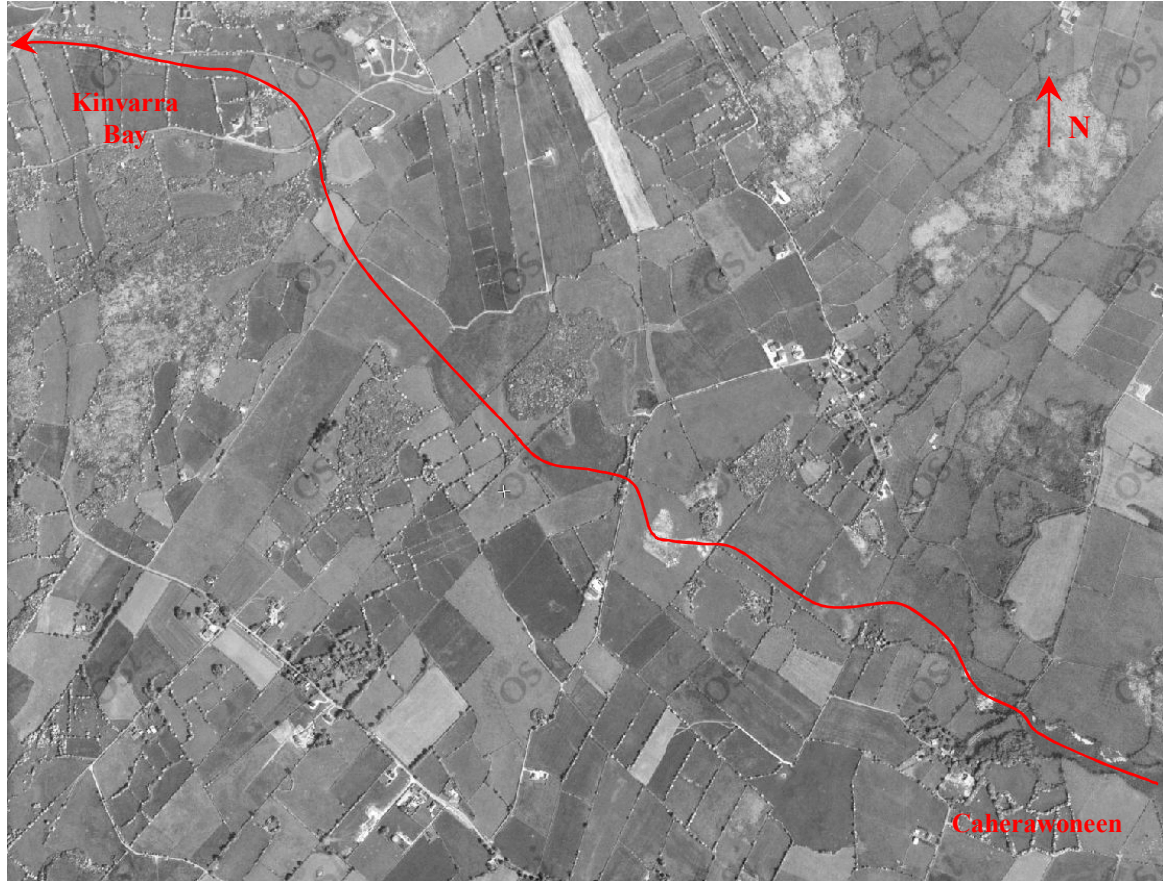
The route of the possible overland flood overflow channel downstream from Caherawoneen to Kinvarra is set out in Figure 5.3 as follows :

*Figure No.5.3 – Possible Caherawoneen to Kinvarra
overland flood overflow channel (continuation from Figure No.5.2)*

As can be seen above, water from the Caherawoneen basin flowed to Kinvarra following the route detailed under Section No.5.4 – Figure 5.3. This natural path crosses a number of boundaries such as hedges, fences and stone walls which caused hydraulic restrictions. Flood waters also crossed over two local roads as shown on Drawing 4721/K/09 (Point D & Point E).

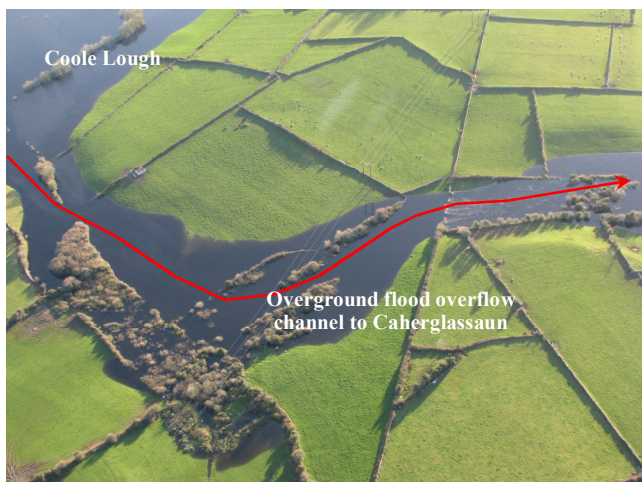
Figures No.6.1 and 6.2 below show aerial photographs of the floods on the 30th of November 2009 in the Coole / Caherglassaun area :

*Figure No.6.1 – Overground Channel Path
from Coole to Caherglassaun
Upstream End*

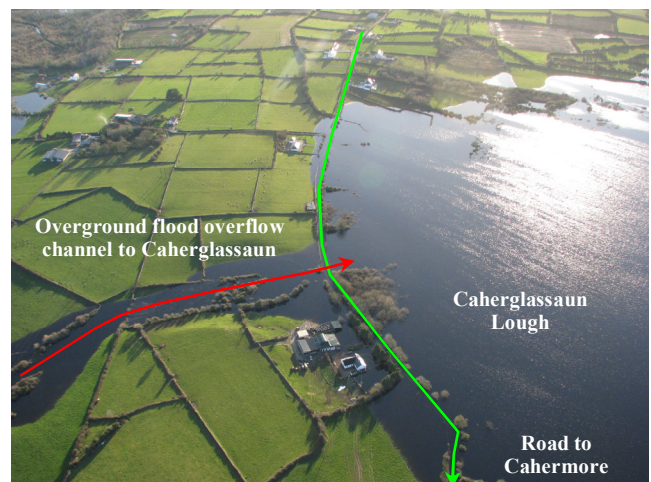
*Figure No.6.2 – Overground Channel Path
from Coole to Caherglassaun
Downstream End*

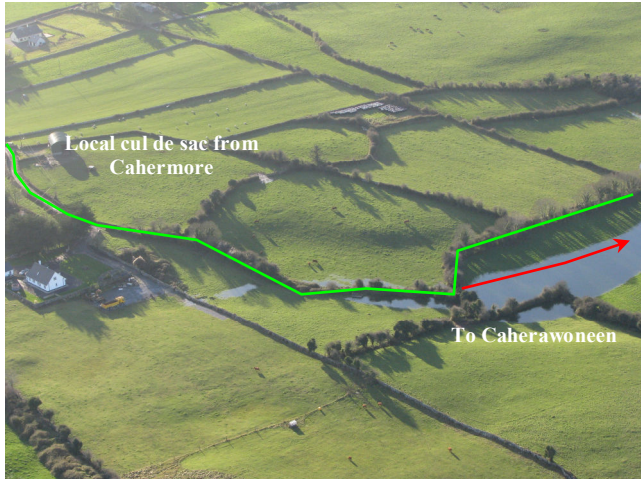
Figures No.6.3 and 6.4 below show aerial photographs of the floods on the 30th of November 2009 in the Caherawoneen / Kinvarra area (upstream side) :

*Figure No.6.3 – Overground Channel Path
from Caherawoneen to Kinvarra
Upstream Side (1 of 2)*

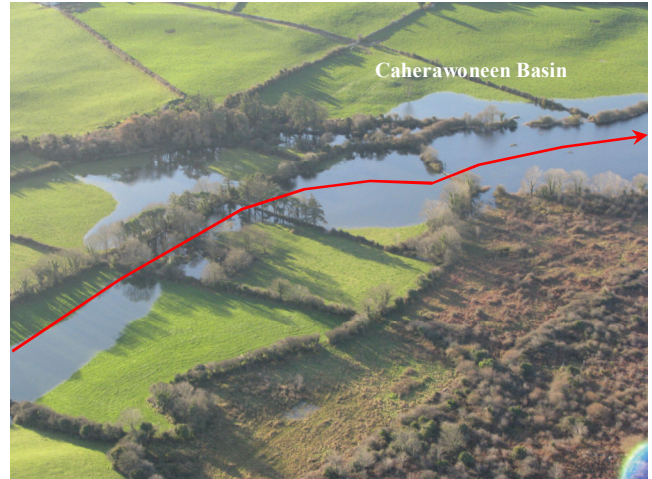
*Figure No.6.4 – Overground Channel Path
from Caherawoneen to Kinvarra
Upstream Side (2 of 2)*

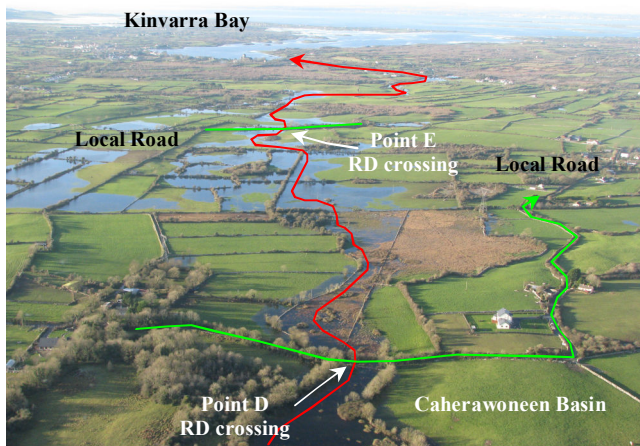
Figures No.6.5 and 6.6 below show aerial photographs of the floods on the 30th of November 2009 in the Caherawoneen / Kinvarra area (downstream side) :

*Figure No.6.5 – Overground Channel Path
 from Caherawoneen to Kinvarra
 Downstream Side (1 of 2)*

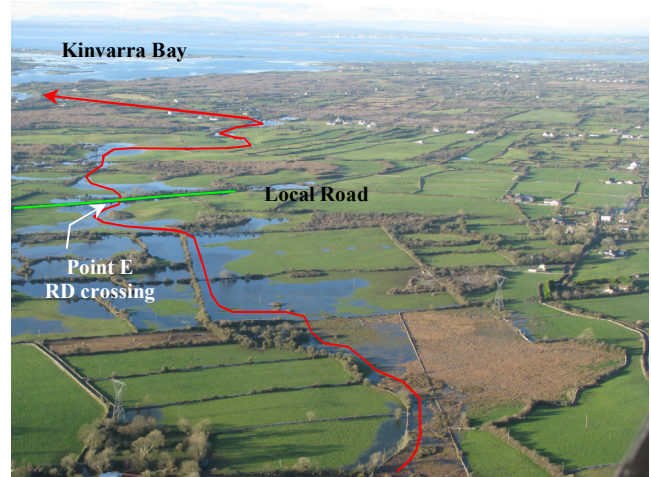
*Figure No.6.6 – Overground Channel Path
 from Caherawoneen to Kinvarra
 Downstream Side (2 of 2)*
