REVIEW OF THE SOUTH GALWAY FLOOD STUDY REPORT

ASSESSMENT OF THE EXISTING KILTIERNAN / BALLINDERREEN FLOOD RELIEF SCHEME

FINAL – NOVEMBER 2010

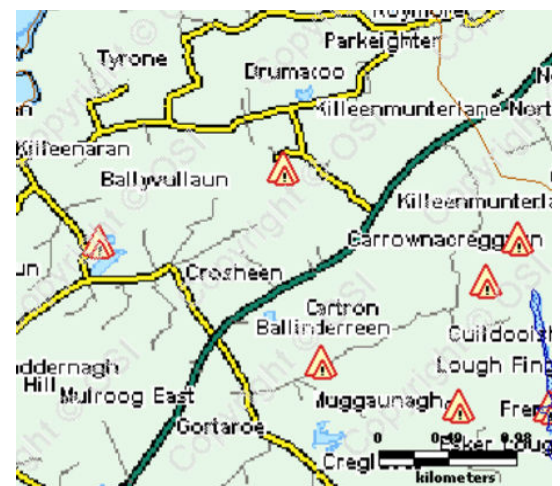
Figure 1.2 : Ballinderreen Area

As can be seen above, large areas within the catchment are prone to flooding. And although emergency works were carried out in 1995, the flood risk remains and flood waters were particularly high in November 2009 as shown in the aerial photographs in Figures 1.3 and 1.4.

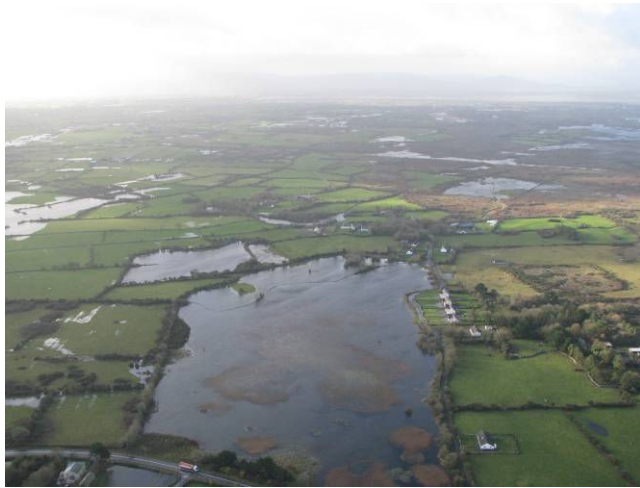
*Figure 1.3 : Tullaghnafrankagh / Caheradoo
Flood Area
November 2009*

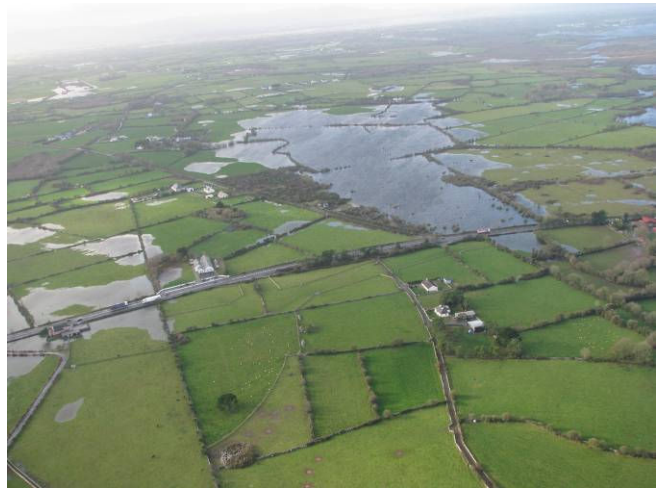
*Figure 1.4 : Kiltiernan School / Keamsellagh
Flood Area
November 2009*

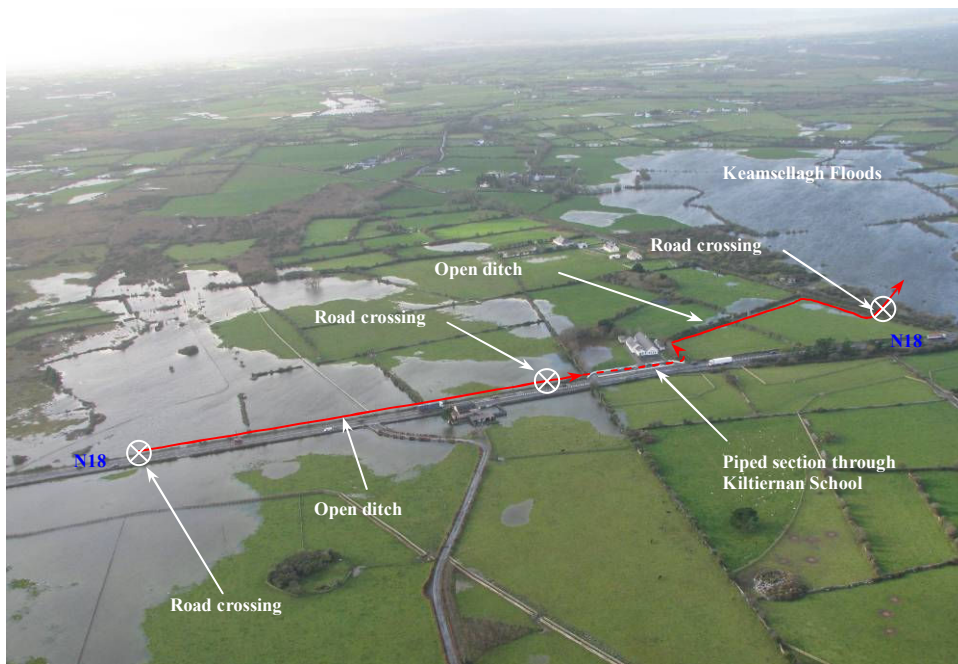
Figure 3.1 : Area surrounding Kiltiernan School – November 2009

The 600mm pipes discharge into an open ditch which crosses under a local road via a 600mm diameter steel pipe. The steel pipe discharges into an overgrown area adjacent to a flood plain known as Keamsellagh Flood.

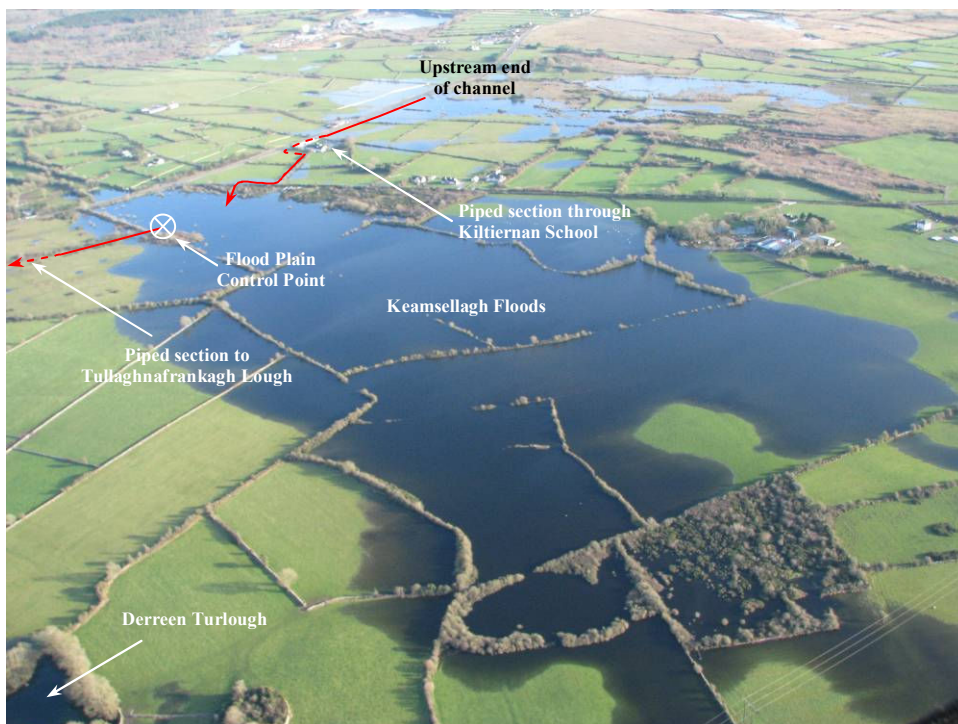
Figure 3.2 : Keamsellagh Floods Area – November 2009

Under flooding conditions, when water levels rise significantly (refer to the longitudinal section), flood waters are transferred to Tullaghnafrankagh Lough via a 446m long concrete pipe 600mm in diameter.

Construct a 900mm diameter concrete pipe to replace the existing pipe between Keamsellagh Flood Plain and Tullaghnafrankagh Lough at a gradient of 1 in 365, overall length 446m. The flow capacity of the upsized section would be in excess of 750 l/s approximately, which is consistent with the regrading works proposed on the upstream sections.

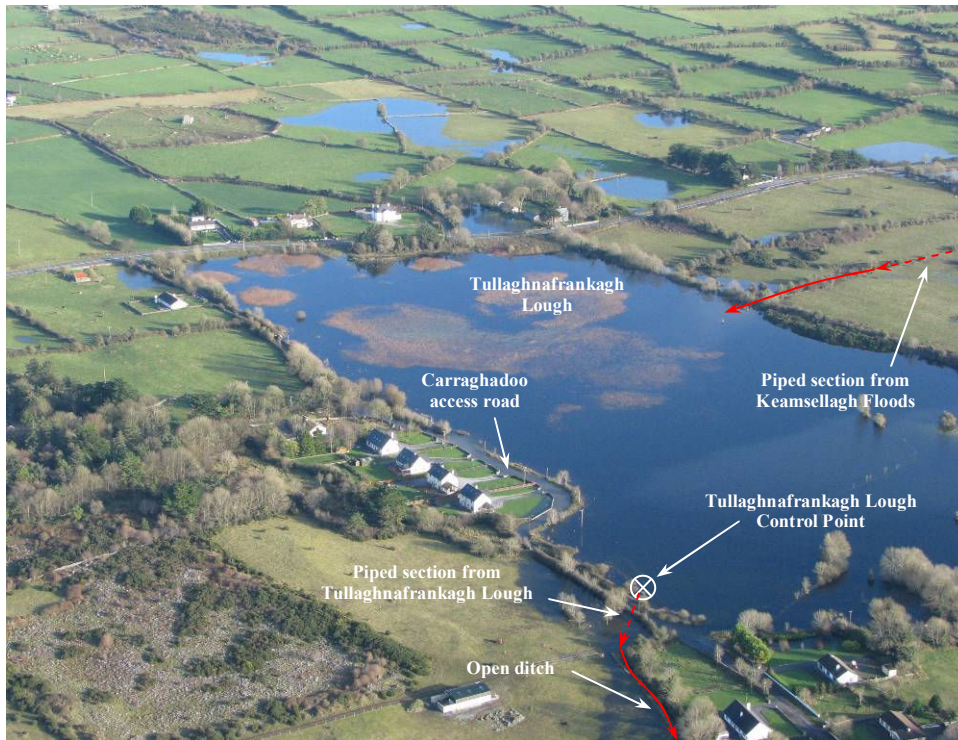
Figure 3.3 : Tullaghnafrankagh Lough – November 2009

On the outlet from Tullaghnafrankagh Lough there is a high level overflow control point allowing flood water to be transferred to Lough Fingall. This control point is located adjacent to a local road serving a number of houses in the Carraghadoo area.

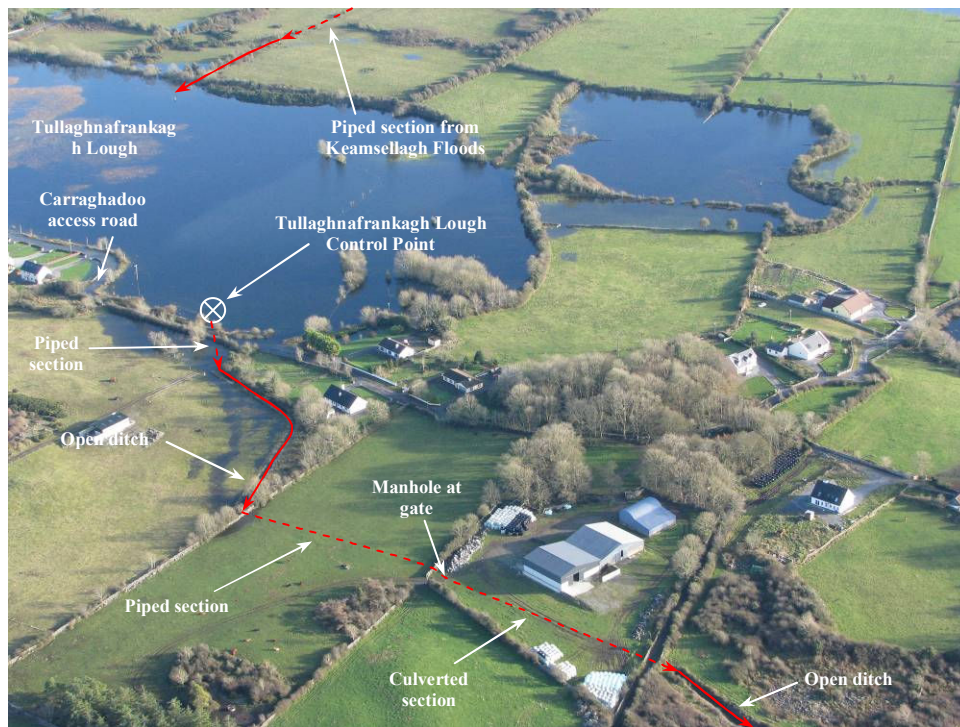
Figure 3.4 : Tullaghnafrankagh Lough / Carraghadoo village – November 2009

Twin 600mm diameter pipes cross under the local road on the outlet to Tullaghnafrankagh Lough and discharge into an open ditch 1200 to 1800mm wide at the base and 600 to 1200mm deep. The drainage system continues underground via twin 600mm diameter pipes initially, changing to a 800mm high by 1500mm wide culvert. The culvert discharges into an open ditch leading to the Lough Fingall flood plains.

Upsize the existing twin 600mm diameter pipes crossing under the local access road to Carraghadoo with a single 1050mm diameter concrete pipe. It is recommended that the new pipe be laid at a gradient of 1 in 800, overall length 58.5m. The flow capacity of the new structure would be 810 l/s approx which is consistent with the regrading works proposed on the upstream and downstream sections.

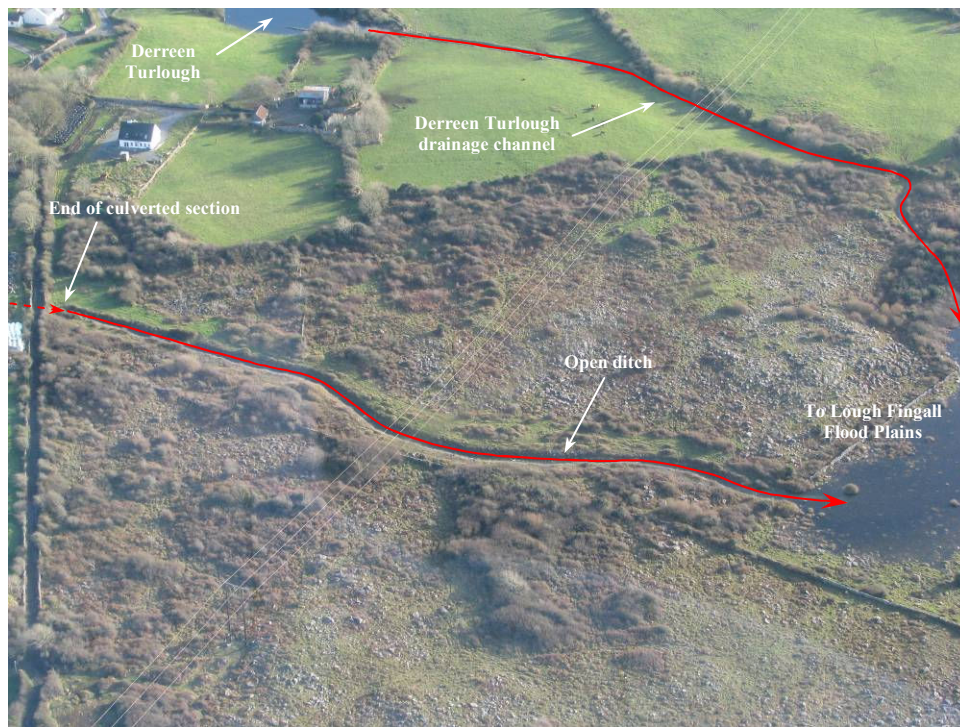
Figure 3.5 : Downstream from Carraghadoo village – November 2009

Figure 3.5 above shows another flood drainage channel running from Derreen Turlough and discharging into Lough Fingall. This channel was privately constructed in parallel with the Kiltiernan emergency flood relief scheme in 1995.

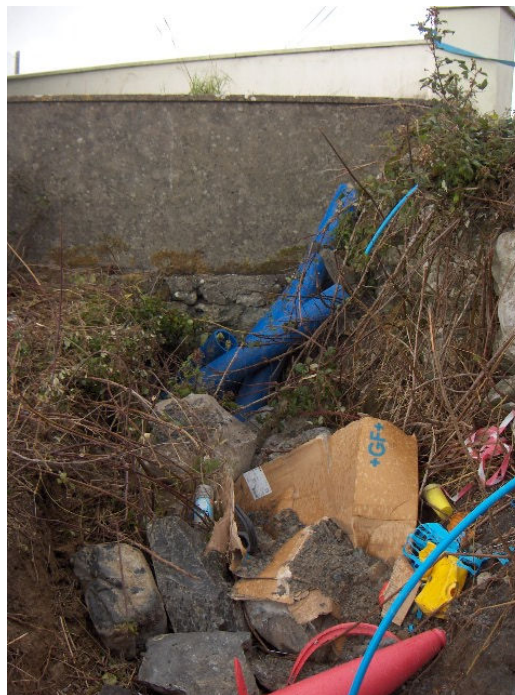
At the time of the site visits in August 2010, construction debris was identified at the upstream end of the culverted section at Kiltiernan school and the culvert was partially blocked and inaccessible. According to OPW records, this section through the school was piped using 600mm diameter concrete pipes. The maximum flow capacity under gravity conditions is assessed to be 185 l/s which is considered low in comparison with most of the open sections of the channel which have capacities well in excess of 1,000 l/s.

*Photo No3 – Looking downstream at start of culverted section through
Kiltiernan School (Chainage 361m)*

Construct a 900mm diameter concrete pipe to replace the existing pipe through Kiltiernan School grounds at a gradient of 1 in 450, overall length 85m. The flow capacity of the upsized section would be in excess of 750 l/s which is consistent with the regrading works proposed on the upstream and downstream sections.

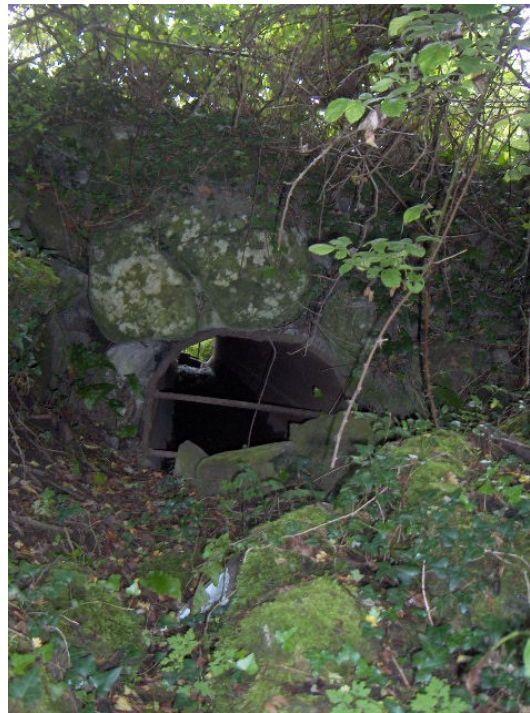
The existing 600mm steel pipe crossing the road at chainage 706m (at Kiltiernan West) is capable of conveying a maximum of 225 l/s under gravity conditions which again is considered low in comparison with most of the open sections of the channel.

*Photo No9 – Local Road crossing – Looking upstream at end of piped section
Refer to Drawing No. 4721/KB/02 for the exact location (Chainage 706.27m)*

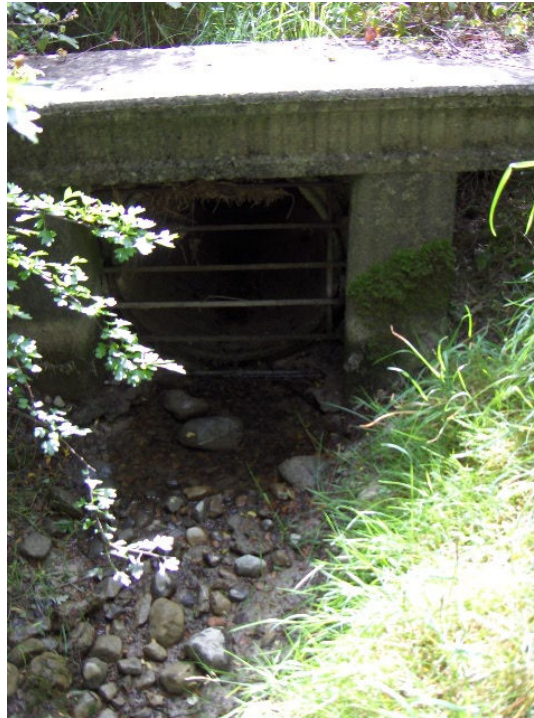
Photo No15 – Looking upstream at end of piped section

The existing 600mm concrete pipe discharging to Tullaghnafrankagh Lough is capable of conveying a maximum of 175 to 220 l/s under gravity conditions which is considered low in comparison with most of the open sections of the channel.

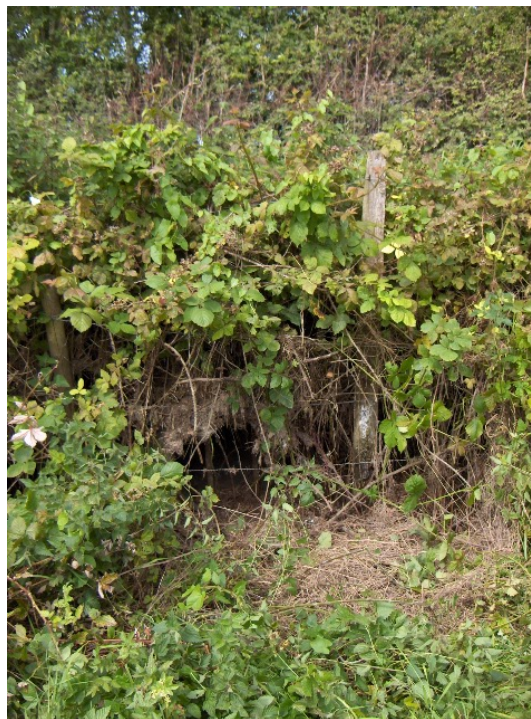
The existing twin 600mm diameter concrete pipe at the outlet of Tullaghnafrankagh Lough is capable of conveying a maximum of 150 l/s under gravity conditions which is considered low in comparison with most of the open sections of the channel. In addition, the first part of this section shows a backfall (negative gradient of -1/900) and overall, the gradient is low at 1 in 3,000 approximately.

*Photo No16 – Looking downstream at start of piped section
Refer to Drawing No. 4721/KB/02 for the exact location*

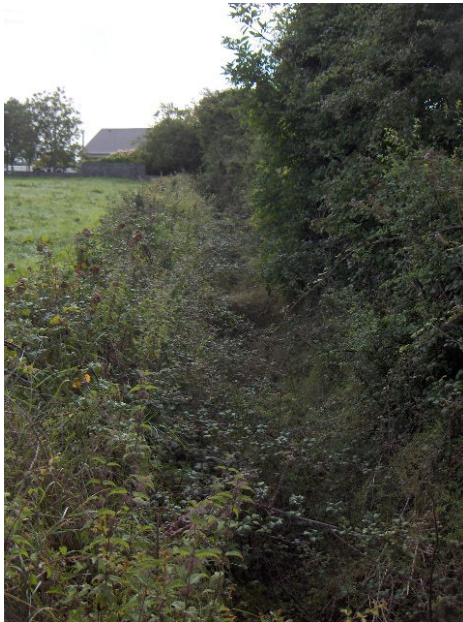
A natural channel with flat gradients resulting in significant weed growth particularly along the upstream section adjacent to Kiltiernan school and immediately downstream from Tullaghnafrancagh Lough.

*Photo No5 – Looking upstream towards
Kiltiernan School*

Cleaning is necessary over the entire length of the Kiltiernan Channel. In addition to the regrading / upsizing works, it is recommended that cleaning be carried out to maintain the capacity of the channel.

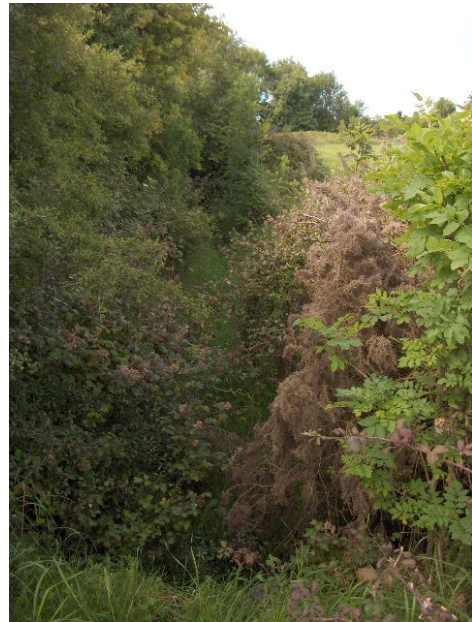
*Photo No17 – Looking downstream –
chainage 1,980.50 metres*

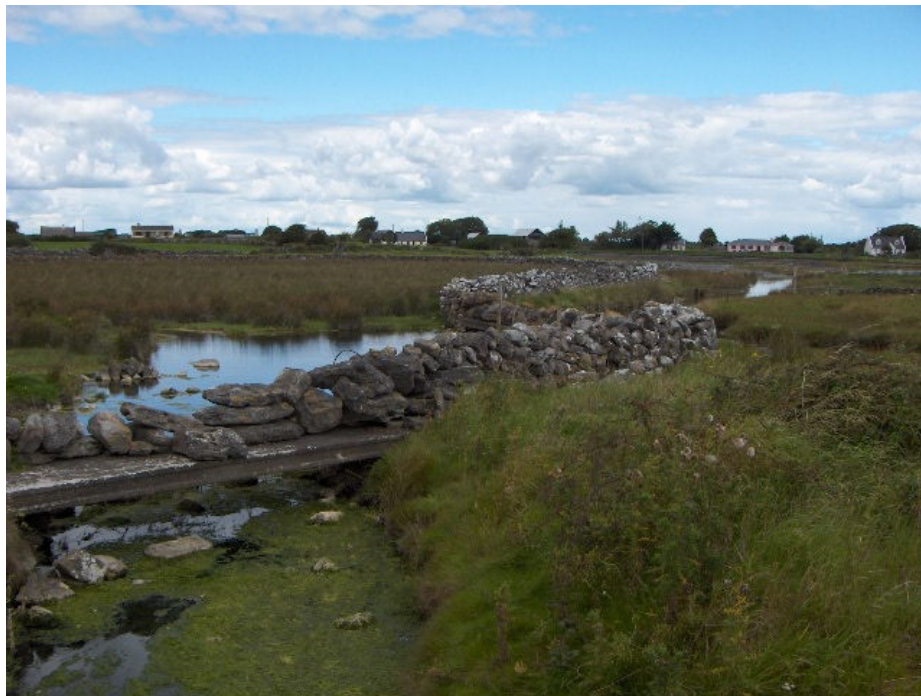
The Bridges at B1 and B2 are located at the downstream end of the channel where flows are affected by the tides. The two bridges are made from precast concrete floor slabs and are used to access agricultural lands. No flow restrictions were identified at this location.

*Photo No37 – Looking downstream towards sea outfall
Refer to Drawing No. 4721/KB/03 for the exact location*

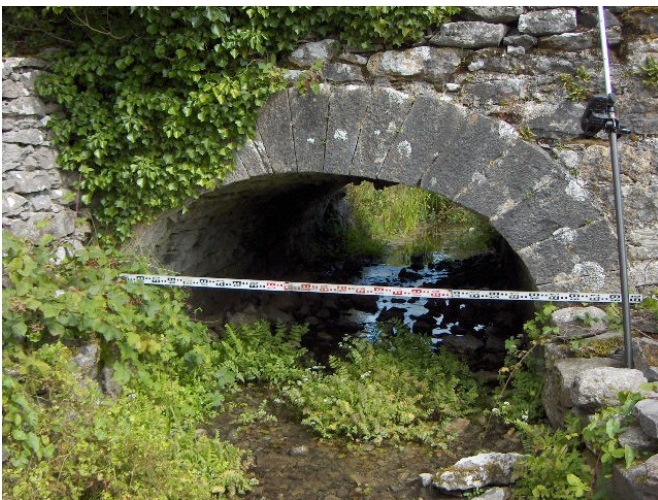
The Bridge at B3 is an old masonry arch bridge located on the local access road to Killeenaran village. It is 2.5 metres wide by 1.5 metres high. The flow capacity of this bridge was deemed to be satisfactory. The bridge was rehabilitated and strengthened structurally in September 2010 under the Galway County Council Bridge Repair Programme 2010.

*Photo No33 – Looking upstream to Bridge No3
August 2010 prior to Rehabilitation Works
Refer to Drawing No. 4721/KB/03 for the exact
location*

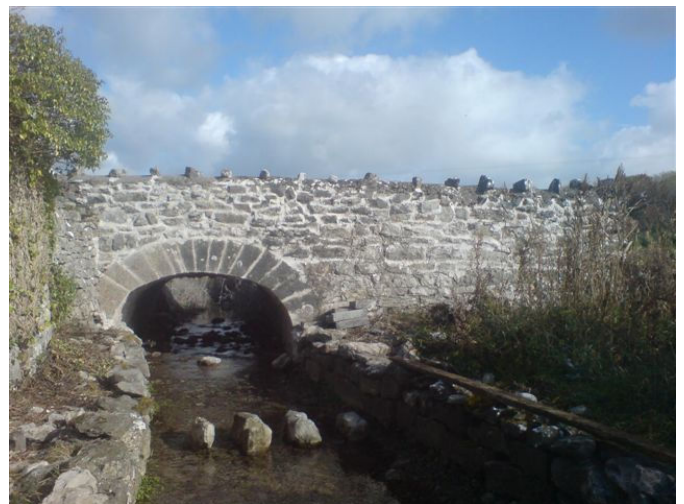
*Photo No33 bis – Looking upstream to Bridge No3
September 2010 post Rehabilitation Works
Refer to Drawing No. 4721/KB/03 for the exact
location*

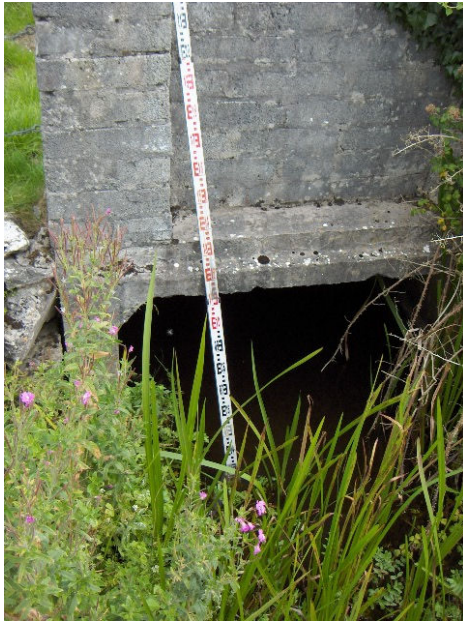
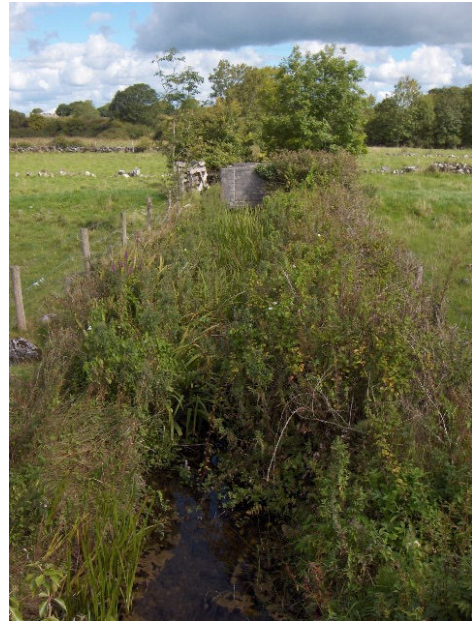
The Bridges from B4 to B8 are used for agricultural land access. They consist of precast concrete box culverts 1.5 metres wide by 1.0 metre high. No flow restrictions were identified for these particular culverts. The structural condition of the culverts is good.

*Photo No30 – Looking upstream to B4
Refer to Drawing No. 4721/KB/02 for the
exact location*

*Photo No31 – Looking upstream to B4
Refer to Drawing No. 4721/KB/02 for the
exact location*

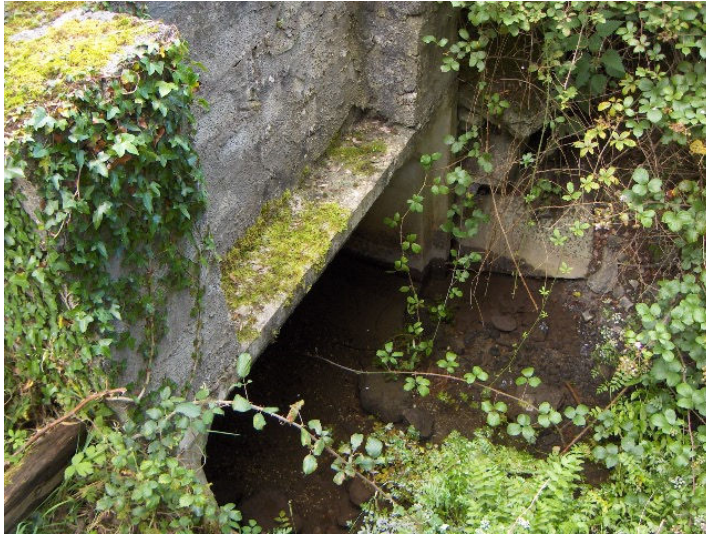
Photo No30 – B4

Refer to Drawing No. 4721/KB/02 for the exact location

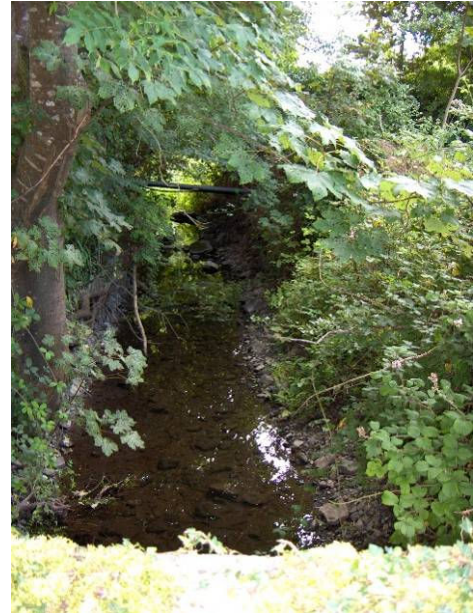
Photo No31

The Bridges at B10 and B12 are used for agricultural land access. They again consist of precast concrete box culverts 1.5 metres wide by 1.0 metre high. No flow restrictions were identified at these locations.

Looking downstream from B12

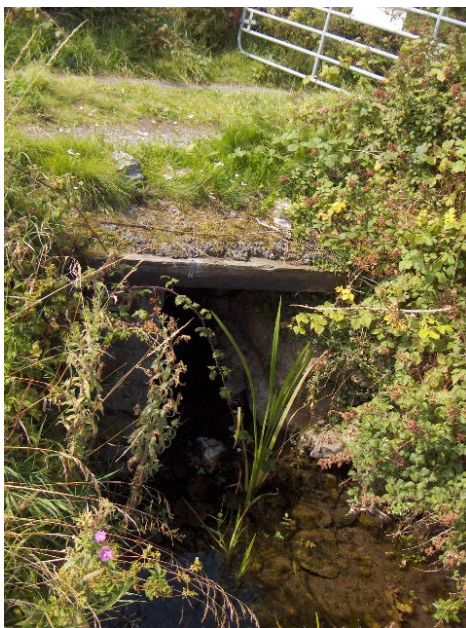
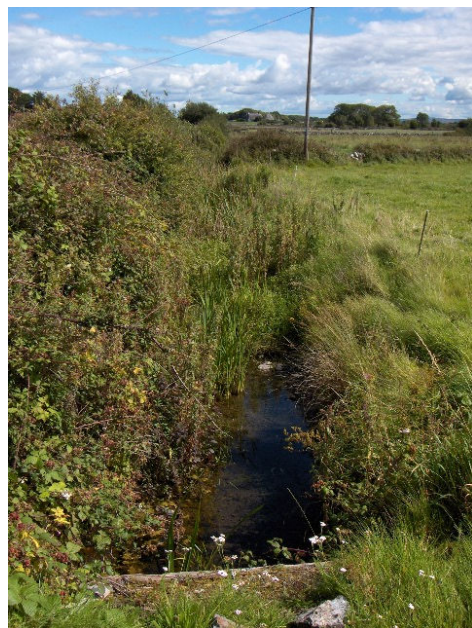
The Bridge at B15 is used to access agricultural lands. This is an old stone bridge in structurally poor condition, measuring 0.7m wide by 1.1m high which is considered to be undersized. Flow capacity through this bridge / culvert is estimated to be approximately 330 l/s which is low in comparison with most of the open sections and culverted sections of the channel showing capacities well in excess of 1,000 l/s

*Photo No20 – Looking downstream to B15
Refer to Drawing No. 4721/KB/02 for the
exact location*

*Photo No21 – Looking upstream from B15
Refer to Drawing No. 4721/KB/02 for the
exact location*

The entire structure would have to be replaced by a precast concrete box culvert 1,750mm wide by 750mm high.

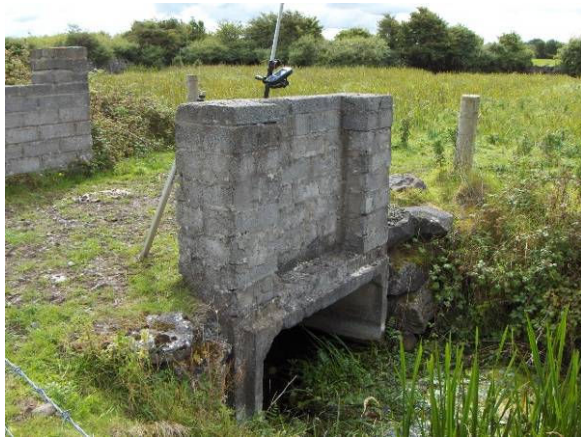
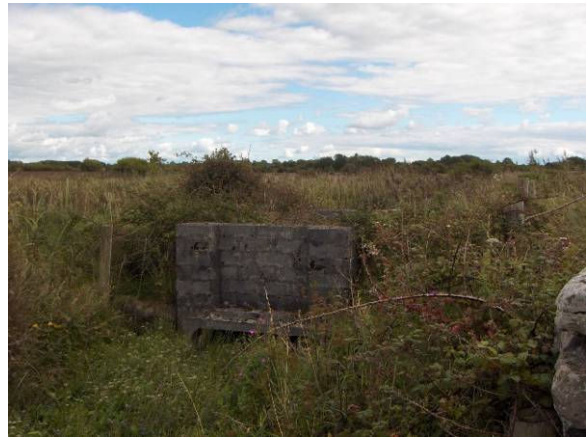
The Bridges from B16 to B20 are used for agricultural lands access. They consist of precast concrete box culverts 1.5 metres wide by 1.0 metre high. No flow restrictions were identified for these particular culverts. The structural condition of the culverts is good.

*Photo No17 – Looking upstream to B16
Refer to Drawing No. 4721/KB/02 for the
exact location*

*Photo No14 – Looking upstream to B19
Refer to Drawing No. 4721/KB/02 for the
exact location*

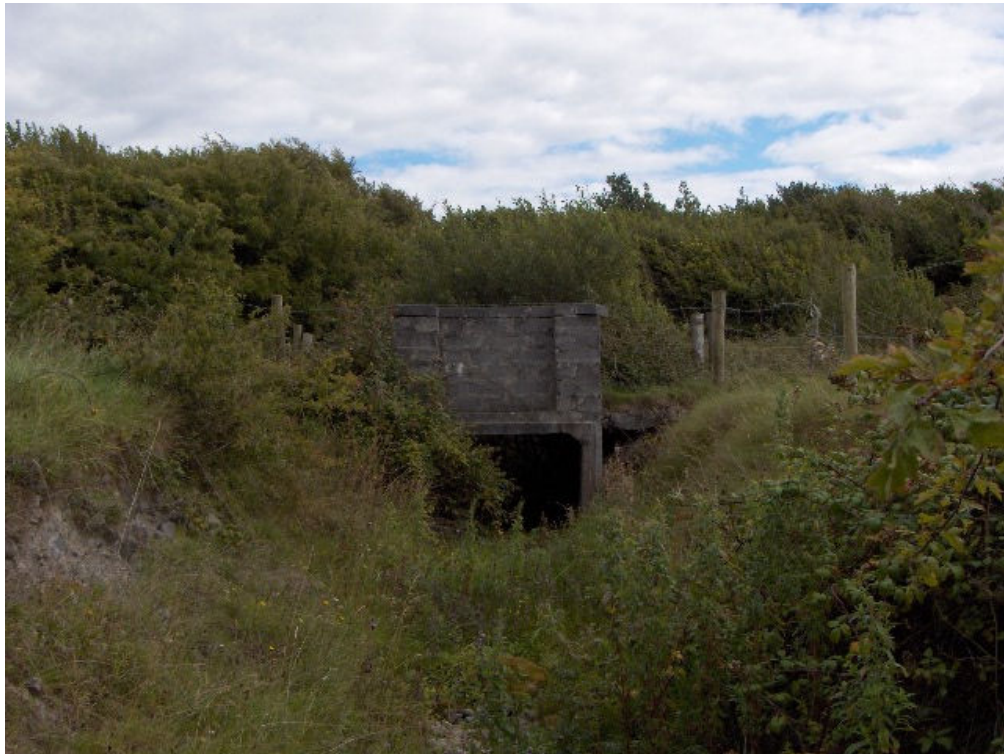
The Bridges from B22 to B24 are used for agricultural land access. They were constructed from precast concrete box culverts 1.5 metres wide by 1.0 metre high. No flow restrictions were identified at these locations. The structural condition of the culverts is good.

Photo No09 – Looking upstream to Bridge No.23

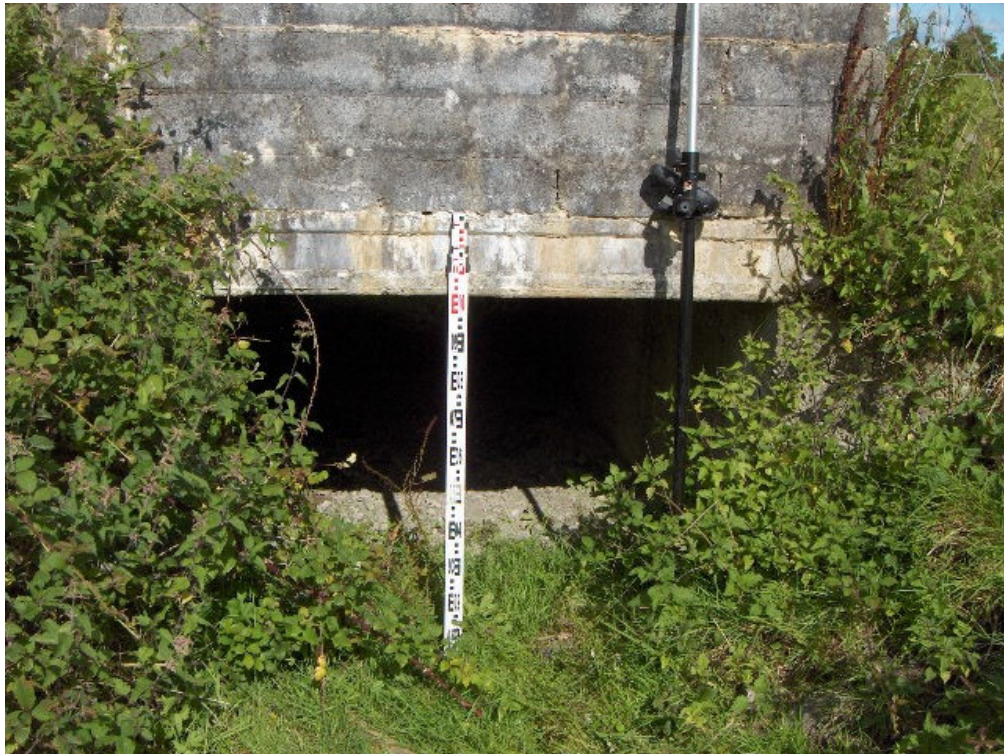
The Bridges at B25 and B26 are used for agricultural land access. They consist of concrete culverts 1.75m wide by 1.0m high made from masonry blocks. No flow restrictions were identified at these locations. The structural condition of the culverts is good.

Photo No04 – Looking downstream to Bridge No.26

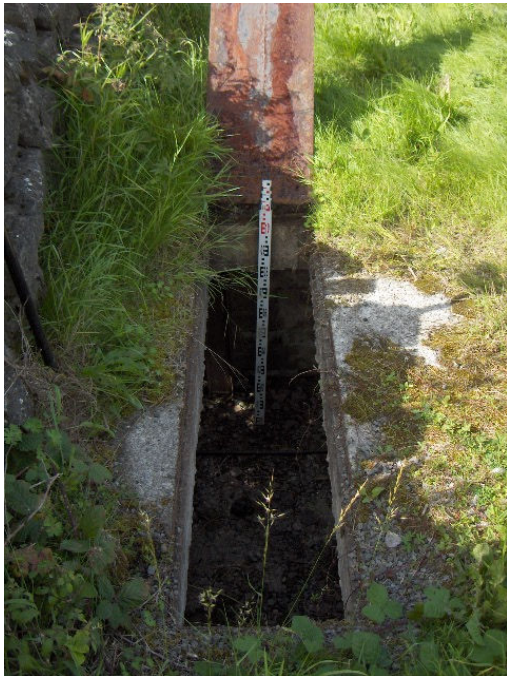
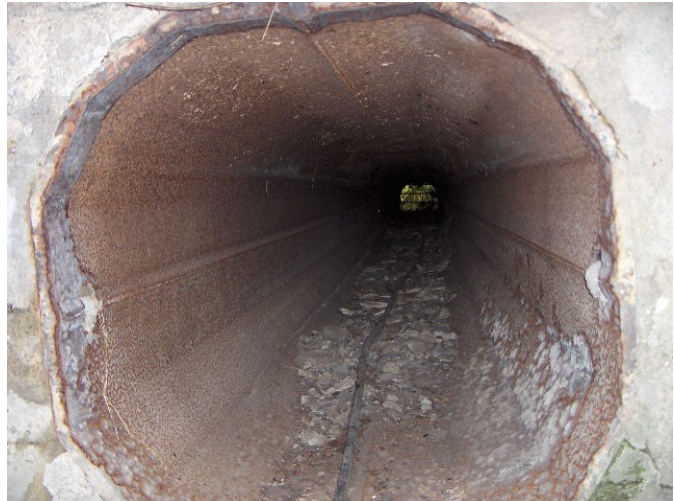
On the N67 Kilcolgan to Kinvarra Road crossing at B27, twin 600mm diameter steel pipes were placed under the N67 roadway. The pipes can be inspected via an existing access chamber located on the upstream end of the crossing. The structural condition is acceptable and the flow capacity under gravity conditions was found to be approximately 1,050 l/s which is good in comparison with the overall achievable flow transfer capacity of the channel.

*Photo No01 – Inspection chamber B27
Refer to Drawing No. 4721/KB/02 for the
exact location*

*Photo No02 – Looking downstream to B27
Refer to Drawing No. 4721/KB/02 for the exact
location*

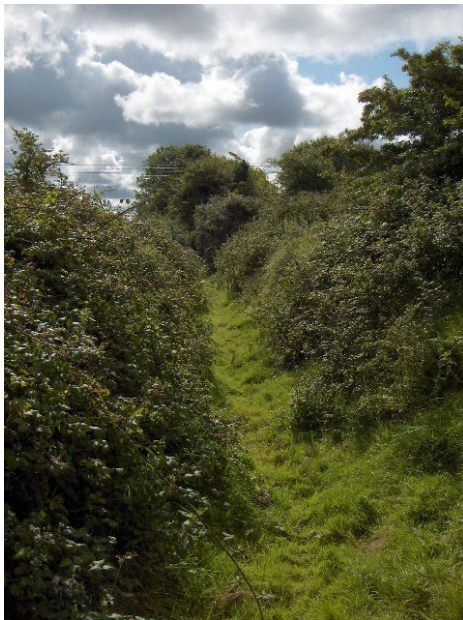
Photo No05 – Looking upstream from B26
Overgrown channel banks
Refer to Drawing No. 4721/KB/02 for the exact location

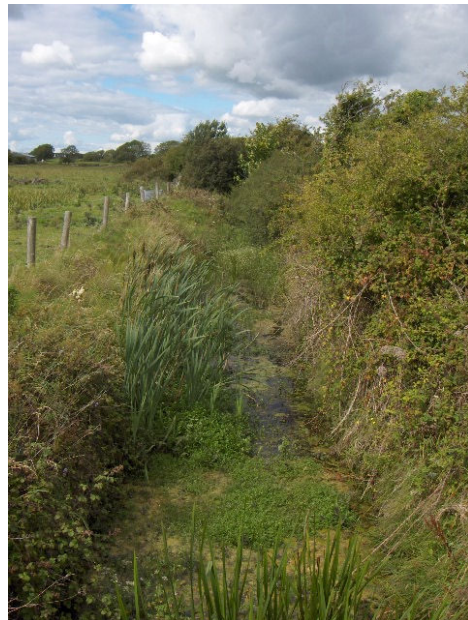
Photo No16 – Looking downstream from B18
Weedy growth & stagnating waters
Refer to Drawing No. 4721/KB/02 for the exact location

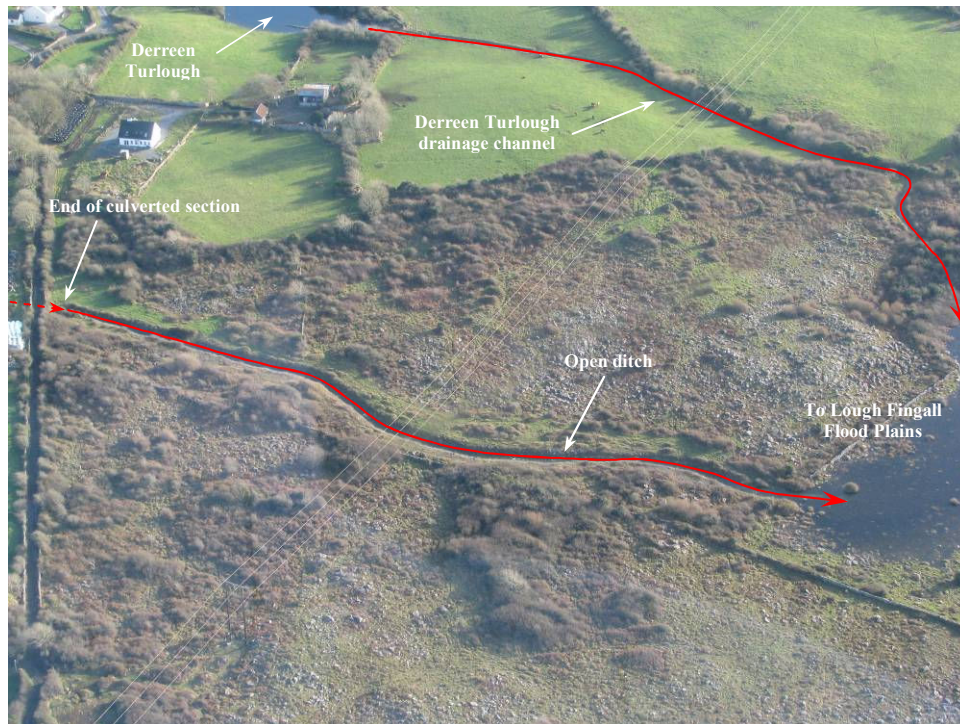
Section 3.1 of this Report described an open channel that was built by the local residents as part of emergency flood relief works from Derreen Turlough to Lough Fingall.

Figure 5.1 : Aerial photo – Existing Derreen Turlough drainage channel

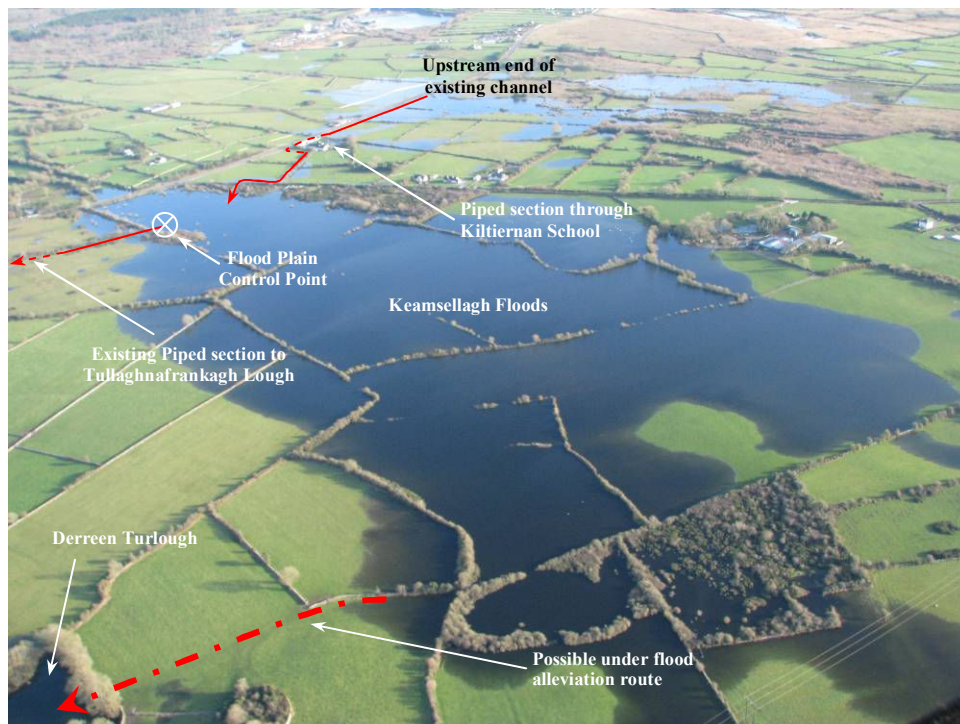
JOD carried out surveying work in August 2010 in the Kiltiernan Area and it was determined that a flood alleviation route could be constructed to hydraulically link the Keamsellagh Flood Plain and Lough Fingall during flood conditions. This would alleviate the amount of flood water entering the Tullaghnafrankagh Lough system in flood conditions only. Drawing No. 4721/KB/11 shows the details of the alleviation route and the option of constructing a short underground section (piped or culverted) to shortcut or by-pass Tullaghnafrankagh Lough under heavy flooding conditions.

Figure 5.2 : Aerial photo – Keamsellagh Floods

This possible alleviation route was not however further investigated as it creates ecological issues through the alteration of hydrological dynamics in the area. The National Parks & Wildlife Service have expressed concerns over the above alleviation route and the possibility of significant environmental damage to Lough Fingall which is registered as a Special Area of Conservation. Any proposal to alleviate flooding through Derreen Turlough would require a full Environmental Impact Assessment.
