Clare River (Claregalway)
Flood Relief Scheme

Aquatic points

Figure 11.4

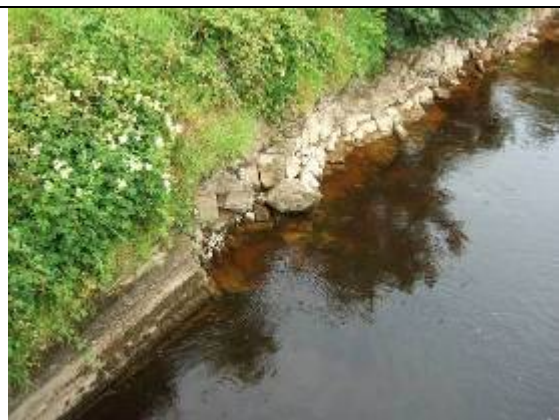
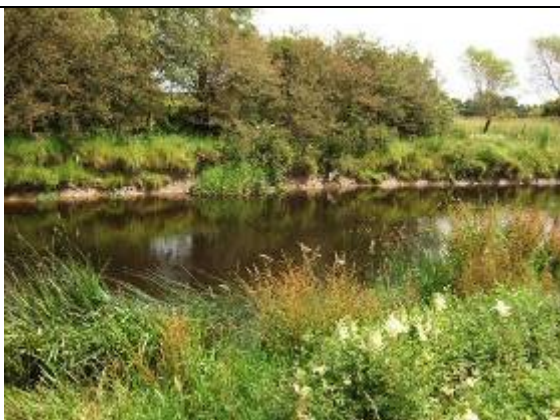
<p>Plate 1: Fractured rock at base of left bank just downstream of Crusheen Bridge (12-7-2011)</p>	<p>Plate 2: Exposed subsoil on right bank of Clare River (Point 75) (12-7-2011)</p>

There are, broadly, four different habitat types within the Clare River study stretch. **Table 11.5** shows the aquatic habitat types that were recorded. Two of these habitat types: glide (Type 1) and riffle / run (Type 2) clearly dominate the study reach. Generally, from between a point approximately 100m upstream of the Islandmore drain confluence to the Curraghmore Bridge the Clare River is characterised by long meandering, glides with submerged and marginal emergent macrophyte stands (Type 1). There were very limited pockets of riffle / run and turbulent water (Types 2 and 3) observed along this stretch, but glide predominated. Approximately 100m upstream of the Islandmore confluence, in the direction of Cregmore Bridge, the bed gradient was a little steeper and the river was dominated by riffle / run type flow over more coarse substrates (Type 2). Historical drainage was in evidence, along the entire study stretch, owing to an over-widened, deepened and uniform channel width, combined with vertical banks backed by high spoil heaps generally running parallel to the channel. The base of the banks comprised fractured bedrock in places (P1) and subsoil with limestone till elsewhere (P2).

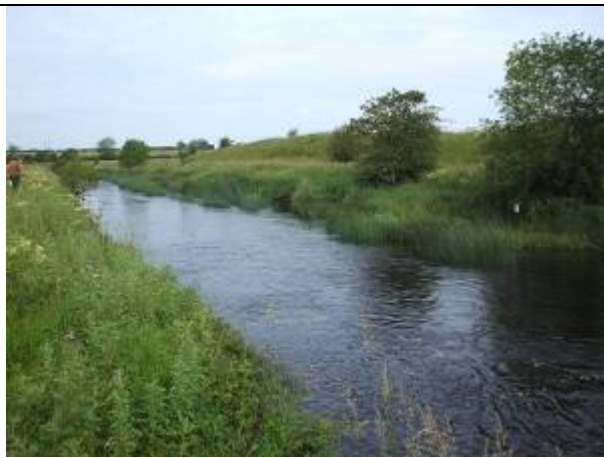
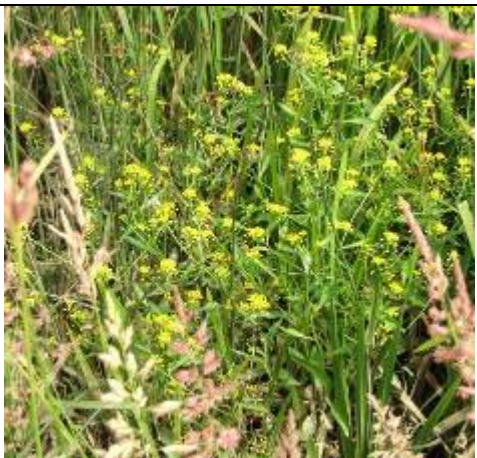
<p>Plate 3: Heavy marginal growth of Club-rush (<i>Schoenoplectus lacustris</i>) on the right bank of Clare River (12-7-2011)</p>	<p>Plate 4: Great Yellow within marginal emergent macrophytes – Clare River (12-7-2011)</p>

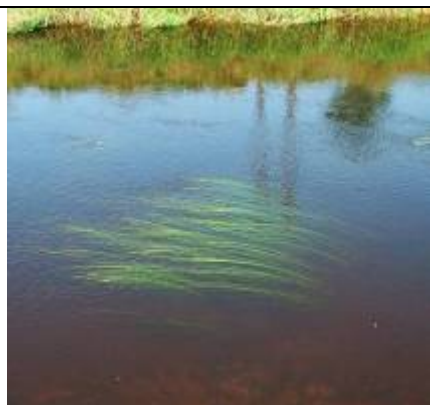
<p>Plate 5: Reed Canary-grass (<i>Phalaris arundinacea</i>) on left bank of Clare River (12-7-2011). Note – smooth, laminar flow over the whole river cross section.</p>	<p>Plate 6: In-channel submerged Club-rush - Clare River (12-7-2011)</p>

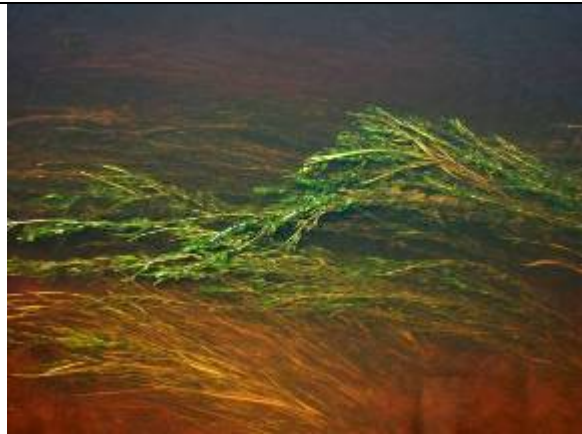
Plate 7 Submerged marginal Pondweed beds (*Potamogeton x nitens* and *P. gramineus*) Clare River (12-7-2011)

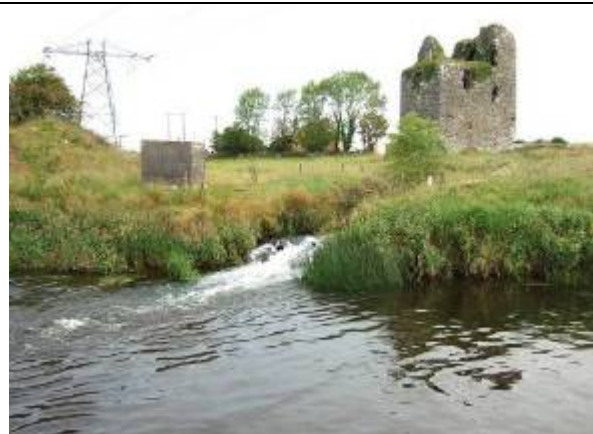
Plate 8: Estevella just downstream of Crusheeny Bridge, causing turbulence on the Clare River (12-7-2011)

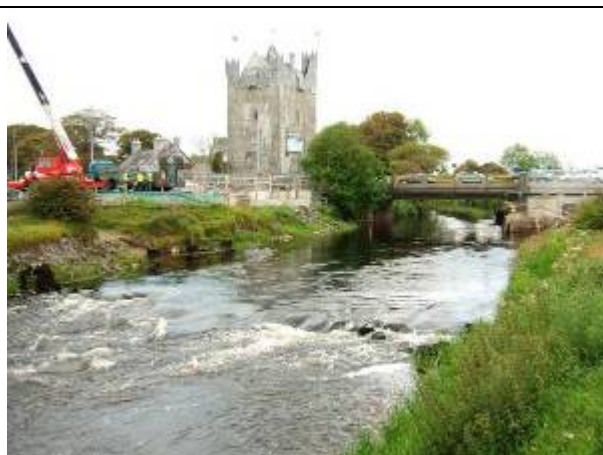
Plate 9: View upstream toward weir downstream of Claregalway Bridge (12-7-2011)

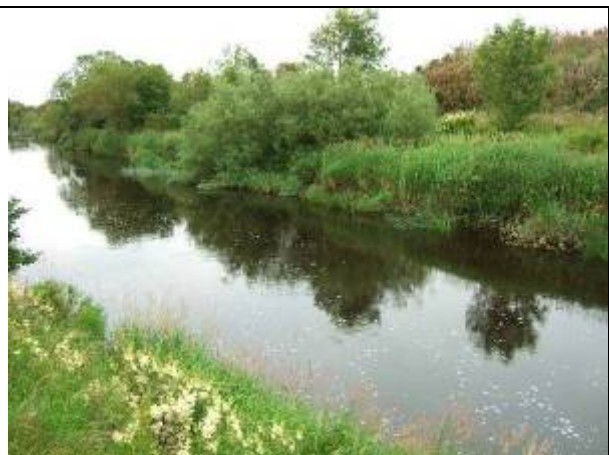
Plate 10: Glide upstream of Crusheeny Bridge (12-7-2011)

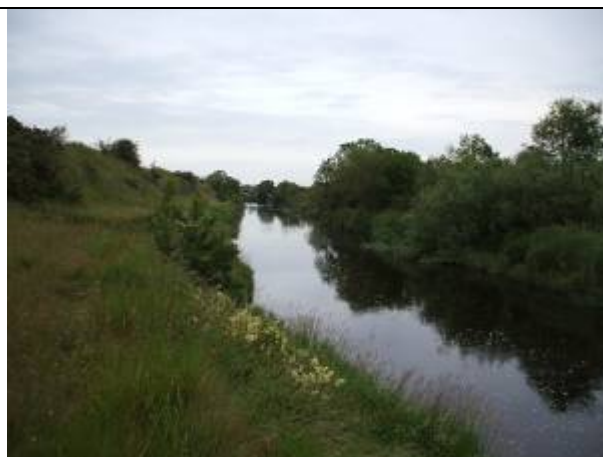
Plate 11: View downstream from confluence of Islandmore tributary with R. Clare showing long glides, steep banks and sparse marginal emergents (12-7-2011)

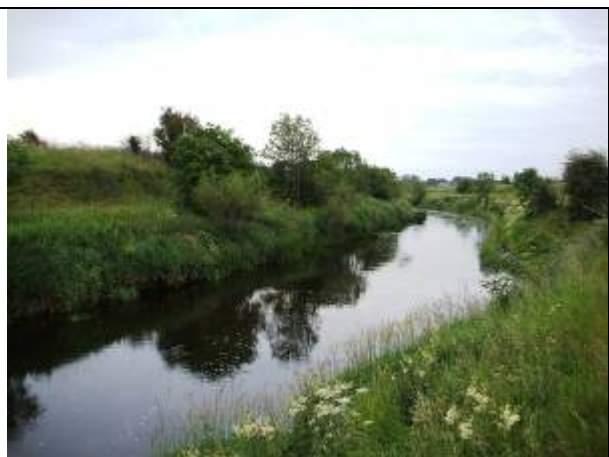
Plate 12: View upstream from confluence of Islandmore tributary with R. Clare showing long glides, steep banks and sparse marginal emergents (12-7-2011)

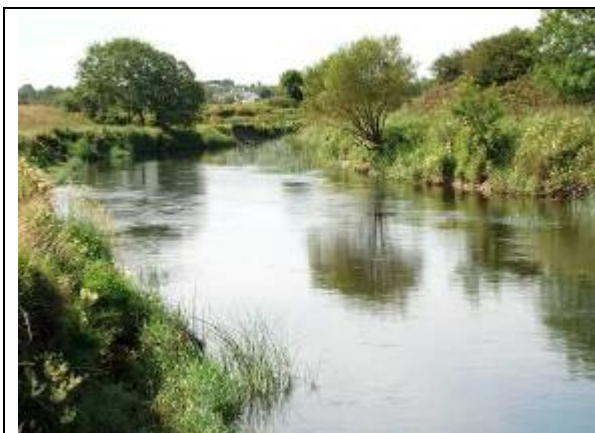
Plate 13: View downstream toward deep holdings on the bend by Point 62 - (12-7-2011)

Deeper, slow flowing stretches and pooling areas (P13) on river bends would be more likely to hold older salmonids i.e. mainly 2+ or older trout as well as pike and coarse species such as roach and perch. Shallower, more turbulent areas would be expected to hold 1+ trout and perhaps 0+ (young-of-the-year) salmon as well, if spawned locally. Several 0+ salmonids were observed during the current survey over

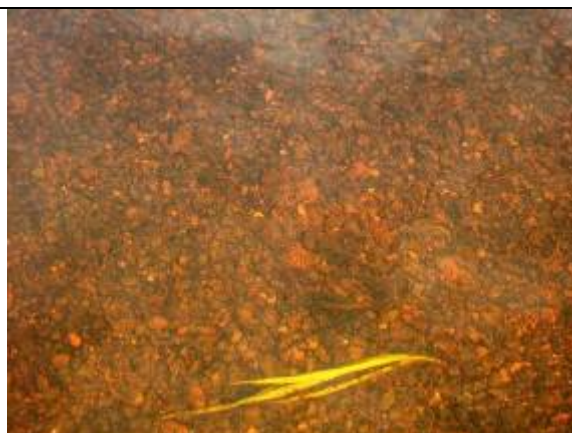
Plate 14: Close up of gravel beds by Point 49 where 0+ salmonids were observed by - Clare River (12-7-2011)

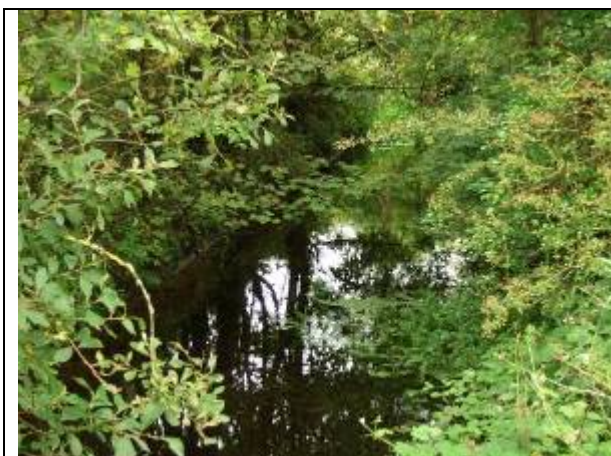
Plate 15: Gortcloonmore drain showing still flow and heavy shade at Point 1 (11-7-2011)

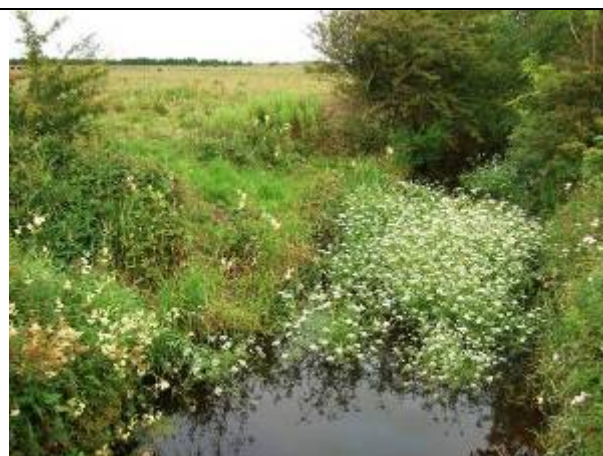
Plate 16: Gortcloonmore drain upstream of by road bridge (Point 5) showing in-channel growth of *Oenanthe* and bankside *Valerian* and *Meadowsweets* Montiagh North (11-7-2011)

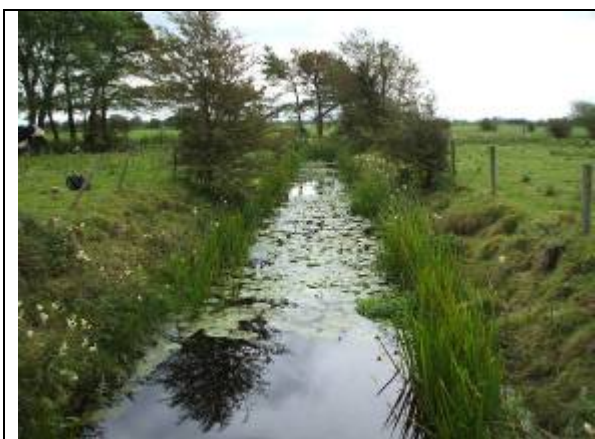
Plate 17: Pond-like stretch of Gortcloonmore drain downstream of byroad bridge (Point 6) showing in-channel growth of Yellow water lillie (*Nuphar lutea*) and emergent *Sparganium erectum* (11-7-2011)

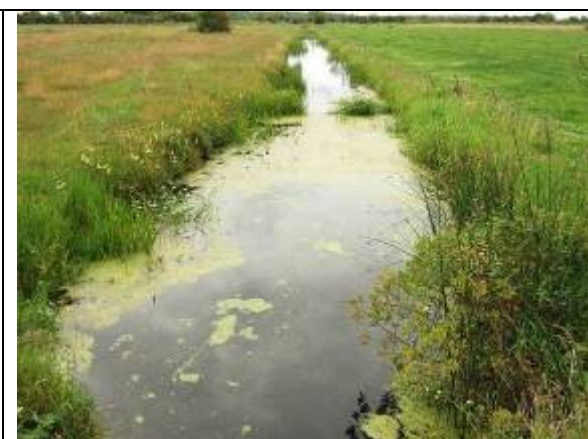
Plate 18: Unnamed drain (3) at Montiagh North (Point 8) (11-7-2011)

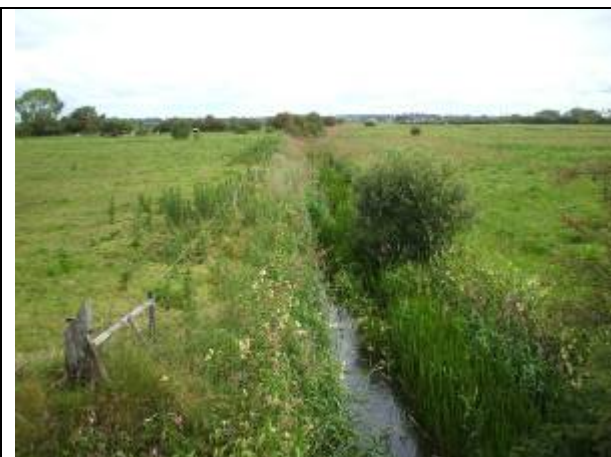
Plate 19: Gortadooey drain upstream of bridge showing dense marginal stands of emergent vegetation - Montiagh North (11-7-2011)

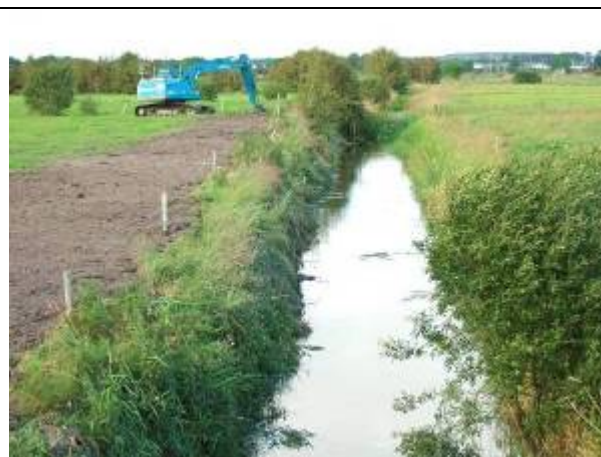
Plate 20: Gortadooey drain as in Plate 5 after drainage one week later (20-7-2011)

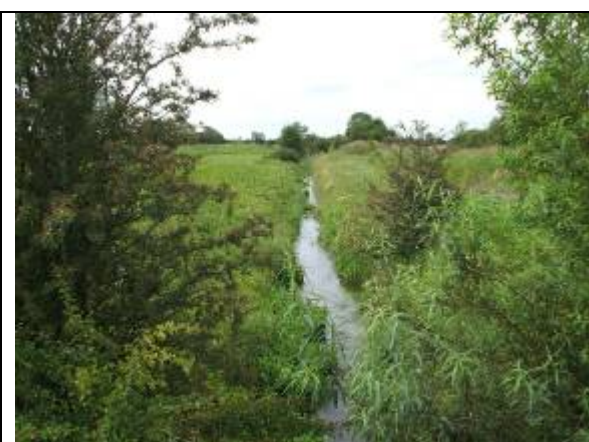
Plate 21: Gortadooey stream downstream of road bridge where there were patches of emergent and submerged *Apium* in faster current speeds (11-7-2011)

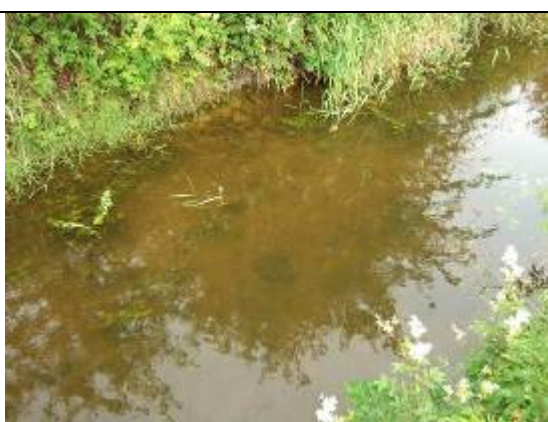
Plate 22: Gortadooey stream farther downstream (Point 11) showing more silted substrate with less instream vegetation.(11-7-2011)

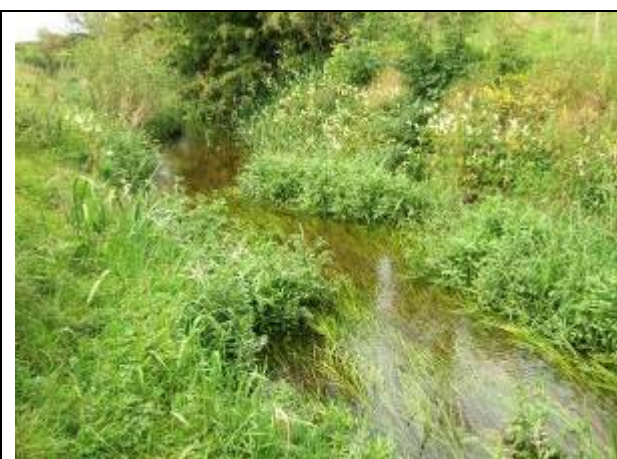
Plate 23: Gortadooey stream just upstream of confluence with Clare River showing heavy instream growth of *Sparganium emersum* and marginal growths of *Berula erectum* in moderate/swift flows (Point 9) (11-7-2011)

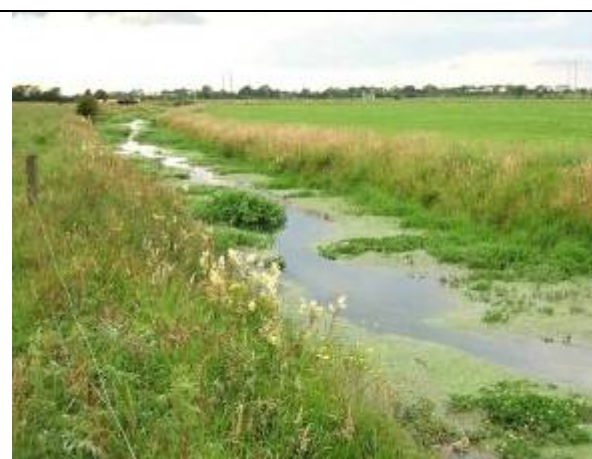
Plate 24: Gortadooey upstream nearer its source (Point 86) with heavy marginal floating and emergent macrophyte growth. (11-7-2011)

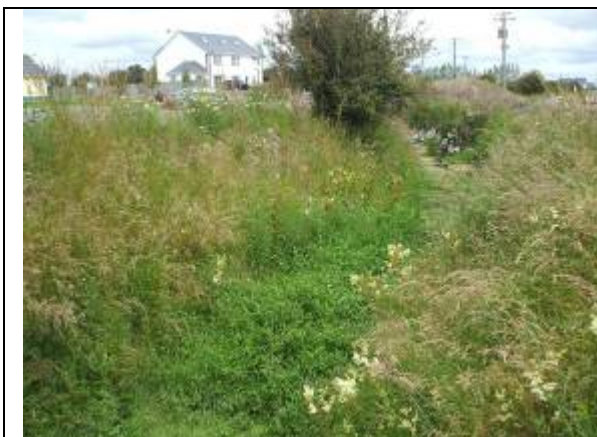
Plate 25: Kiniska trib. showing heavy in-channel growth of macrophytes obscuring the channel (Point 12) with heavy marginal floating and emergent vegetation.

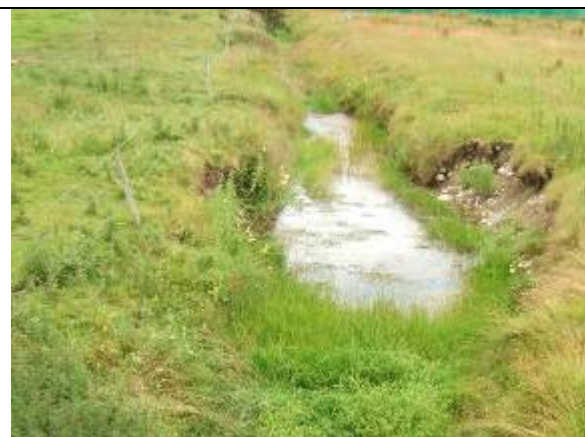
Plate 26: Kiniska trib. upstream of road bridge (Point 80) showing limited open water with *Ranunculus* sp. and fringing Flote Grass (*Glyceria* sp.) - (11-7-2011)

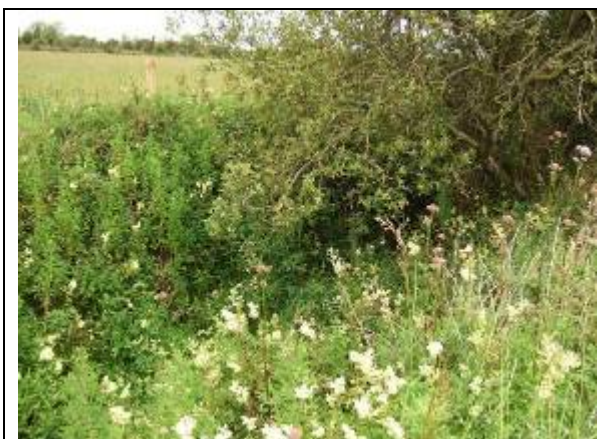
Plate 27: Kinsika trib. showing banks with Valeria, Meadowsweet and Great Willowherb (Point 13) – (11-7-2011)

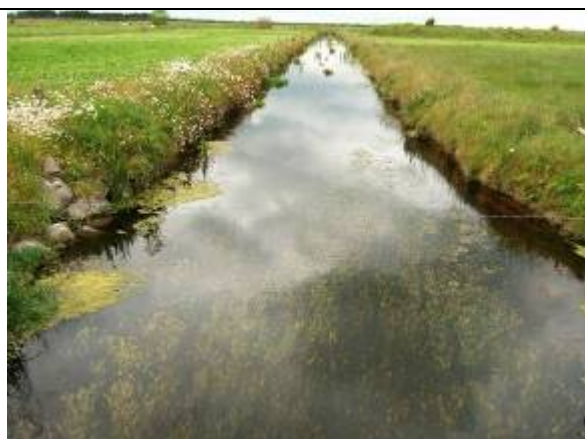
Plate 28: Montiagh South un-named tributary (3), view downstream from bridge (Point 17), showing submerged *Potamogeton natans* (11-7-2011)

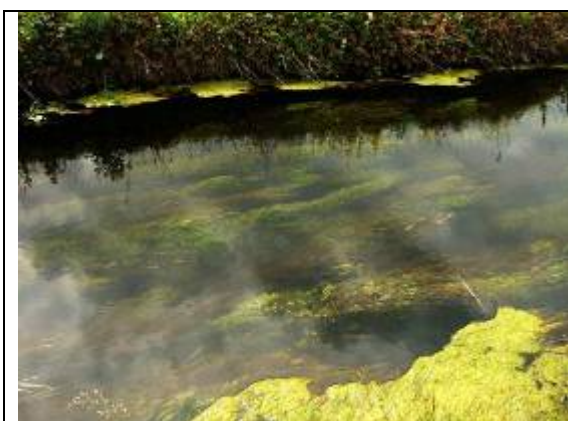
Plate 29: Montiagh South un-named tributary (3) upstream from bridge (Point 19), showing submerged *Callitriche*, *Apium* and *Melosira* with floating filamentous algae marginally - (11-7-2011)

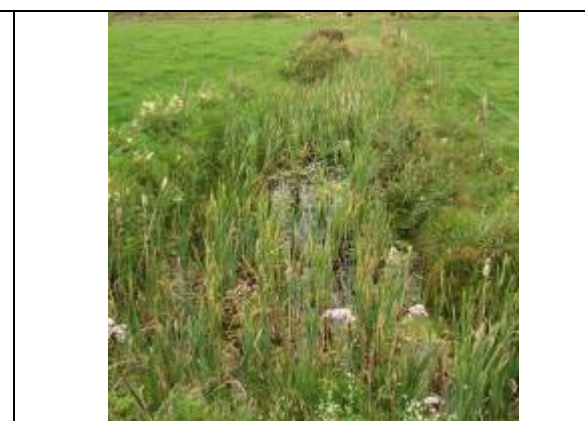
Plate 30: Montiagh South drain series (2) (Point 21) showing *Typha* and *Valerian* in drainage ditch. (11-7-2011)

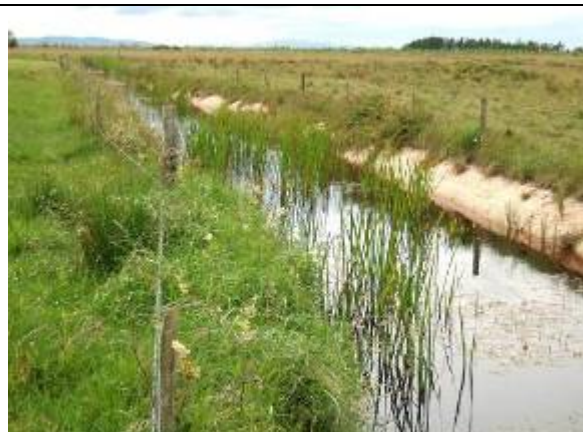
Plate 31: Montiagh South, main east-west drain in drain series (2) (Point 22) showing emergent and floating macrophytes (11-7-2011)

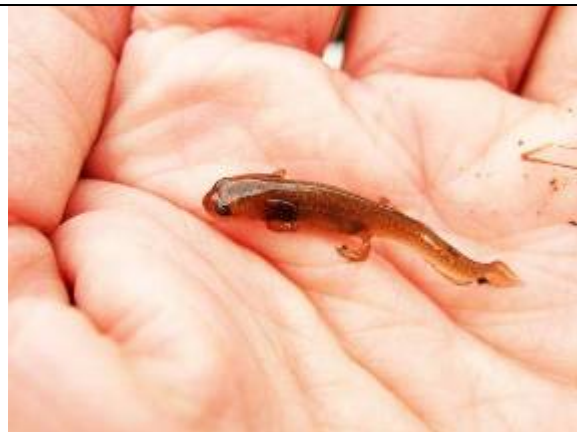
Plate 32: Montiagh South drain series (2): smooth newt (*Lissotriton vulgaris*) tadpole (left) from a ditch at Point 27 (11-7-2011)

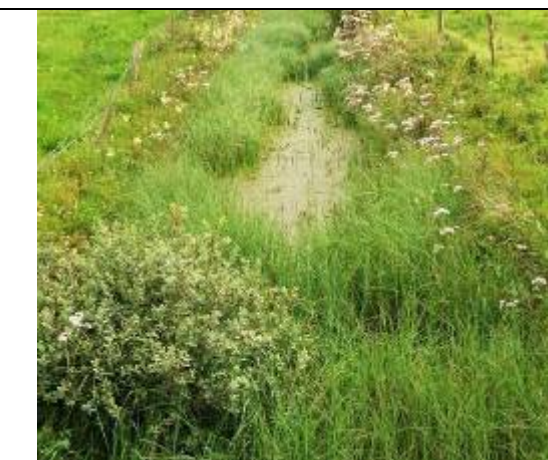
Plate 33: Montiagh South drain series (2): plant-choked drain running south and east from Point 27 Sedges (*Carex* sp.) and Valerian as emergents. (11-7-2011)

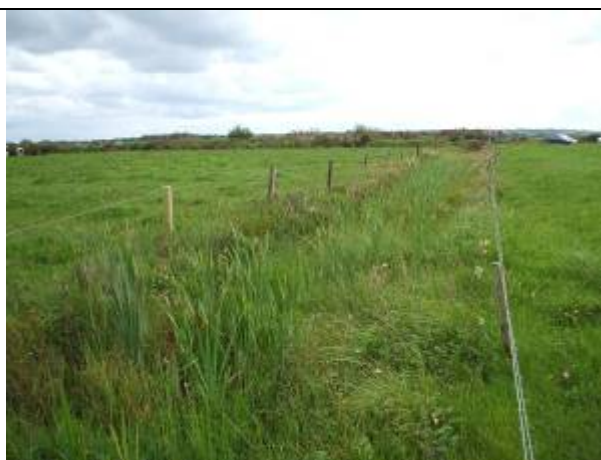
Plate 34: Montiagh South drain series (2) (Point 87) overgrown by Common Reed and with *Typha* and *Valerian* also present – view upstream (20-7-2011)

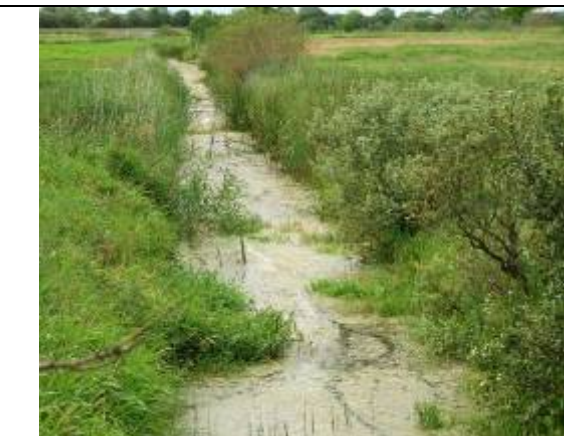
Plate 35: Montiagh South drain series (2) (Point 87) view downstream showing stagnant flow floating algal scum and dense marginal emergents – (20-7-2011)

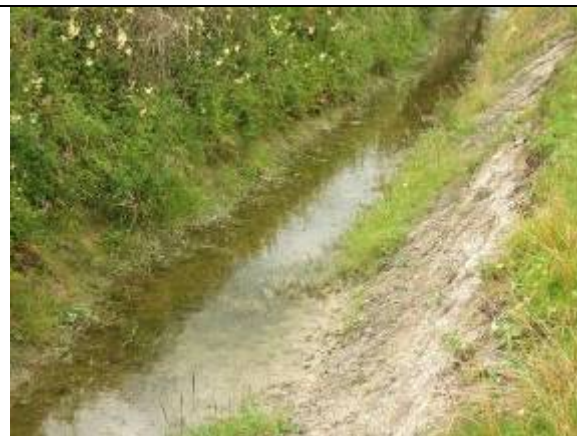
Plate 36: Caherlea drainage ditch: this ditch was effectively dry at this point (Pt 29) (11-7-2011)

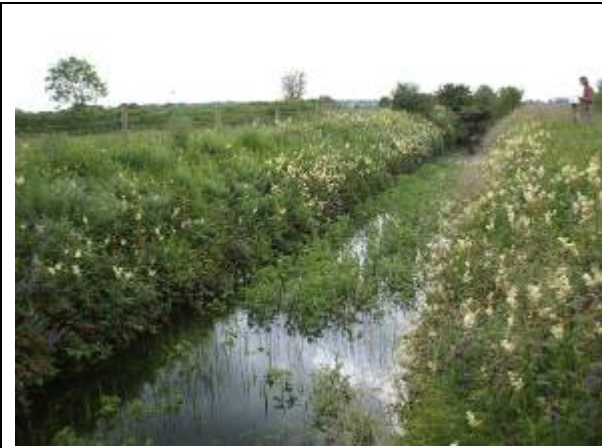
Plate 37: Islandmore drain at Point 31 showing emergent *Berula erecta* in still water (11-7-2001)

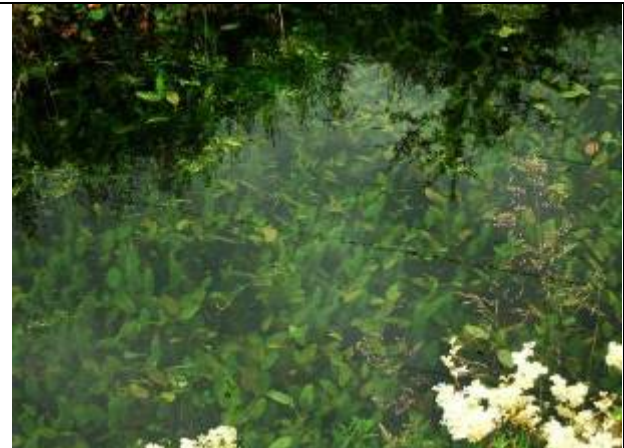
Plate 38: Islandmore drain at Point 36 showing submerged *Potamogeton* and *Hippuris* in still water (11-7-2001)

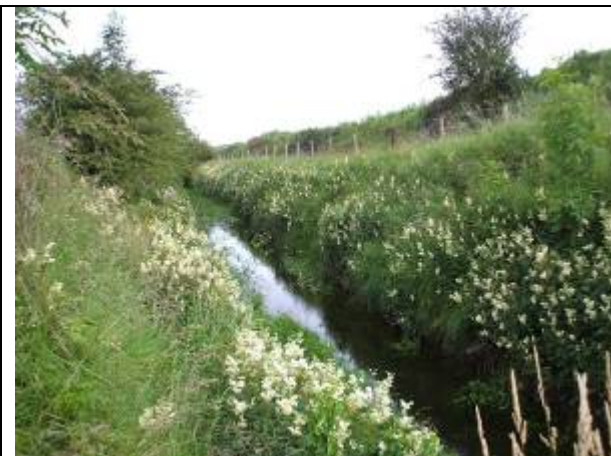
Plate 39: Islandmore drain at Point 38 close to outlet to Clare River showing steep banks (11-7-2011)

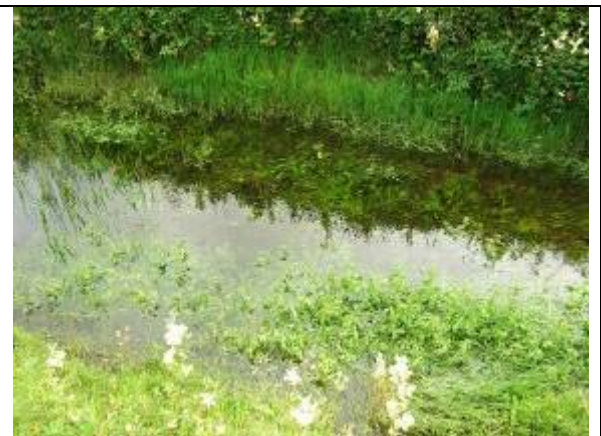
Plate 40: Islandmore drain near Point 38 showing submerged and emergent macrophytes in shallow flow (11-7-2011)

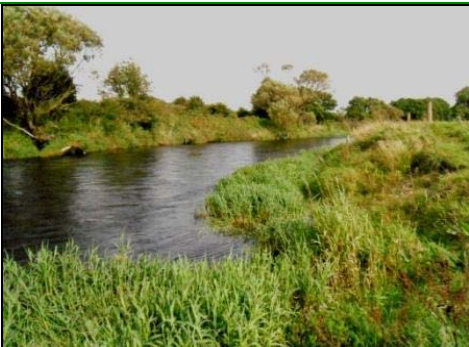
Location	Grid Reference	Habitat description of survey 'patch' and methods employed.	Site Photograph	Crayfish habitat assessment
Approx 1km US Crusheeny Bridge	M 40574 32404	30m stretch of cobble overlaying silty gravels at river margin, with emergent and overhanging Reed Canary Grass (<i>Phalaris arundinacea</i>). 20min search of refuges + weed sweeping for juveniles.

Quite extensive stretches of potentially optimal habitat at river margins; Slightly sub-optimal habitat at the mid-channel owing to potential for very swift flow + lack of stable refuges.
c. 100m U/S Crusheeny Bridge	M 39826 32835	10m stretch of boulder/cobble overlaying silty gravels at river margin, with some emergent and overhanging Reed Canary Grass and submerged <i>Sparganium emersum</i> . 30min search of refuges + overnight trapping.

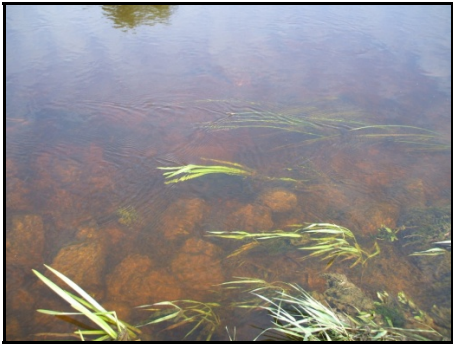
Sub-optimal habitat at river margin and poor habitat in

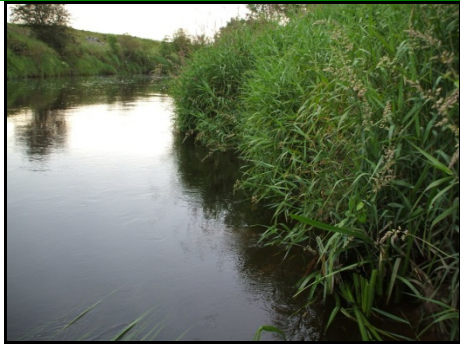
30m US Crusheeny Bridge	M 39750 32886	10m stretch of emergent and overhanging Reed Canary Grass with slightly undercut banks and small boulders overlaying very silty gravel at river margin. 30min net sweep search + overnight trapping.

Sub-optimal or Poor habitat for juveniles and adults at river margins owing to the majority of Canary Grass not being rooted in the channel; Poor habitat mid-channel owing to lack of cover. Possibility of burrowing where stable banks are vertical or undercut beneath overhanging vegetation.
30m DS Crusheeny Bridge	M 39671 32917	Combination of cut limestone stepped banks with numerous cracks and crevices and some small boulder and large cobble at river margin. Difficult to manually search. Overnight trapping

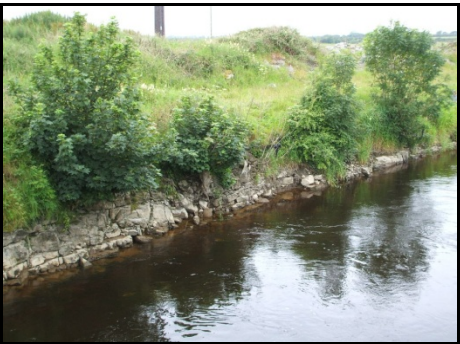
Patches of optimal habitat at river margins; Poor habitat at mid-channel.

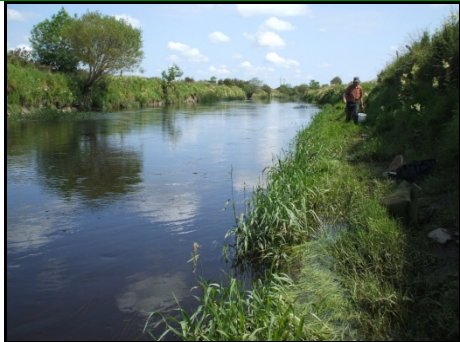
c. 700m DS Crusheeny Bridge		10m stretch of emergent and overhanging macrophytes, mainly Reed Canary Grass with some submerged <i>S. emersum</i> . Small boulders and large cobbles overlaying very silty gravel at river margin. 30 min net sweep + search of refuges.

Sub-optimal habitat at river margins owing to low vegetative cover in-stream – much of the canary grass was not be rooted in the channel as the river had formed a low berm along the stretch; Sub-optimal/poor habitat at mid-channel.

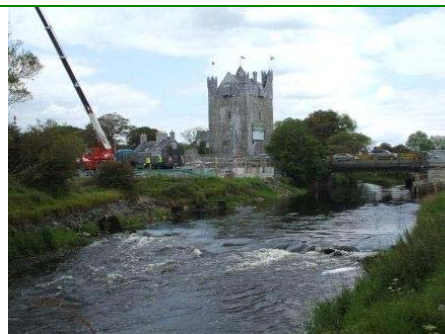
40m DS Claregalway Bridge

Margins of turbulent flow at the 'natural' weir below the bridge. Some mossy boulder overlying gravel + coarse sand, plus patches of bedrock with moss. Manual search of refuges for 30 minutes using net and viewing bucket.

Patches of optimal habitat at the river margins and just upstream of the weir in shallower bouldery parts of glide/run; turbulent areas poor owing to water velocity.

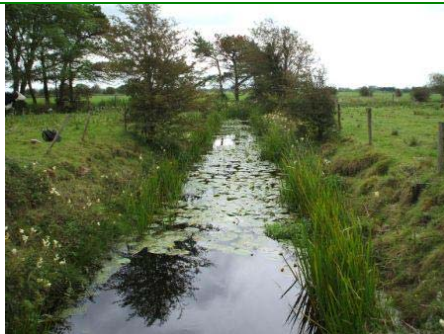
Location	Grid Reference	Habitat description of survey 'patch' and methods employed.	Site Photograph	
Gortcloonmore Tributary	M 35056 34223	10m stretch of deep (>1m) stagnant, weed choked drain manually searched. Poor (100%) crayfish habitat. 30min weed sweep. Crayfish = 0.

Poor crayfish habitat, however crayfish can be found in these types of sluggish drains.

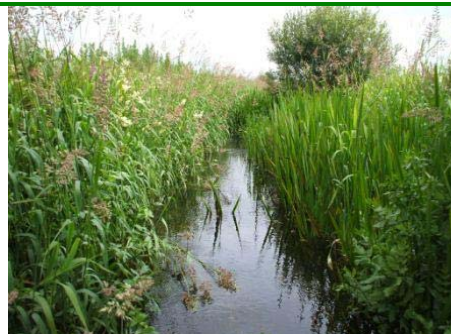
Gortadooey Tributary M 36720 33849 20m stretch of emergent Burr reed and emergent and overhanging Reed Canary Grass. Substrates of small boulder over gravel, sand and silt. crayfish habitat. 30min net sweep search + overnight trapping. Crayfish = 0.

Patches of optimal habitat within emergent vegetation and in areas of boulder/cobble glide, but these were removed by dredging u/s of the bridge. Some sub-optimal habitat remains below the bridge. Habitat for crayfish in the upper Gortadooey stream, near the source was poor, with very little cover available once summer vegetation disappears.

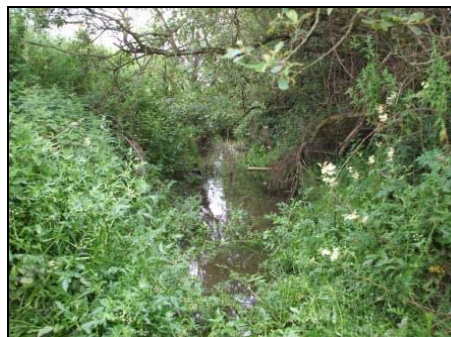
Kiniska Tributary M 38173 33583 Two x 10m stretches of potential habitat manually searched for 15 minutes each. Limited patches of cobble over silty gravel and sand with overhanging vegetation. Patches of instream emergents also searched. Crayfish = 0.

Poor crayfish habitat but crayfish can be found in these types of sluggish drained streams. Water quality may be too impaired to be ideal for crayfish. There was a sewage input towards the u/s end of the channel.

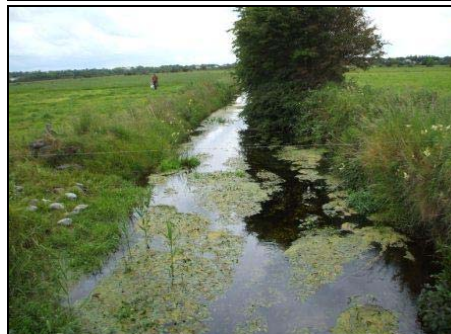
Montiagh South Un-named Tributary (3) M 34467 33063 15min manual search of marginal vegetation and accessible bouldery glide in suitable patches. Crayfish = 0.

Sub-optimal- to-Poor. Presence of small boulder and large cobble substrates, plus mainly submerged aquatic macrophytes and bank side tree roots may provide refuges for crayfish.

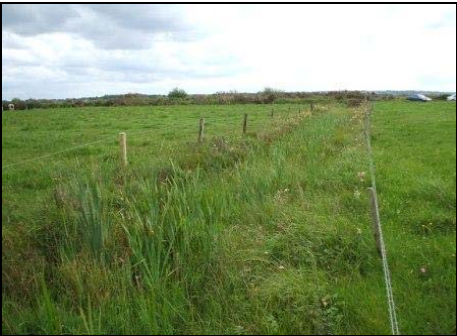
Site 1 - Montiagh South Western Drain Series (2)	M 33925 32998	This was one of 2 sites searched in this drain series. 10min search of emergent and submerged aquatic vegetation within channels with some open water. Crayfish = 0.

Some of the drains were totally unsuitable for crayfish owing to level of weed growth (mire like). Other drains were either stagnant pools with mostly floating vegetation. or recently drained with no habitat remaining. Poor in general.
Site 2 - Montiagh South Western Drain Series (2)	M 33918 33078	15min search in any available patches of submerged vegetation. Crayfish = 0.

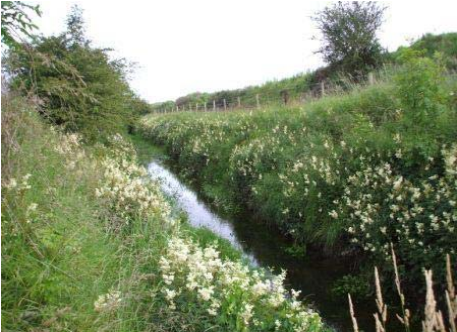
Poor, no suitable habitat owing to quite recent drainage.
Islandmore / Caherlea Arterial Drainage network (5) – just upstream of R. Clare confluence	M 40053 32446	Shallow glide with some scattered large cobbles over gravel and fine substrates in places. Submerged aquatic vegetation, mostly <i>Myriophyllum alternifolium</i> and <i>Potamogeton natans</i> .. 15mins manual search and overnight trapping. Crayfish = 0.

Sub- optimal with patches that could be optimal. Flow and water quality characteristics suitable also.

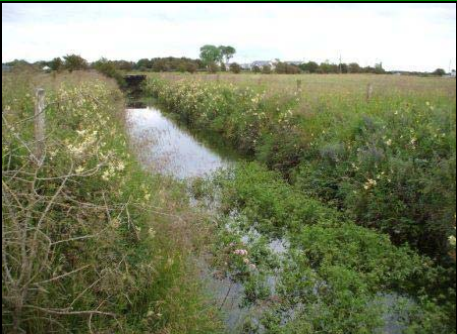
Islandmore / Caherlea Arterial Drainage network (5)	M 40075 31507	Canalised drain, approx. 1m deep with an abundance of emergent and submerged aquatic vegetation, primarily <i>Berula</i> sp.

Poor, though crayfish can be found in these types of sluggish drains.
Islandmore / Caherlea Arterial Drainage network (5)	M 40161 31392	Recently drained, probably not active during dry weather. Crayfish = 0.

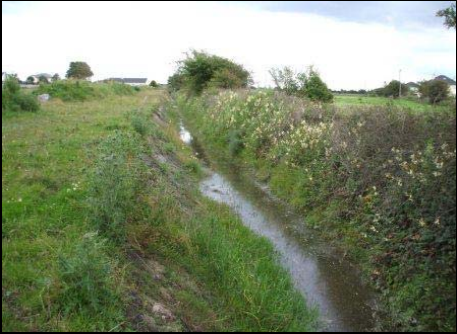
Unsuitable – temporary flow; very little refuge habitat or cover.
