Re: Clonakilty Flood Relief Scheme.

AQUATIC ECOLOGY AND FISHERIES ASSESSMENT

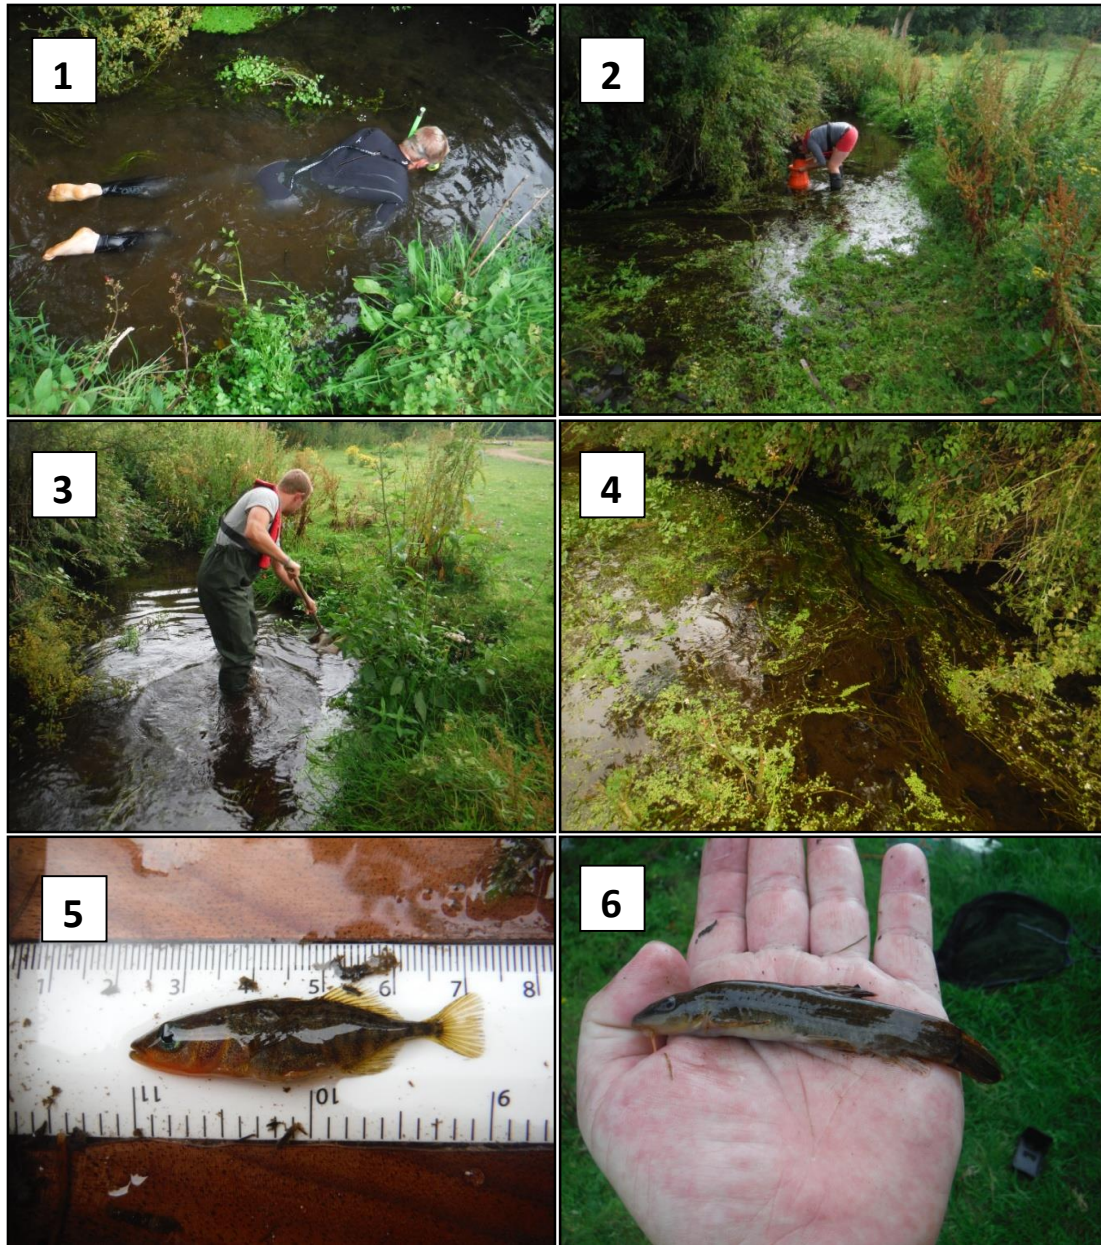
Plates 1 -6: (1) Snorkel hand searching for crayfish, (2) using bathyscope for crayfish survey (Site 1) (3) Sweep netting for crayfish (4) Heavy effluent algal growth at Sample Site 1 (5) Three spined Stickleback (6) Stoneloach from Sample Site 1.

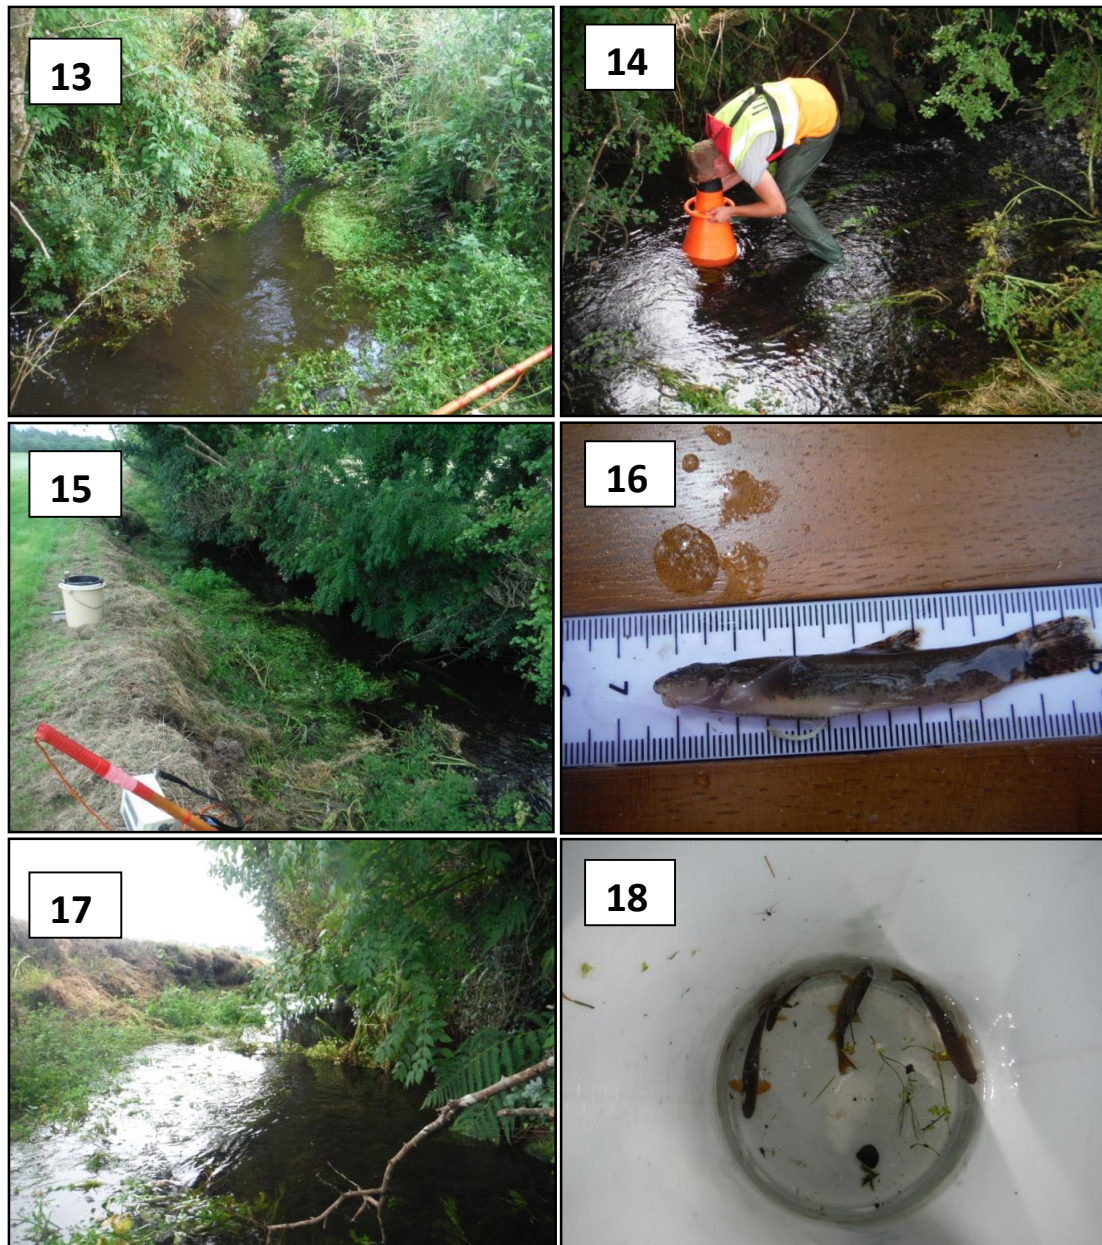
Plates 13 - 18: (13) Note sediment in the water column at Sample site 1 (14, 15 & 17) Sample site 2 (16 & 18) stoneloach and salmonids from Sample site 2.

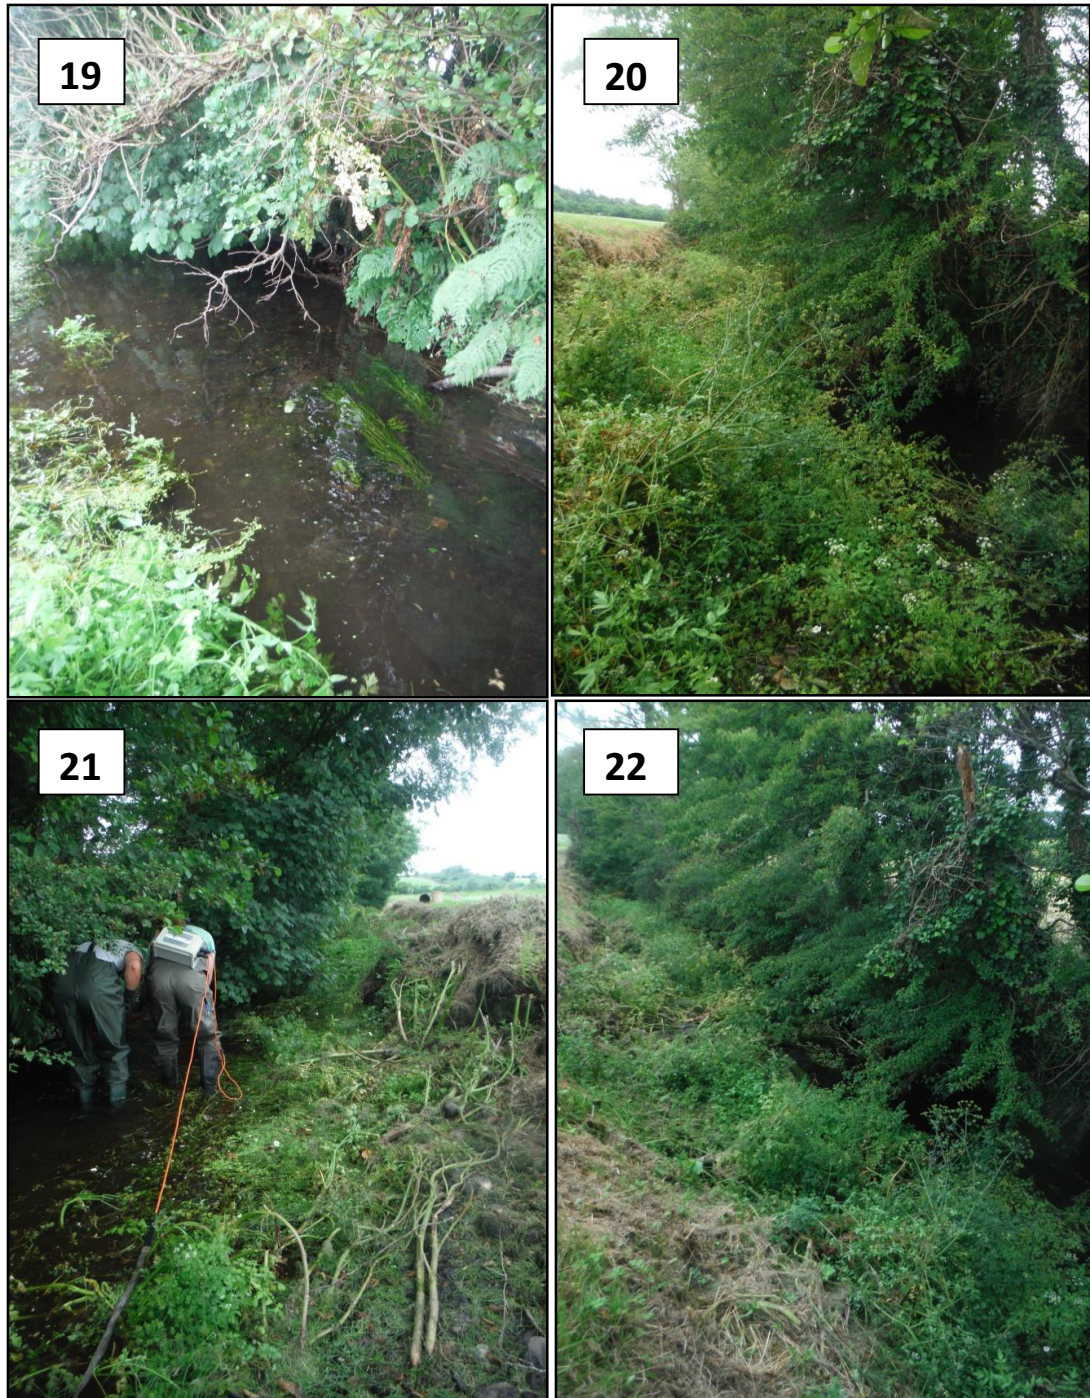
Plates 19, 20 & 22: Sample site 2 showing the congested stream and habitat characteristics
(21) Difficult electrofishing conditions.

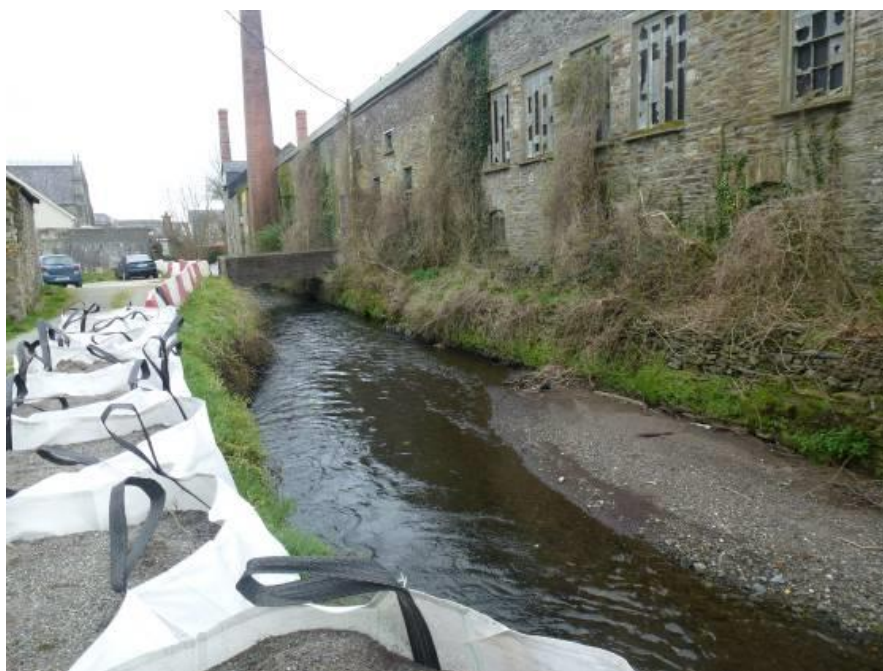
Figure 2-5 Urban Constrictions and temporary flood defences

The channel floodplain and corridor becomes more confined through urbanised areas (due to floodplain pressures and development) as a result of flood embankments and buildings adjacent to the channel (Figure 2-5). These pressures have led to accumulation of fine sediment in some areas, due to lower in channel energy levels (in areas where gradient has been reduced) than would normally be expected.

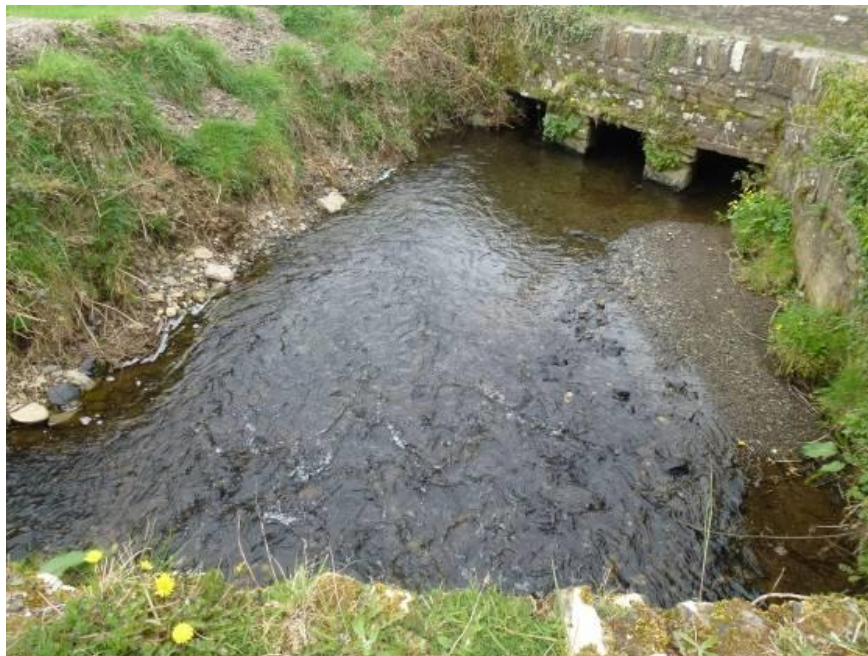
Figure 2-6 Gravel deposition upstream of bridge as a result of constriction

The bed of the channel is comprised of a mixture of cobbles, gravels and sands throughout the catchment. In some locations in the upper reaches constrictions and barriers in the channel have led to increased deposition, particularly of sands and gravels upstream of bridges (Figure

2-6). In some areas gravels appear to have been removed from the channel, presumably for flood protection.

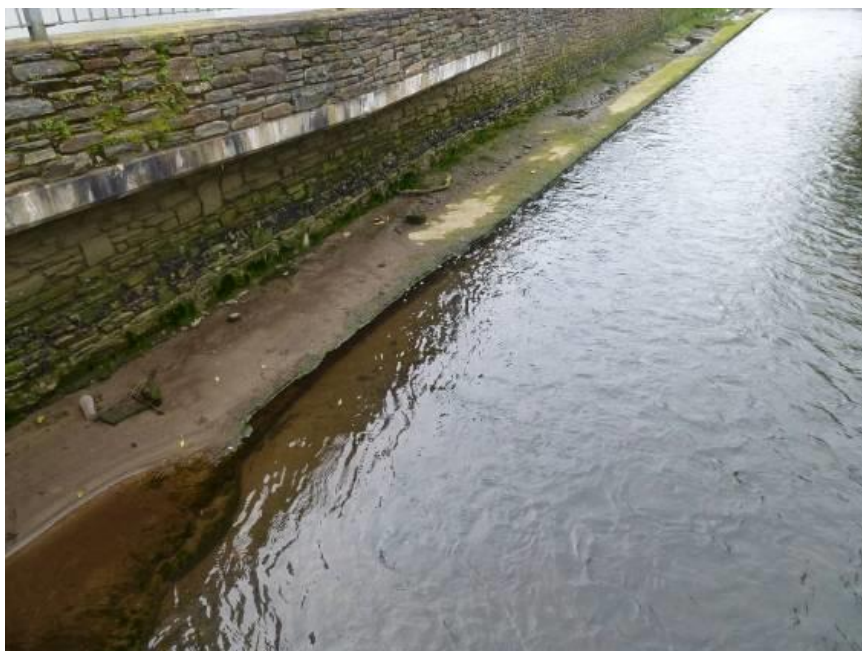
Figure 2-7 Lateral fine sediment deposition in the lower tidally influenced reaches

The downstream reaches of the Fealge River are tidal (from Rossa Street downstream). The Fealge discharges into the south-west of Clonakilty Bay alongside The Croppy Road, with a second smaller watercourse joining from the north-east at Facksbridge. Much of the tidal harbour area has been modified, however, limited evidence of excessive fine sediment deposition (Figure 2-7) was seen, suggesting existing flows have the ability to transport these and are flushed back out to sea during fluvial dominated flows and as part of the tidal cycle.

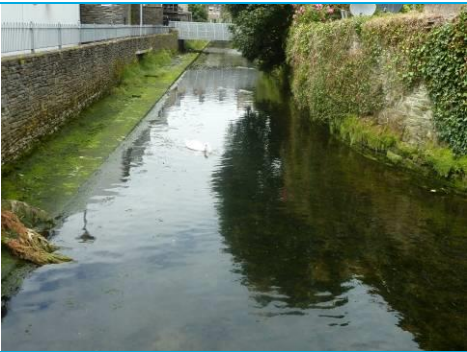
Reach 1

<p>Reach Description - Tidal dominated reach with high walls alongside the channel. Limited bankside vegetation and deep in most places.</p> <p>Gravel Condition - The reach is dominated by fine sediment, mixed sands, gravels and some cobbles. Small gravel and sand bars exist in protected pockets adjacent to the bridge, however these were covered in in channel weeds at the time of survey.</p> <p>Unlikley to be used as spawning habitat by salmonid fish. Significant numbers of adult trout observed under the road bridge.</p>
Reach 2

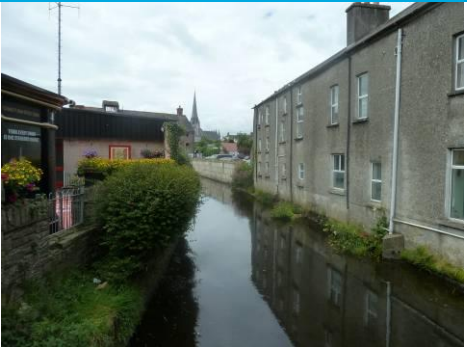
<p>Reach Description - Weir impounded reach confined by high walls and buildings. Limited bankside vegetation.</p> <p>Gravel Condition - The reach is dominated by fine sediment, with some sands and gravels. Some small areas of deposition exist in protected pockets where levels are shallower.</p> <p>Spawning habitat limited by the deposition of fine sediment.</p>

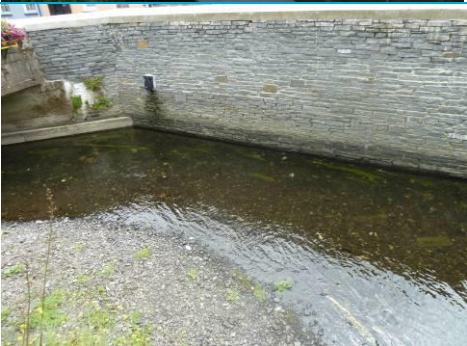
Reach 3

<p>Reach Description - Reach confined by high walls and buildings. Limited bankside vegetation. Varied channel depths with deeper and shallower areas.</p> <p>Gravel Condition - Cleaner sands and gravels on the channel bed, along with the development of a gravel and sand bar on the inside channel bend.</p> <p>The point bar pictured may provide spawning habitat if wetted under higher winter flows. The sediment for the remainder of the reach is too corase.</p>
Reach 4

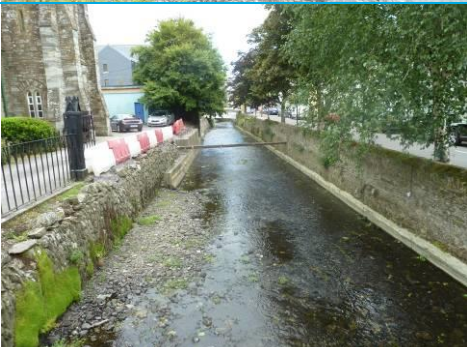
<p>Reach Description - Confined reach surrounded by walls and raised roads, with limited in channel vegetation. Shallow flow conditions.</p> <p>Gravel Condition - The bed is dominated by cobbles interspersed with some gravels and sands. Some lateral deposition of larger gravels and cobbles is evident.</p> <p>Very limited spawning habitat, reach dominated by cobbles.</p>
Reach 5

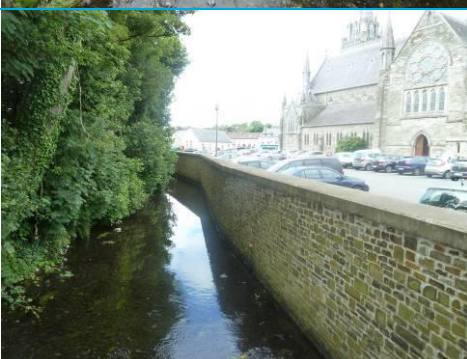
<p>Reach Description - Confined reach which is deep in most places, surrounded by walls and raised roads, with limited in channel vegetation.</p> <p>Gravel Condition - The bed is dominated by cobbles with limited gravels present.</p> <p>Very limited spawning habitat, reach dominated by cobbles.</p>

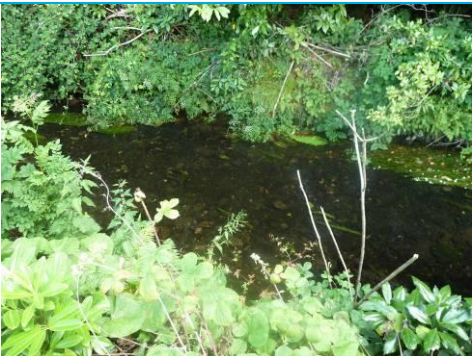
Reach 6

<p>Reach Description - The channel remains confined, however more bankside vegetation is present outside of the urban area.</p> <p>Gravel Condition - Evidence of old cobble channel lining which has been eroded. Some gravels and sands present, but cobbles dominate the reach.</p> <p>Very limited spawning habitat, reach dominated by cobbles.</p>
Reach 7

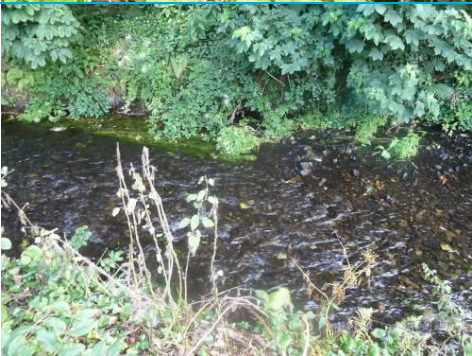
<p>Reach Description - The channel remains confined and exhibits pool - riffle sequences (deeper and shallower areas).</p> <p>Gravel Condition - Cobbles and larger sized gravels dominate the reach which are in filled with sands.</p> <p>Very limited spawning habitat, reach dominated by cobbles.</p>
Reach 8

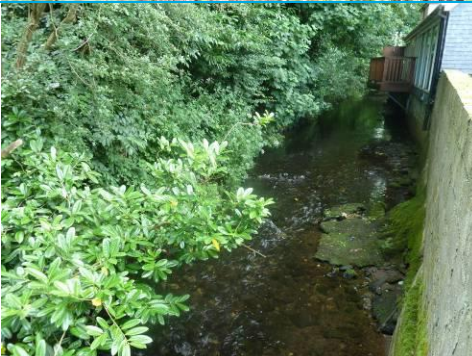
<p>Reach Description - The channel remains confined and exhibits pool - riffle sequences (although larger and deeper pools dominate the reach).</p> <p>Gravel Condition - Cobbles and larger sized gravels dominate the reach which are in filled with sands.</p> <p>Very limited spawning habitat, reach dominated by cobbles.</p>

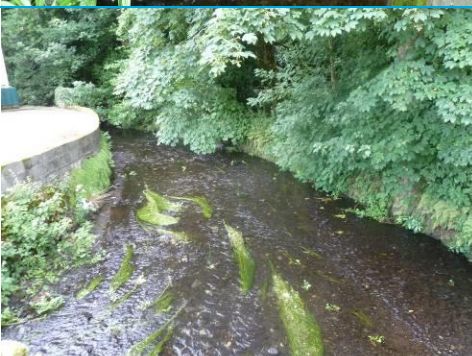
Reach 9

<p>Reach Description - The channel becomes less confined at the bridge crossing and consequently exhibits shallower flows.</p> <p>Gravel Condition - Gravels dominate this reach which are infilled with sands. Some cleaner gravels were present within stronger flow paths.</p> <p>Very localised patch of spawning habitat in a reach dominated by cobbles.</p>
Reach 10

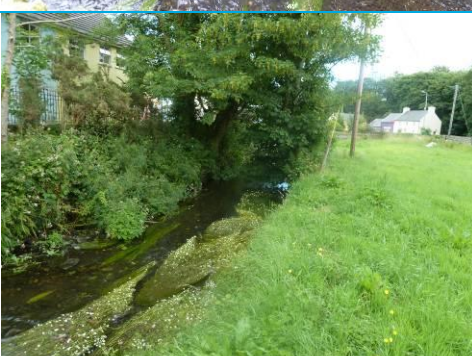
<p>Reach Description - A generally well connected reach on the left bank with a raised right bank.</p> <p>Gravel Condition - Gravels and sand dominate this reach. Limited areas of clean gravels were noted due to the strong presence of sand.</p> <p>Deposition of sand in this reach limits the quality of the spawning habitat, some areas of cleaner gravels were observed where the instream vegetation constricts flow. Character of this reach will be different without the instream vegetation.</p>

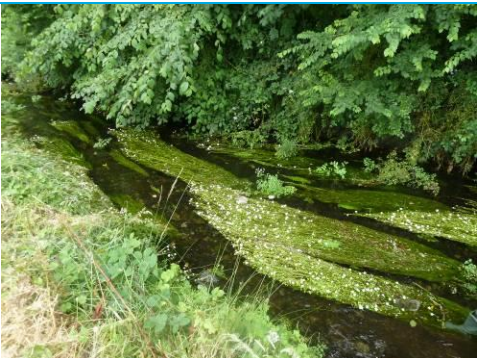
Reach 13

<p>Reach Description - Dominated by pool riffle sequences and sands, gravels and cobbles. Reach contains a significant amount of in channel vegetation.</p> <p>Gravel Condition - Gravels and sand dominate the reach, however there are no areas containing clean gravels.</p> <p>No suitable spawning gravels in this reach.</p>
Reach 14

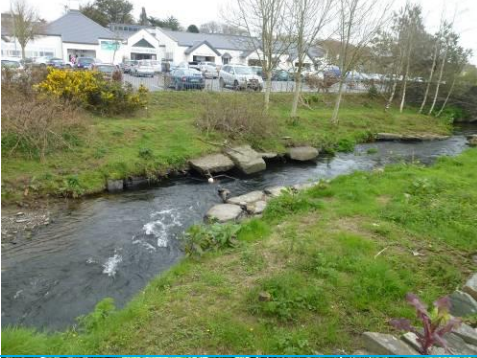
<p>Reach Description - Modified reach containing pool and riffle sequences with some areas of shallow flows.</p> <p>Gravel Condition - The stronger flows in this reach a riffle locations result in small areas of clean gravels (although some sand is contained under the surface gravel layer).</p> <p>The areas of suitable gravels are very small within this constrained reach, spawning habitat limited.</p>
Reach 15

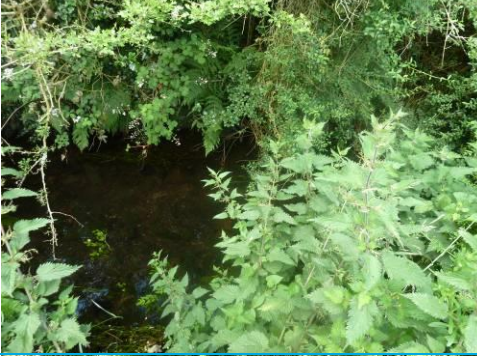
<p>Reach Description - Heavily vegetated banks and shaded river reach.</p> <p>Gravel Condition - Potential for some clean gravels in higher flows, but large amounts of fines and gravels contained within the channel during summer conditions.</p> <p>Difficult to determine quality of habitat, gravels may well be cleaner during elevated flows during the autumn spawning season.</p>

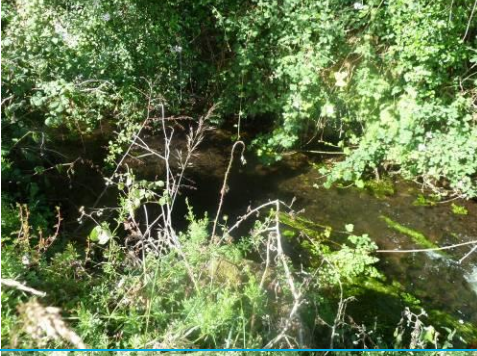
Reach 16

<p>Reach Description - Heavily vegetated banks and shaded river reach.</p> <p>Gravel Condition - Potential for some clean gravels in higher flows, but large amounts of fines and gravels contained within the channel during summer conditions.</p> <p>Difficult to determine quality of habitat, gravels may well be cleaner during elevated flows during the autumn spawning season.</p>
Reach 17

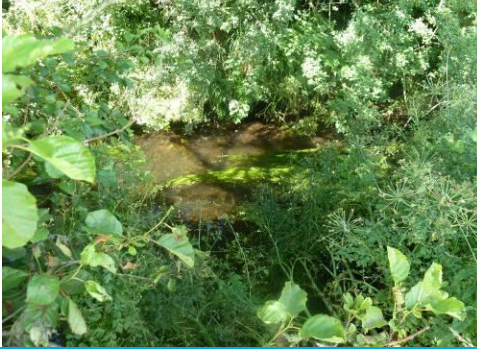
<p>Reach Description - Heavily vegetated banks and shaded river reach.</p> <p>Gravel Condition - Potential for some clean gravels in higher flows, but large amounts of fines and gravels contained within the channel during summer conditions.</p> <p>Difficult to determine quality of habitat, gravels may well be cleaner during elevated flows during the autumn spawning season.</p>
