### 3.2.3 Reaches 21 to 30 (Fealge River)

### 3.2.4 Reaches 31 to 39 (Feagle River)

### 3.2.5 Reaches 40 to 51 (tributary)

### 3.2.6 Reaches 52 to 60 (tributary)

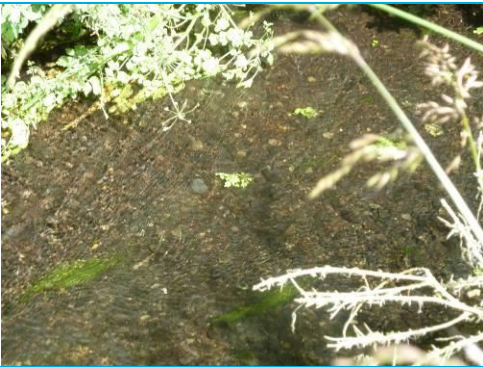
Reach 18

<p>Reach Description - Heavily vegetated banks and shaded river reach.</p> <p>Gravel Condition - Potential for some clean gravels in higher flows, but large amounts of fines and gravels contained within the channel during summer conditions.</p> <p>Difficult to determine quality of habitat, gravels may well be cleaner during elevated flows during the autumn spawning season.</p>
Reach 19

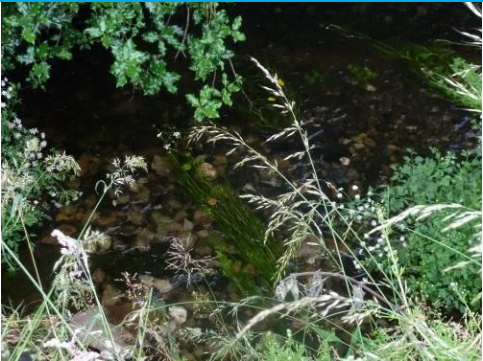
<p>Reach Description - Heavily vegetated banks and shaded river reach.</p> <p>Gravel Condition - Cobbles dominate this section of channel with limited areas of gravel deposition. Accumulations of sand were noted beneath of the top cobble layer.</p> <p>Limited spawning habitat as reach dominated by cobbles and sand.</p>
Reach 20

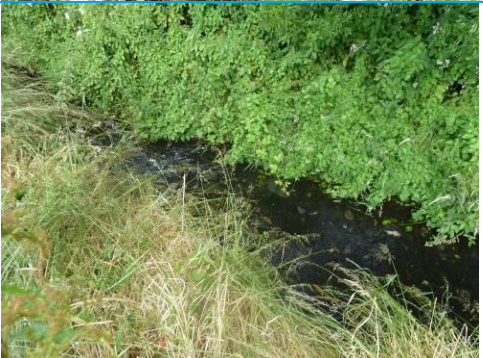
<p>Reach Description - Vegetated banks which afford some shade to the river reach. Some evidence of historic rock armour to provide bank protection.</p> <p>Gravel Condition - Cobbles dominate this section of channel with limited areas of gravel deposition. Accumulations of sand were noted beneath of the top cobble layer.</p> <p>Limited spawning habitat as reach dominated by cobbles and sand.</p>

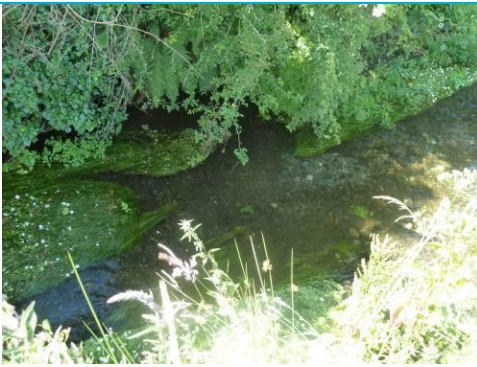
Reach 23

<p>Reach Description - Vegetated banks provide some shade to the channel. The reach is generally shallow but deepens towards its downstream extent.</p> <p>Gravel Condition - The bed is dominated by gravels and sands, and limited areas of clean gravels exist.</p> <p>Difficult to confidently determine quality of spawning habitat, but the cleanliness of the gravels under the higher velocities suggests that under higher autumn discharges a greater proportion of the gravels may be kept clear of fine sediment.</p>
Reach 24

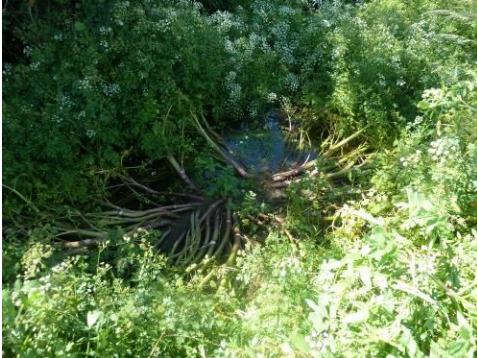
<p>Reach Description - A generally shallow reach. Heavily vegetated banks and channel (invasive species) act to reduce flows and encourage fine sediment deposition.</p> <p>Gravel Condition - Pockets of gravels exist mixed with sands, however the dense in channel vegetation has encouraged the deposition of silts over the gravels and sands.</p> <p>Whilst suitably sized gravels are present in this reach, the heavily vegetated nature of the reach makes determination of spawning habitat difficult.</p>

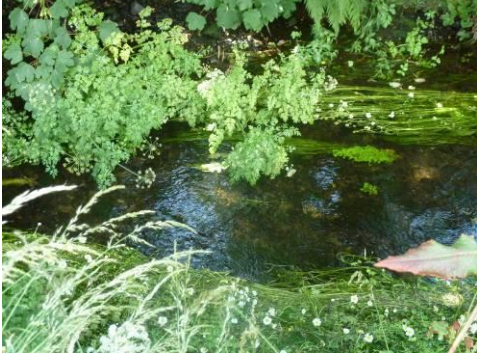
Reach 25

<p>Reach Description - Heavily vegetated steep banks with some in channel vegetation act to reduce flows and encourage fine sediment deposition. Where the channel deepens there is a smaller abundance of in channel vegetation.</p> <p>Gravel Condition - Pockets of gravels exist mixed with sands, however the gravels are rarely clean.</p> <p>Difficult to confidently determine quality of spawning habitat, but the cleanliness of the gravels under the higher velocities suggests that under higher autumn discharges a greater proportion of the gravels may be kept clear of fine sediment.</p>
Reach 26

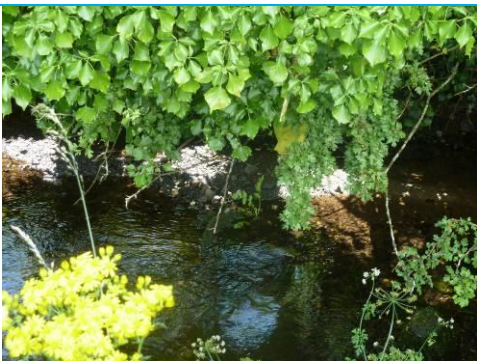
<p>Reach Description - Heavily vegetated steep banks. Some in channel vegetation encourages fine sediment deposition.</p> <p>Gravel Condition - Pockets of gravels exist (including exposed gravel bars) mixed with sands, however the gravels are rarely clean.</p> <p>Difficult to confidently determine quality of spawning habitat, but the cleanliness of the gravels under the higher velocities suggests that under higher autumn discharges a greater proportion of the gravels may be kept clear of fine sediment.</p>

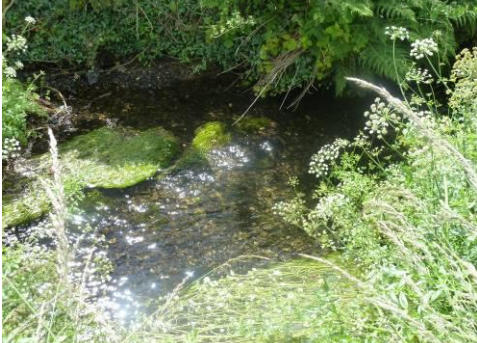
Reach 27

<p>Reach Description - Heavily vegetated steep banks. Some in channel vegetation encourages fine sediment deposition, particularly along the lateral extents.</p> <p>Gravel Condition - Some small pockets of clean gravels exist where flows are higher but these are large in size and mixed with some small cobbles.</p> <p>The areas of exposed gravels are small and generally larger than ideal spawning habitat.</p>

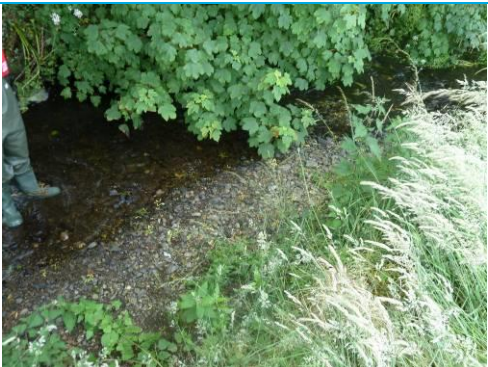
Reach 28

<p>Reach Description - Bankside vegetation provides shade to this reach, however there is little in channel vegetation.</p> <p>Gravel Condition - There is a strong supply of gravels at the tributary confluence point, however, gravels remain mixed with sands</p> <p>Gravels abundant and of a size suitable for salmonid spawning. The sands present may be removed by elevated winter flows.</p>
Reach 29

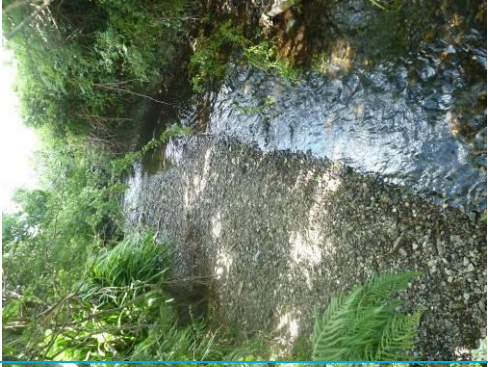
<p>Reach Description - Bankside vegetation provides shade to this reach, however there is little in channel vegetation.</p> <p>Gravel Condition - There is a strong supply of gravels along this tributary confluence point, however, gravels remain mixed with sands</p> <p>Gravels abundant and of a size suitable for salmonid spawning. The sands present may be removed by elevated winter flows.</p>
Reach 30

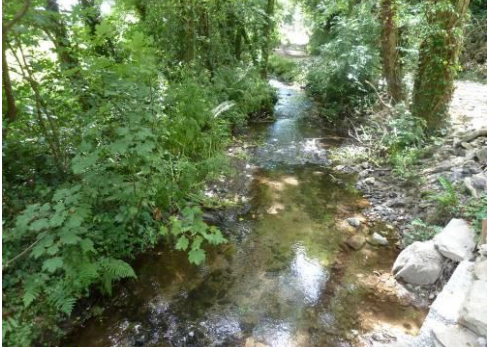
<p>Reach Description - Bankside vegetation provides shade to this reach, however there is little in channel vegetation. The reach is generally steep.</p> <p>Gravel Condition - This reach is dominated by large gravels and cobbles. Fines and sands dominate the pool areas. Few clean gravels exist and are generally mixed with sand.</p> <p>Limited spawning habitat available in this reach, as gravel availability limited.</p>

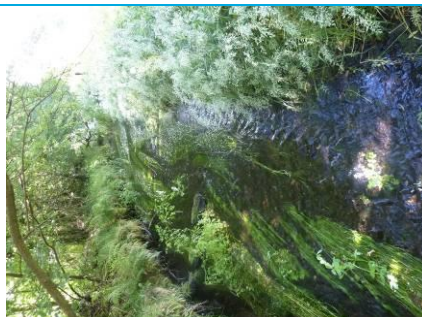
Reach 31 - 37  
(photo depicts a  
typical section)

**Reach Description** - The channel along these reaches contains vegetated banks and a channel of varied widths with some in channel islands.

**Gravel Condition** - The reaches contain a mixture of cobbles, gravels and sands distributed over several pool and riffle sequences. Gravels occur in abundance in some locations, however these are rarely clean and are generally mixed with sands.

Access to this section of river was limited, as such it was difficult to pinpoint particular habitat,

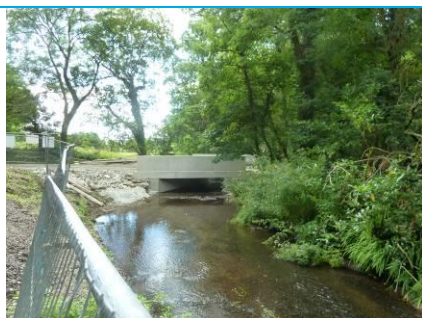
Reach 38 - 39  
(photo depicts a  
typical section)

**Reach Description** - The channel along these reaches contains vegetated banks and a channel of varied widths with some in channel islands.

**Gravel Condition** - The reaches contain a mixture of cobbles, gravels and sands distributed over several pool and riffle sequences. Gravels occur in abundance in some locations, however these are rarely clean and are generally mixed with sands.

In particular extensive gravels were observed

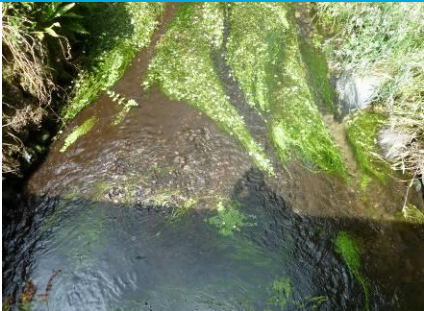
<p>Reach 38 - 39 (photo depicts a typical section)</p>

<p>around the bridges. Although the observed gravels contained sands and gravels during the summer, they may well be kept clean by higher flows in the winter months.</p>
--	---	---

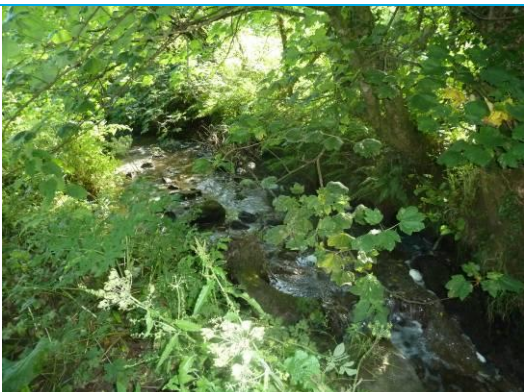
Reach 42

<p>Reach Description - The channel along this reach is steep and narrow and naturally confined with heavily vegetated banks. Several pool and riffle sequences exist.</p> <p>Gravel Condition - The bed of the channel is coarse with little gravel deposition evident. The bed is dominated by cobbles and sands.</p> <p>Despite the pool riffle sequence, there is little evidence of gravel deposition in this reach. Limited spawning habitat.</p>
Reach 43

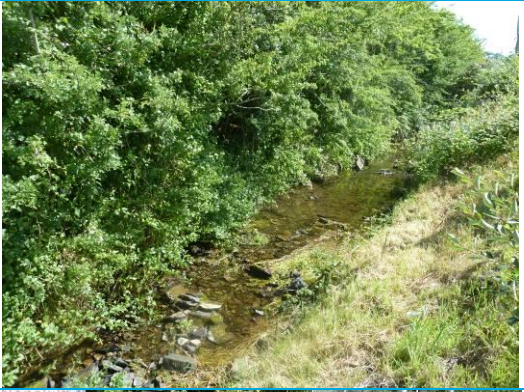
<p>Reach Description - The channel along this reach is steep and narrow and artificially confined due to a sports ground development. Several pool and riffle sequences exist.</p> <p>Gravel Condition - The bed of the channel is coarse with little gravel deposition evident. The bed is dominated by cobbles and sands.</p> <p>Limited spawning habitat present in this reach.</p>
Reach 44

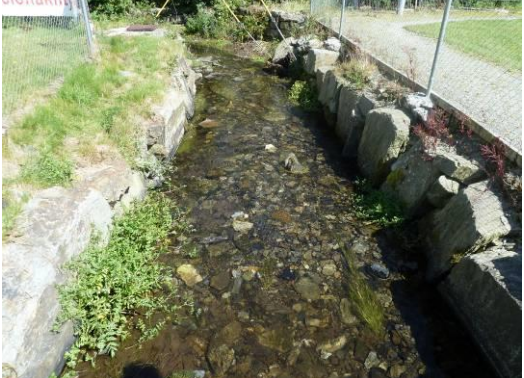
<p>Reach Description - The channel along this reach is steep and narrow and artificially confined due to a sports ground development. Several pool and riffle sequences exist.</p> <p>Gravel Condition - The bed of the channel is coarse with little gravel deposition evident. The bed is dominated by cobbles and sands. Gravel may just be flushed through during high flow events due to the confined nature of the channel.</p> <p>Limited spawning habitat available.</p>

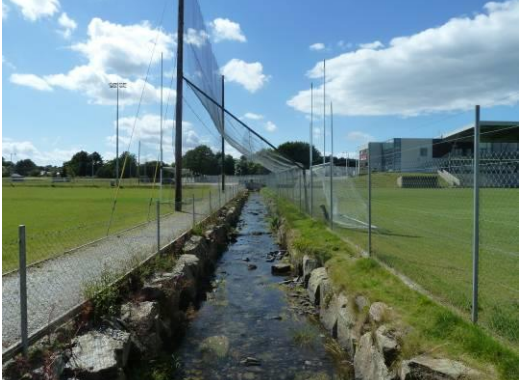
Reach 45

<p>Reach Description - The channel along this reach is steep and narrow and artificially confined due to a sports ground development. Several pool and riffle sequences exist.</p> <p>Gravel Condition - The bed of the channel is coarse with little gravel deposition evident. The bed is dominated by cobbles and sands.</p> <p>Limited spawning habitat.</p>

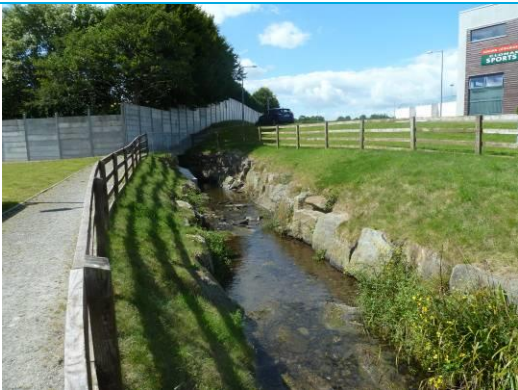
Reach 46

<p>Reach Description - The channel along this reach is steep and narrow and artificially confined due to a sports ground development. Several pool and riffle sequences exist.</p> <p>Gravel Condition - The bed of the channel is coarse with little gravel deposition evident. The bed is dominated by cobbles and sands.</p> <p>Limited spawning habitat.</p>
Reach 47 Reach 48	No access

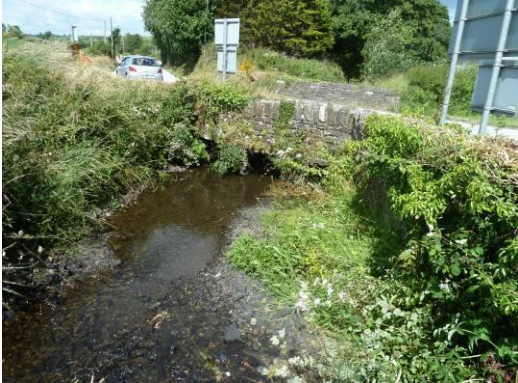
<p>Reach Description - The channel along this reach is impacted by a small bridge constricting flows and causing excessive gravel deposition.</p> <p>Gravel Condition - The bed of the channel is dominated by gravel deposition, which is mixed with sands and some small cobbles.</p> <p>Some potential as spawning habitat, if the gravels can be kept clean of fine sediment during higher autumn flows.</p>
Reach 49

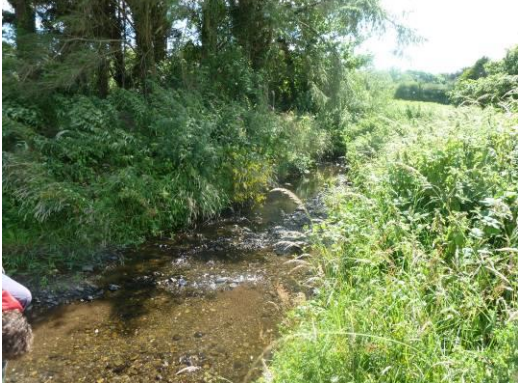
<p>Reach Description - Upstream of the bridge several pool and riffles exist which are dominated by gravels. The banks are vegetated, but limited in channel vegetation occurs.</p> <p>Gravel Condition - The bed of the channel is dominated by gravel, which is mixed with sands and some small cobbles. Sands remain mixed with gravels over higher flowing sections.</p> <p>Excellent potential as spawning habitat.</p>

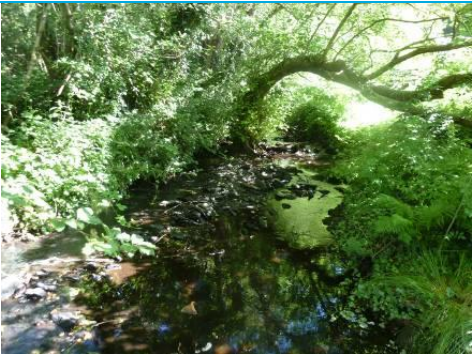
Reach 52

<p>Reach Description - The channel along this reach is very steep and narrow and naturally confined with heavily vegetated banks. Several step - pool sequences exist.</p> <p>Gravel Condition - The bed of the channel is coarse with little gravel deposition evident, except in protected pockets. The bed is dominated by large cobble, boulders and bed rock.</p> <p>Limited spawning habitat.</p>
Reach 53	No access	
Reach 54	No access	
Reach 55

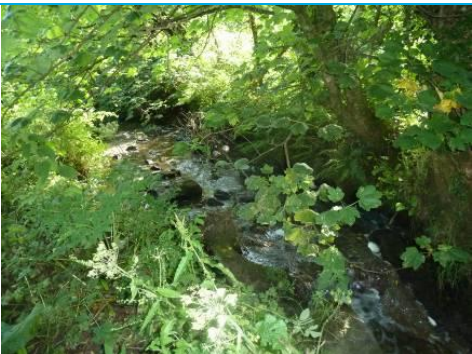
<p>Reach Description - The channel along this reach is very steep and narrow and naturally confined with heavily vegetated banks. Several step - pool sequences exist.</p> <p>Gravel Condition - The bed of the channel is coarse with little gravel deposition evident, except in protected pockets. The bed is dominated by large cobble, boulders and bed rock.</p> <p>Little spawning habitat.</p>
Reach 56	Inaccessible	
Reach 57	Inaccessible	
Reach 58	Inaccessible

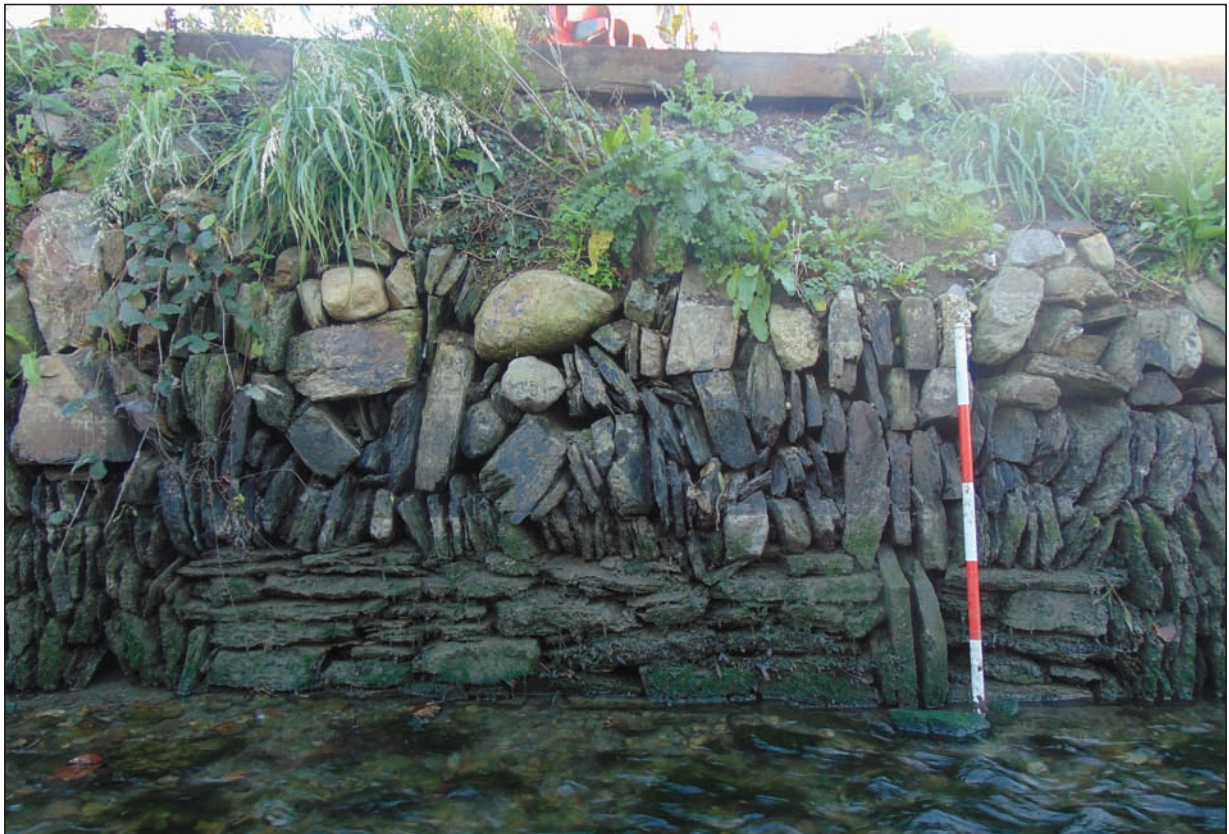
Plate 6 - An example of dry-stone revetment style evident along the present river channel and at Deasy's Quay

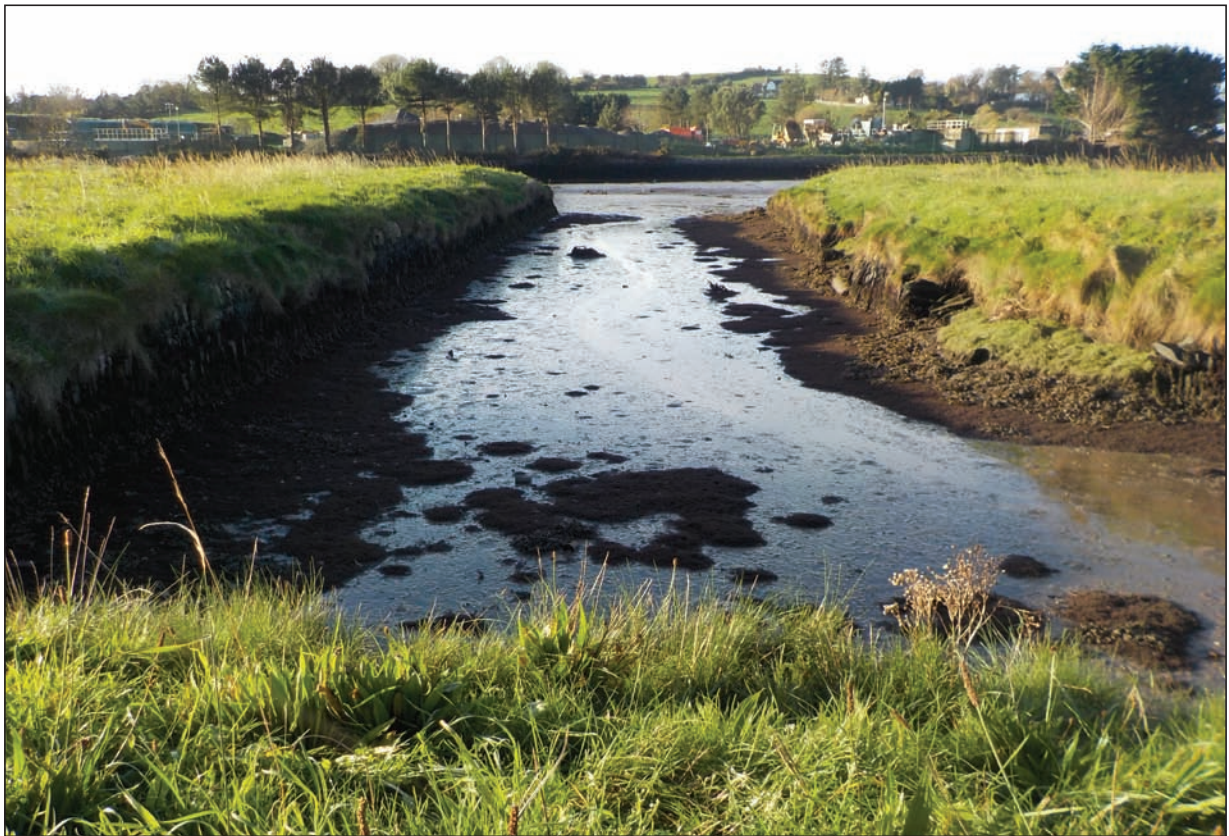
Plate 7 - Possible dry-dock/shipyard at Deasy's Quay, facing southwest

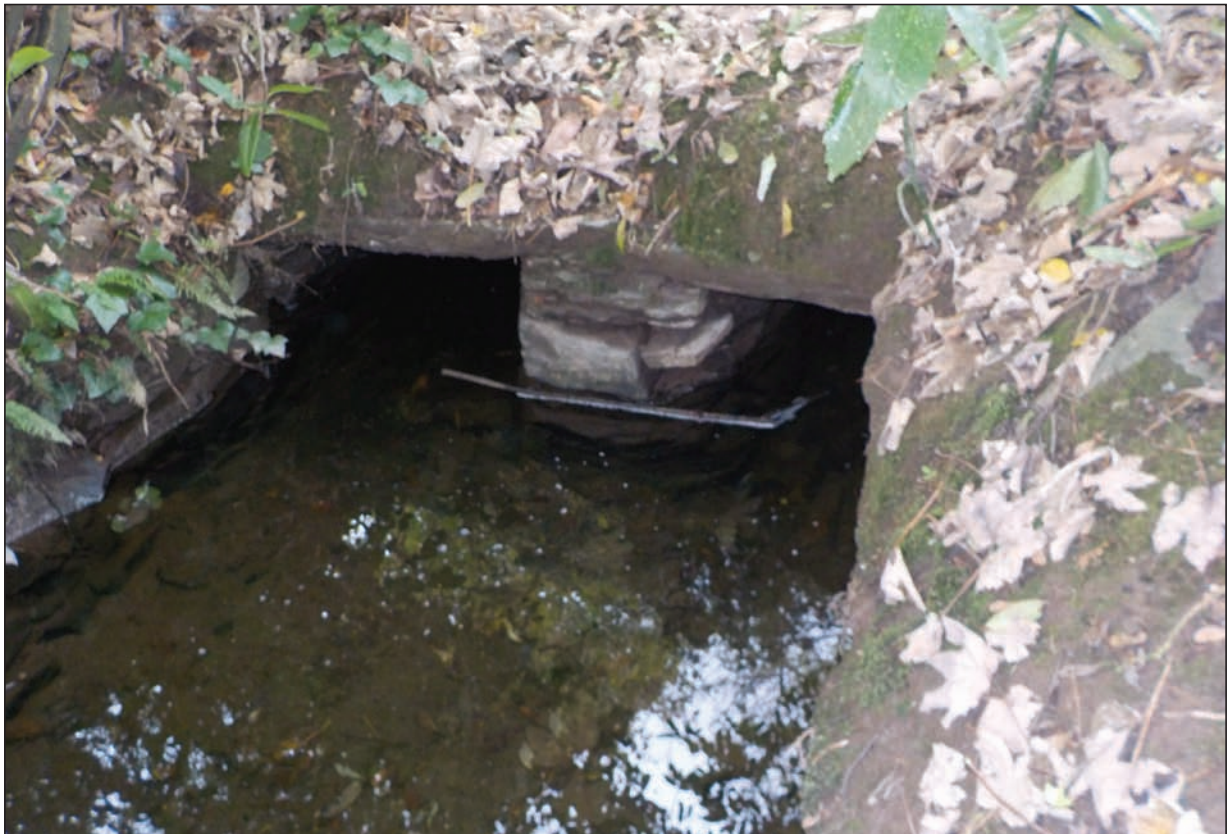
Plate 8 - Culvert located to the southwest of Forge Cottage
