**SERIES OF ECOLOGICAL ASSESSMENTS ON
ARTERIAL DRAINAGE MAINTENANCE No 4**

**Ecological Impact Assessment (EcIA) of the
Effects of Statutory Arterial Drainage
Maintenance Activities on the Otter
(Lutra lutra)**

The Office of Public Works Ecological Impact Assessment (EcIA) of the Effects of Statutory Arterial Drainage Maintenance Activities on the Otter (*Lutra lutra*)

Report No: 2514

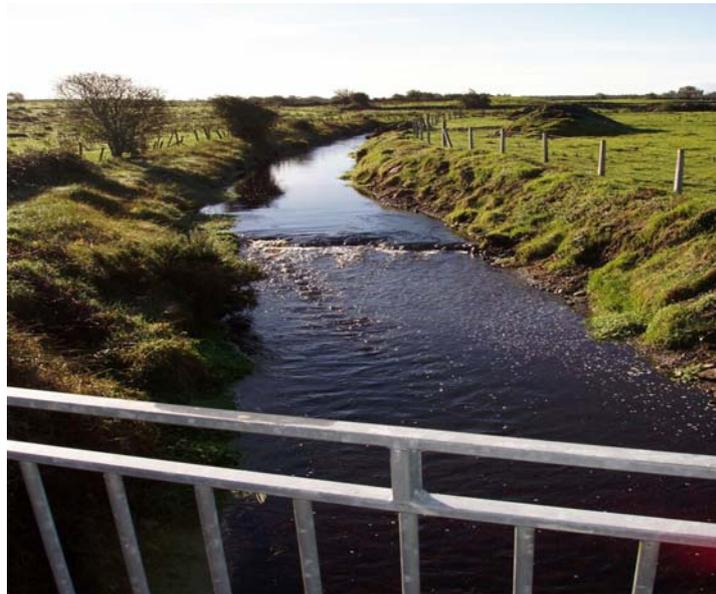
Site 1 - River Moy SAC (00298) - OPW channel (C1/21/1/5/18/3)

Figure 1: OPW Channel (C1/21/1/5/18/3) Looking Upstream

Maintenance activities - Standard channel works by hydraulic excavator (maintenance observed during survey).

Otter disturbance within the survey area was relatively low, however, an otter slide at a point where the species entered and exited the water, and a clearly marked couch was observed. The couch (~400m upstream from the road bridge crossing) is regularly being used by otter. At this particular location fresh otter spraint (<1week) was recorded.

Couches/Lay-ups - As discussed a clearly marked couch was identified (~400m upstream from the road bridge crossing). This lay-up site was found under a densely foliated alder tree, with a thick root network running up to the waters edge and sheltered from a boulder/rock wall. During the survey a heron (*Ardea cinerea*) was observed in this particular area. This is a good indicator that fish populations are present, thus suitable feeding grounds for otter.

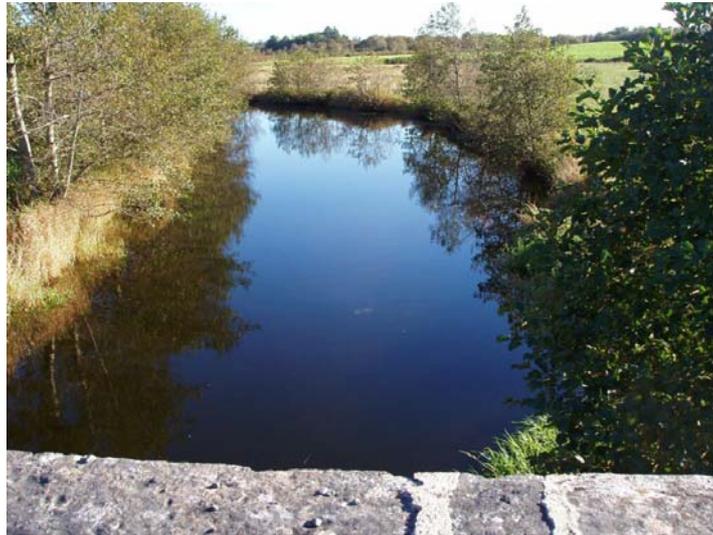
Site 2 - Lough Carra / Mask SAC (001774) - OPW channel (CM5/10)

Figure 2: OPW Channel (CM5/10) Looking Upstream

Maintenance activities - Weed cutting by boat (post maintenance).

Otter disturbance within the survey area was relatively low, however, an otter slide at a point where the species entered and exited the water, and a heavily marked couch was observed. The couch (directly under the road bridge crossing) is regularly being used by otter. At this particular location fresh otter spraint (<1week) and re-spraint was recorded.

Couches/Lay-ups - As discussed a heavily marked couch site was identified. This lay-up site was found directly under the road bridge crossing, with good access to the water and very well sheltered (overhead bridge and large boulders). During the survey trout (*Salmo trutta*) were observed in the large pool adjacent to the couch site. This is indicative of suitable feeding grounds for otter.

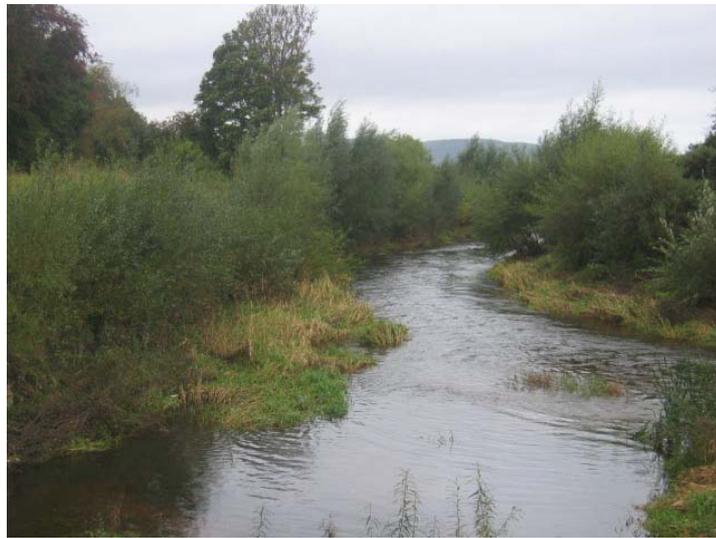
Site 3 - Lower River Shannon SAC (002165) – Mulkear River
OPW channel (C1)

Figure 3: OPW Channel (C1) Looking Downstream

Maintenance activities - Extensive channel works by hydraulic excavator (before maintenance).

Otter disturbance within the survey area was relatively low, however, a potential couch and holt (clearly marked) was observed. The holt (~400m downstream from the road bridge crossing) is regularly being used by otter. At this particular location fresh otter spraint (<1week) and re-sprainting was recorded.

Holts - A potential holt site was observed (as described above). This active site was positioned under a densely foliated ash tree, with a thick root network running up to the waters edge and very well sheltered with vegetation. A prominent rock at the potential holt entrance was clearly marked fresh spraint and signs of re-sprainting was evident.

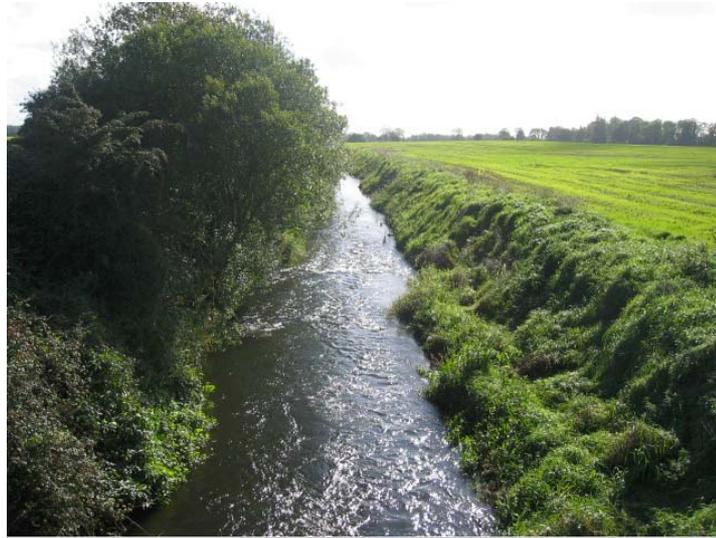
Site 4 - River Boyne and River Blackwater SAC (002299) – Athboy River
OPW channel (C1/21)

Figure 4: OPW Channel (C1/21) Facing Downstream

Maintenance activities – Standard channel works by hydraulic excavator (post maintenance).

Otter disturbance within the survey area was relatively low, however, a potential couch was observed (~200m downstream from the road bridge crossing). No obvious signs that otter are using the site frequently were observed, other than large broken snail shells (feeding remains).

Couches/Lay-ups - As discussed a potential couch site was identified. This lay-up site was found under a densely foliated willow tree, with a thick root network running up to the waters edge and sheltered from the bankside. During the survey a heron (*Ardea cinerea*) and a kingfisher (*Alcedo atthis*) and good numbers of trout (*Salmo trutta*) were observed in this particular area. This is indicative of suitable feeding grounds for otter.
