9 LANDSCAPE

9.1 INTRODUCTION

This section of the Environmental Impact Statement addresses the landscape and visual aspects of the proposed flood relief scheme for Bandon, Co. Cork. The Study Area, which in the case of this chapter is defined as the channel, floodplain and surroundings of the Bandon River from Baxters Bridge upstream of the proposed works as far as Curranure, downstream of O'Driscoll's Bridge, where works will terminate, is described with reference to Landscape Character and Landscape Type, and the ratings that have been assigned to it in terms of Value, Sensitivity and Importance. The relevant landscape policy recommendations that have been set out for this area by Cork County Council in terms of landscape and visual characteristics are also addressed.

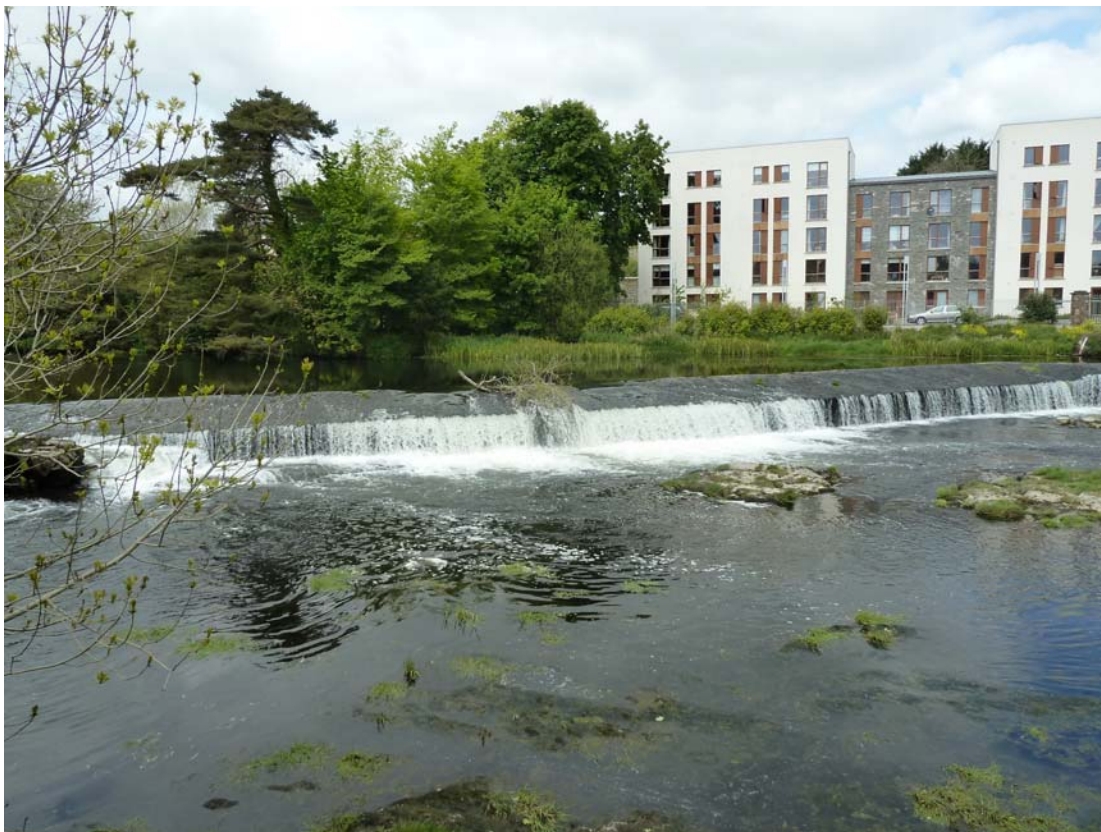
9.4 presents a view of the Bandon Weir from the southern bank of the river. Upstream of this weir the banks of the river are bounded by grassland with mature broadleaf trees. Plate 9.5 presents a view of the Bridewell River within Bandon Town looking downstream. The view from the Church of the Immaculate Conception & St. Patrick, which is located on top of the valley wall to the south of the Bandon River is shown in Plate 9.6. While the townscape is visible from this vantage point, the river corridor is barely perceptible from this location.

Plate 9.4 View of Bandon Weir upstream of Bandon Bridge

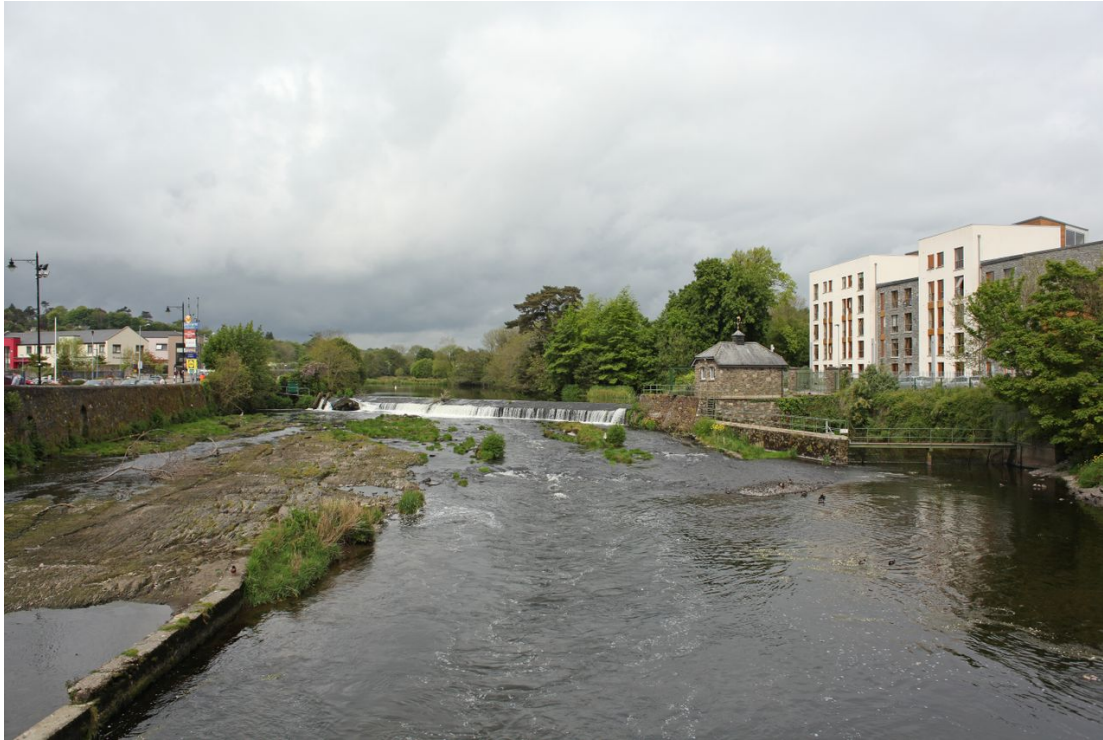
Plate 9.17 Existing view looking upstream from photo-location 1 (Pedestrian Bridge)

Photo-location 1 is on the pedestrian footbridge linking the north and the south banks of the Bandon River upstream of Bandon Bridge and just downstream of the Bandon Weir. The existing view looking upstream from the footbridge presented in Plate 9.17 shows the Bandon Weir in the centre of the photograph with the river wall visible to the left of the picture (southern bank) and modern apartment block to the right (northern bank). The Bandon River itself flows through the centre of the photograph. Upstream of the Bandon Weir, mature broadleaved trees line the river bank, although some are also present downstream of this point. Downstream of the weir within the river channel, areas of bedrock and small islets vegetated with rank grasses are visible, particularly to the left of the photograph. On the southern bank, part of the urban fabric of Bandon Town is also shown.

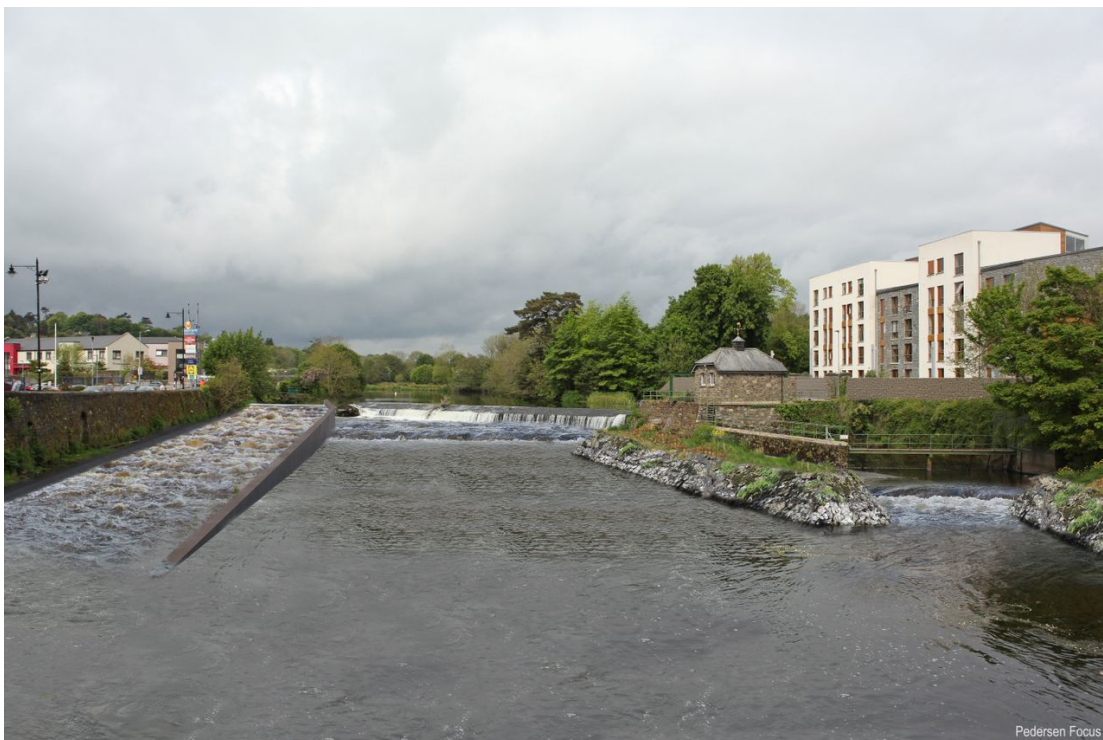
Plate 9.18 Proposed view looking upstream from photo-location 1 at average flow (Pedestrian Bridge)

The proposed view at average flow at photo-location 1 (Plate 9.18) shows the proposed rock ramp, which will serve as a fish pass to the left of the picture. The weir and all other infrastructure visible in the existing view will remain *in-situ*. Apart from the presence of the proposed rock ramp, the most noticeable change will involve the drop in the channel bed resulting from the dredging of substrate during the proposed works. This will leave exposed rock at the base of the river banks, as shown along the northern bank as shown to the right of the photomontage. The channel downstream of the hydro-electric station on the northern bank will enter the Bandon River with a greater fall and therefore will result in more turbulence at its outfall. The proposed flood defence wall on the northern bank to be constructed in front of the multi-storey modern apartment block is also visible in this proposed view. The proposed view shows less turbulence in the river channel than in the existing view as the bed of the river will be lowered and the river at this location will have more pool characteristics than at present.

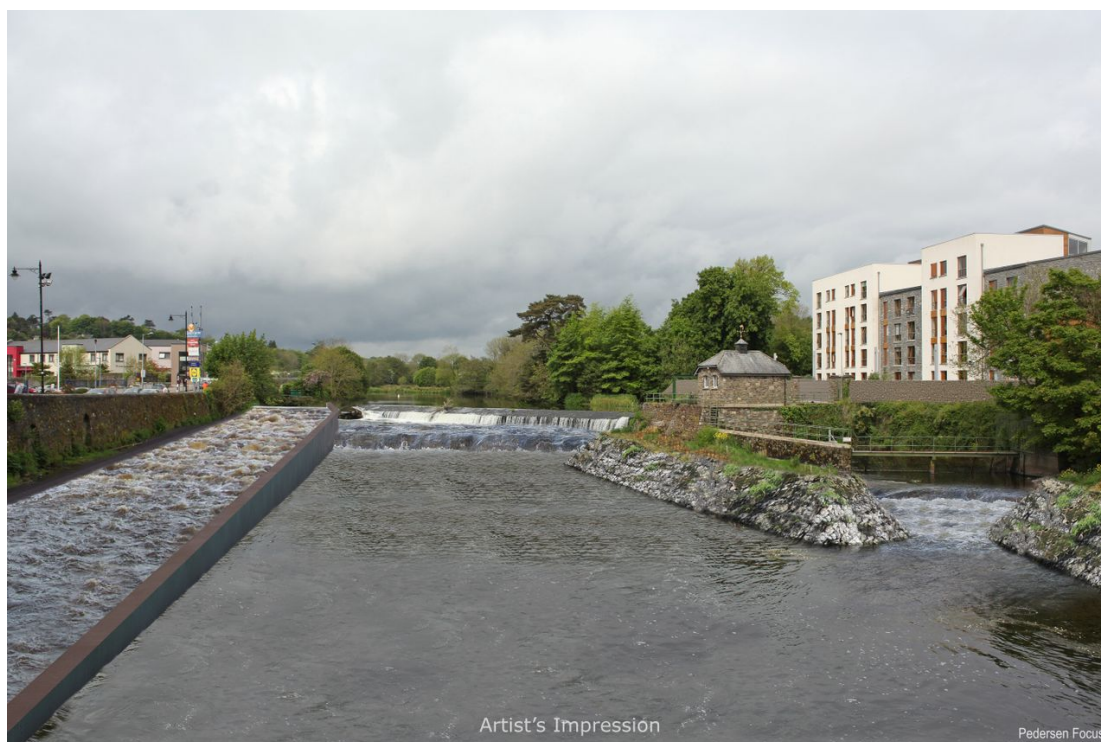
Plate 9.19 Proposed view looking upstream from photo-location 1 at low flow (Pedestrian Bridge)

The proposed low flow view (Plate 9.19) shows a similar scene to the proposed average flow view, with lower water levels evident in the latter. The lower part of the rock ramp is also exposed. In this view the location of the start of the dredge is quite noticeable as there is a visible drop from the original bed level below the Bandon Weir to the start of the dredged area, which resembles a second weir.

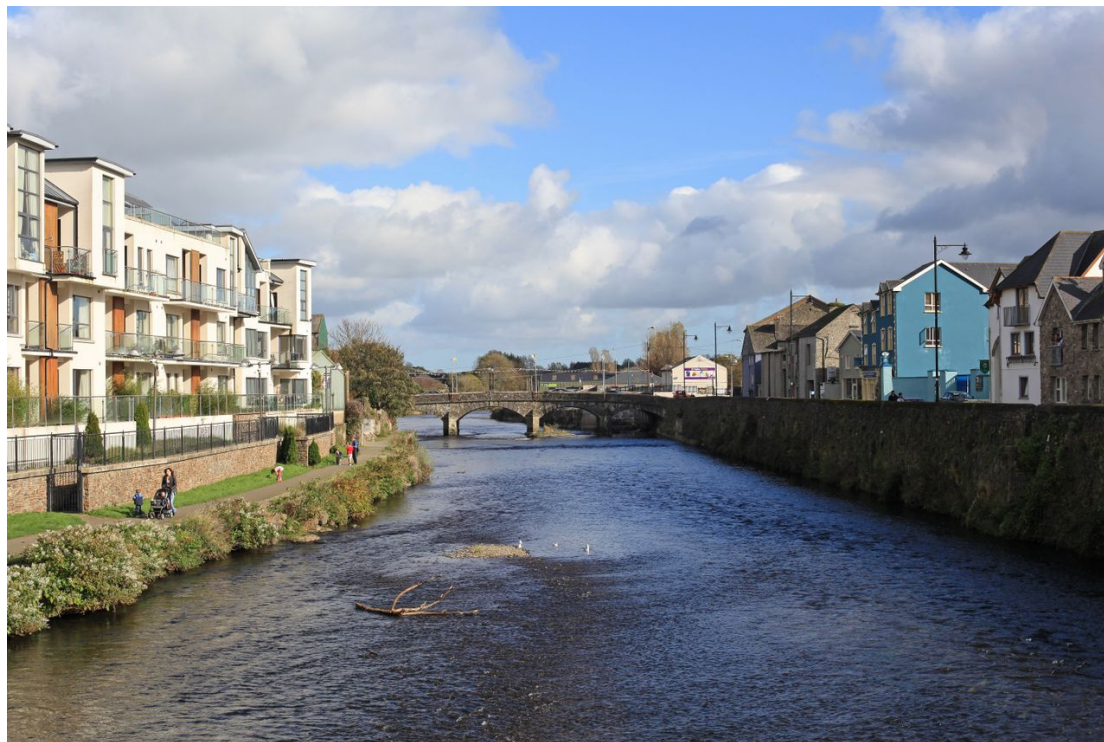
Plate 9.20 Existing view looking downstream from location 1 (Pedestrian Bridge)

The existing view looking downstream from the pedestrian bridge shows Bandon Bridge in the centre of the photograph (Plate 9.20). This stone bridge is an important landmark and is a dominant feature within the river in Bandon Town. The photograph shows modern apartments to the left (northern bank) and Bandon Town Centre to the right (southern bank). The pedestrian walkway is visible on the northern bank and the river wall forms the boundary of the river channel to the south. Small islets are also present within the river channel.

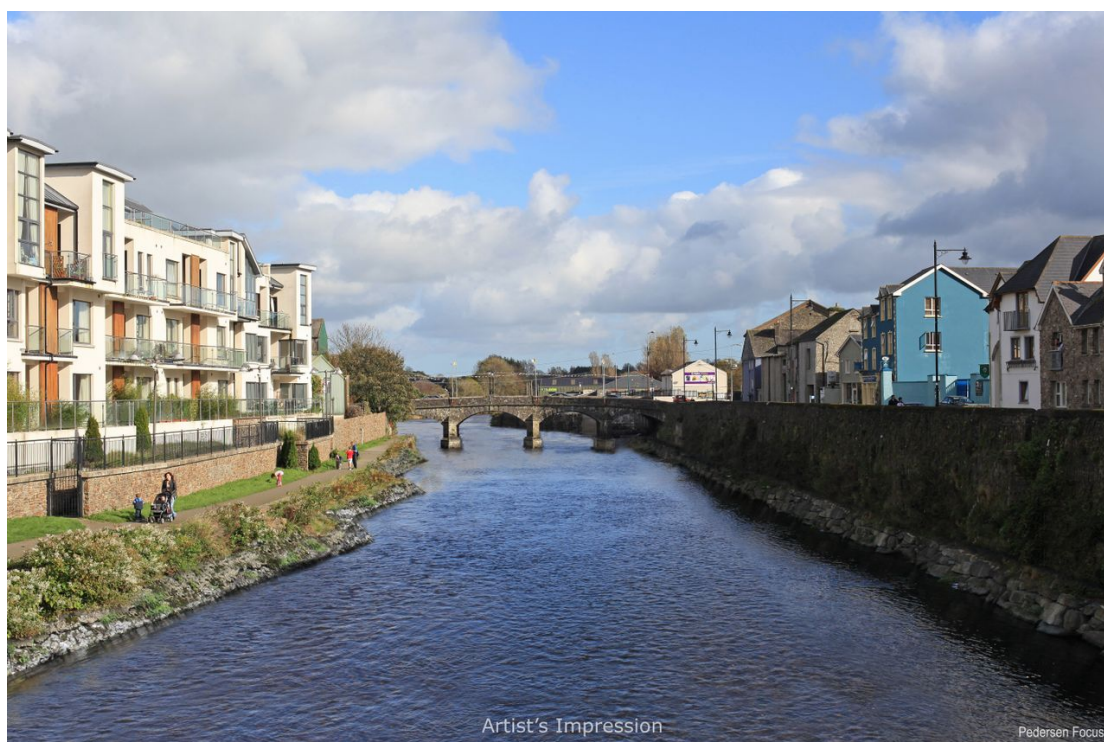
Plate 9.21 Proposed view looking downstream from location 1 at average flow (Pedestrian Bridge)

The proposed view looking downstream from photo-location 1 (Plate 9.21) shows a lower water level due to the deepened river bed resulting from the proposed dredging works. The lowered channel bed level as presented in the photomontage has the effect of exposing rock along both banks and the pier bases of Bandon Bridge.

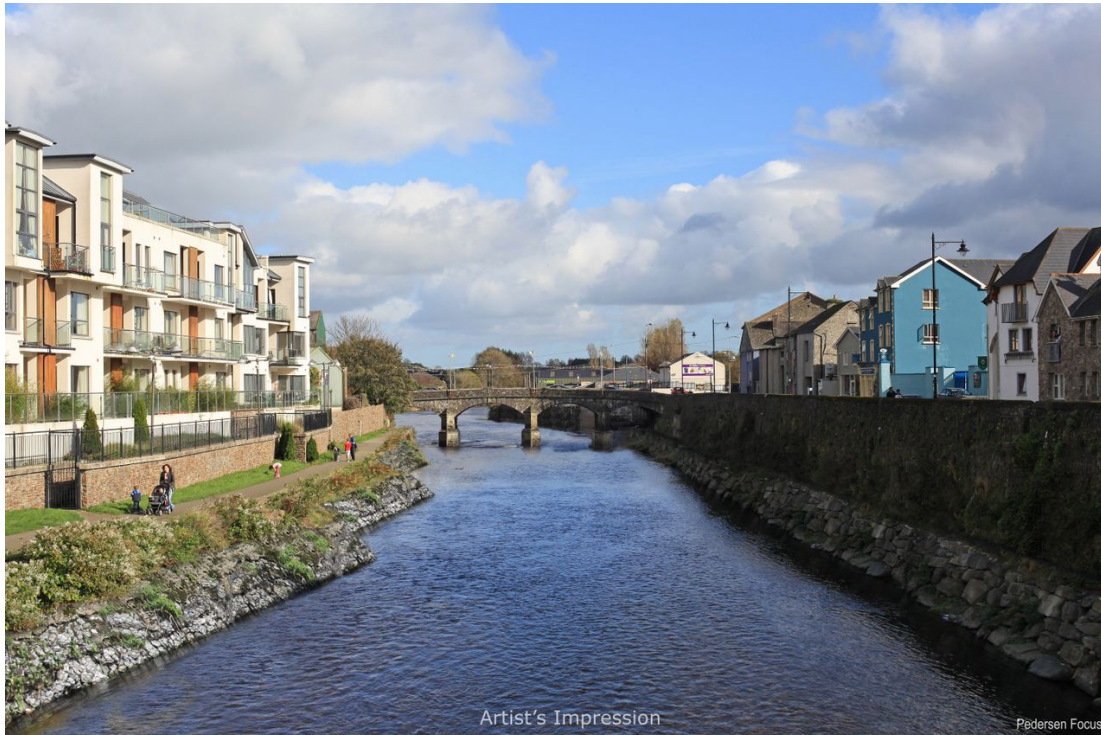
Plate 9.22 Proposed view looking downstream from location 1 at low flow (Pedestrian Bridge)

The proposed low flow view (Plate 9.22) is similar to the proposed average flow view, with the exception of water levels being a metre lower in the latter photomontage.

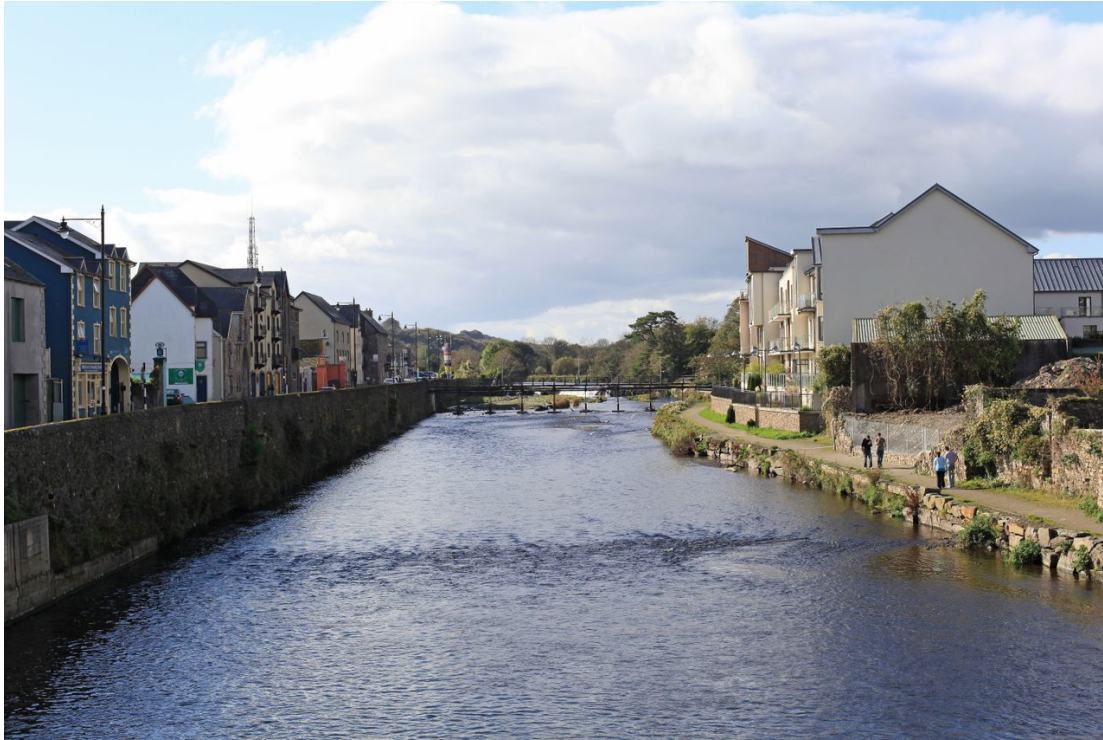
Plate 9.23 Existing view looking upstream from photo-location 2 (Bandon Bridge)

The existing view upstream from Bandon Bridge (Plate 9.23) shows the existing pedestrian bridge in the background at current water levels. Bandon Town centre is visible to the left on the southern river bank and on the northern bank the modern apartments and pedestrian walkway are shown.

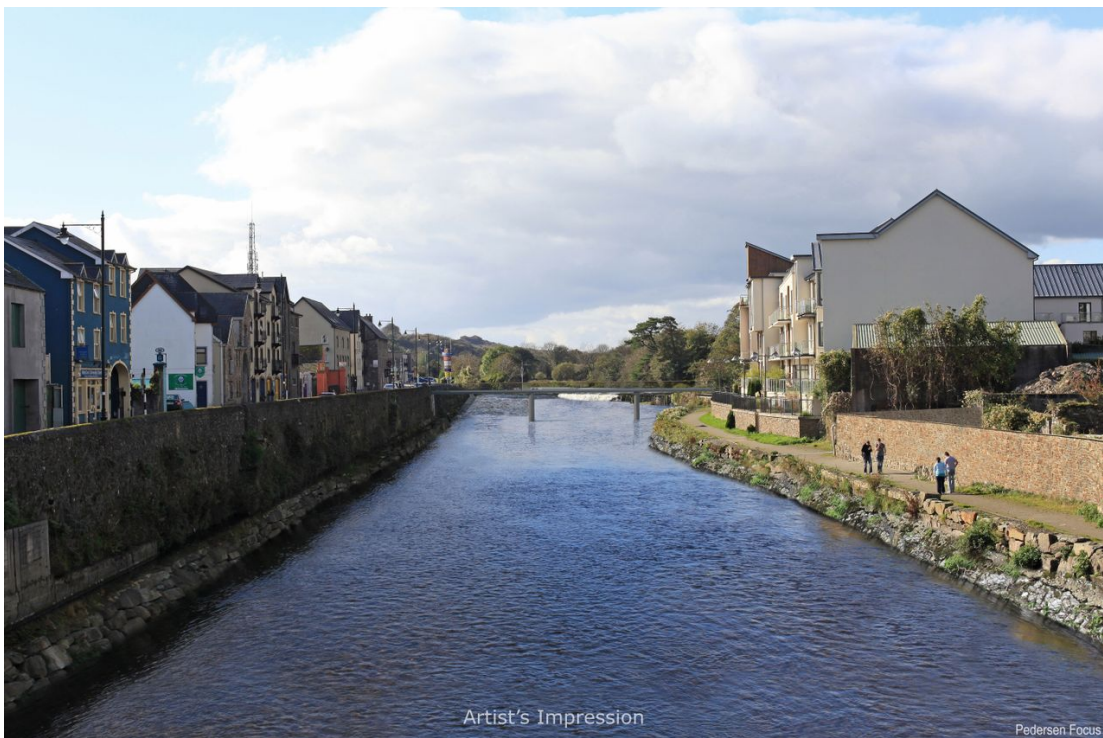
Plate 9.24 Proposed view looking upstream from location 2 at average flow (Bandon Bridge)

The proposed view upstream from photo-location 2 on Bandon Bridge (Plate 9.24) presents a view of the proposed new pedestrian bridge, whose design concept incorporates representations of the natural features of the riparian environment in order to complement its setting. As discussed above, the deepening of the river bed exposes bedrock on both banks.

In order to accommodate the proposed dredging works in the vicinity of the existing pedestrian bridge, this will be removed and replaced by a specially designed new pedestrian bridge. The design concept of the proposed new pedestrian bridge focuses on the natural elements of the Bandon River's riparian setting and references fauna such as Salmon and Herons, which are inextricably linked with the river. The replacement of the existing bridge with a bespoke design will add to the visual amenity of the Bandon River and Bandon Town.

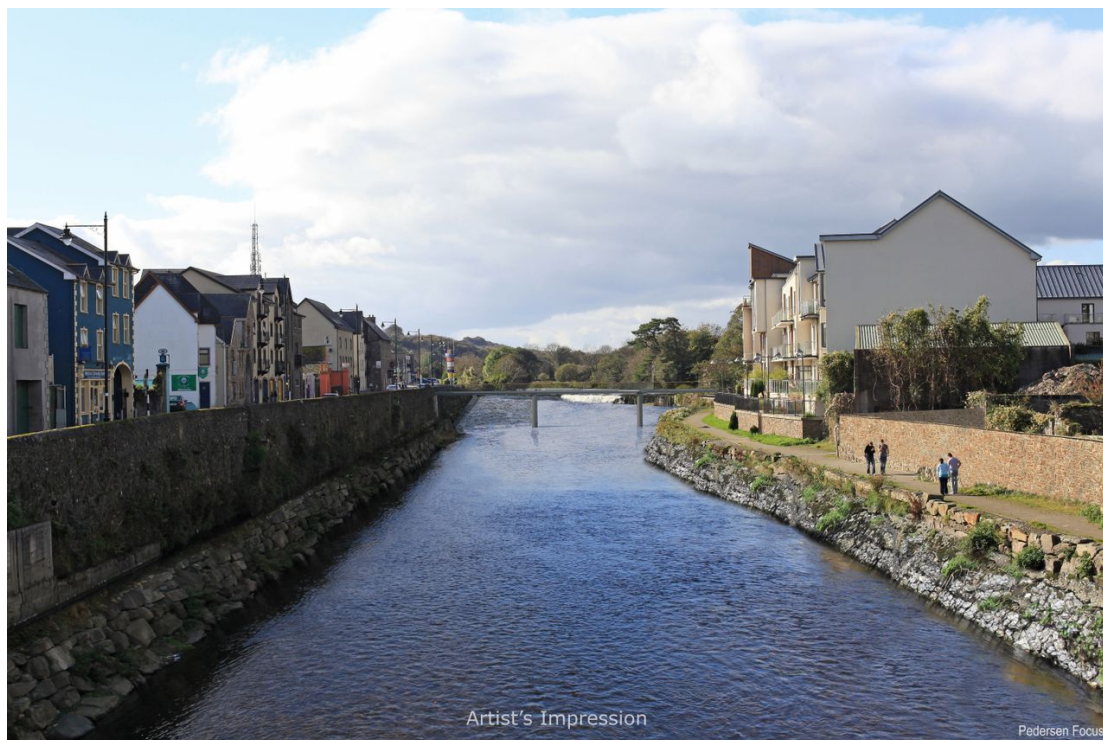
Plate 9.25 Proposed view looking upstream from location 2 at low flow (Bandon Bridge)

The proposed low flow scenario is similar to the proposed view at average, with the exception of water levels being a metre lower in the latter photomontage.

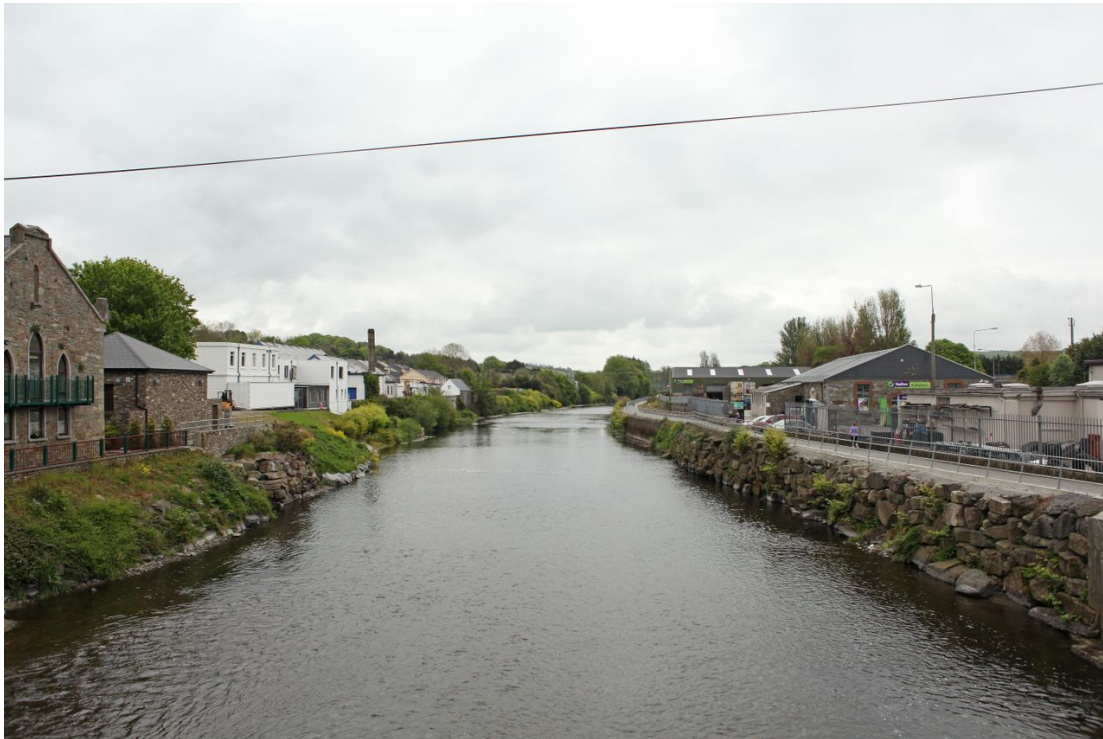
Plate 9.26 Existing View looking downstream from photo-location 2 (Bandon Bridge)

Photo-location 2 is on Bandon Bridge, the sole route across the Bandon River in Bandon Town for vehicular traffic. The existing view looking downstream from this location is presented as Plate 9.26. Both banks are host to various commercial/industrial premises, which back onto the river. The pedestrian walkway is visible on the right hand of the photograph (southern bank). Mature broadleaved trees flank the river further downstream in the background of this photograph.

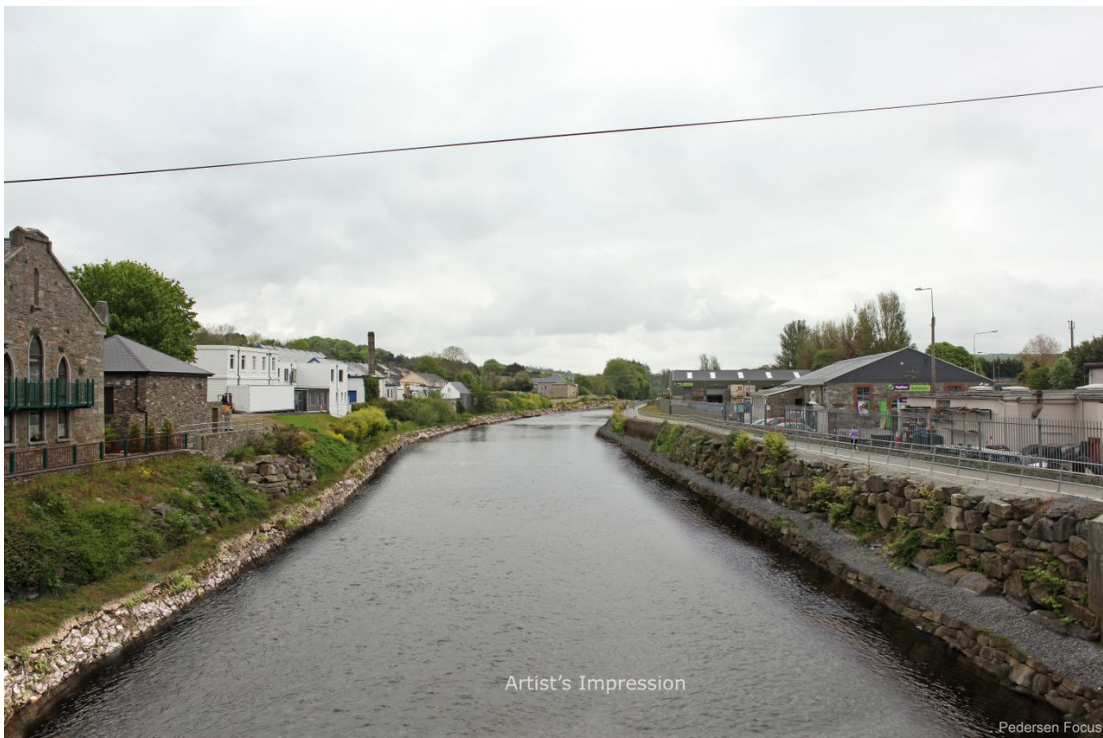
Plate 9.27 Proposed view looking downstream at average flow from photo-location 2 (Bandon Bridge)

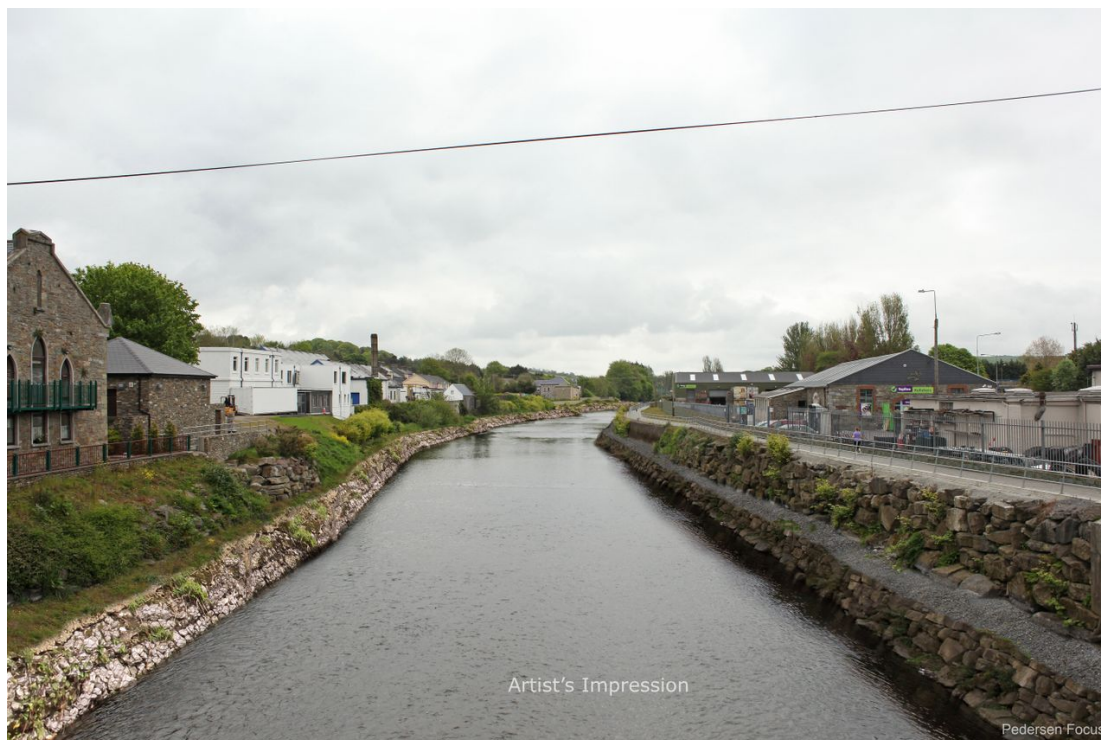
Plate 9.28 Proposed view looking downstream at low flow from photo-location 2 (Bandon Bridge)

The proposed low flow view shows a similar scene to the proposed average flow view, with the exception of water levels being markedly lower in the latter montage.

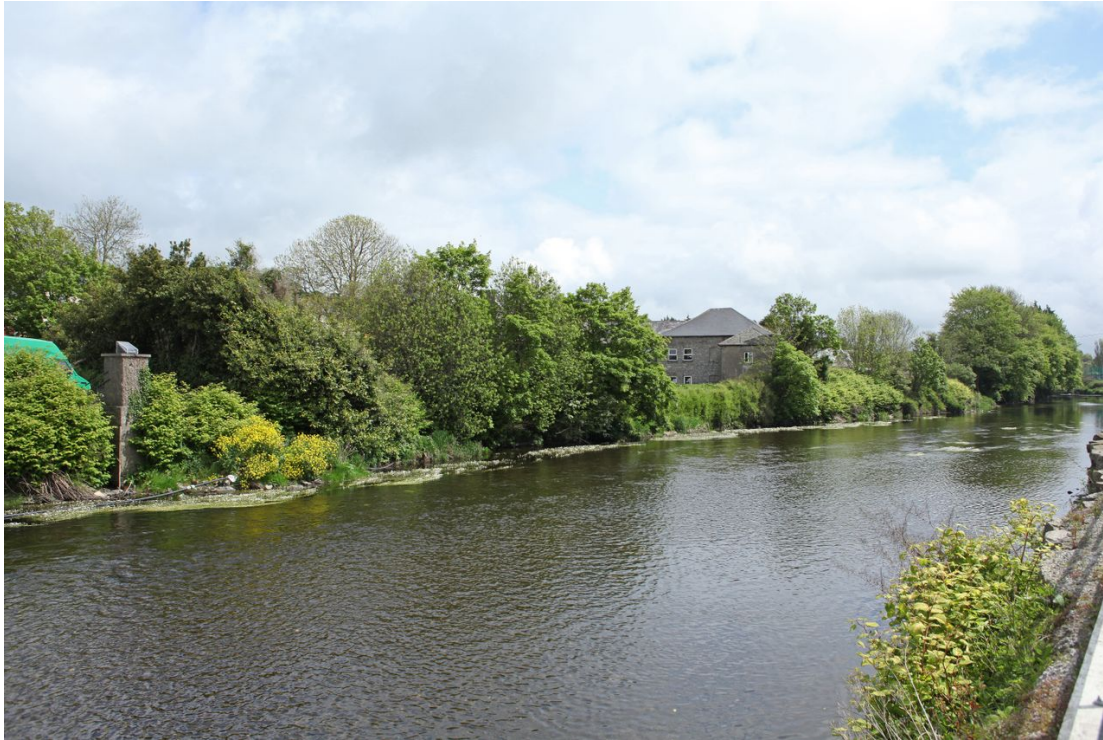
Plate 9.29 Existing view looking downstream from photo-location 3 (d/s of Bandon Bridge on right bank)

Photo-location 3 is on the southern bank of the Bandon River approximately 250 metres downstream of Bandon Bridge on the pedestrian walkway along the river bank. The existing view presented in Plate 9.29 shows the view downstream looking in a north easterly direction. Mature broadleaved trees border the northern river bank on the left hand side of the photograph. A large stone dwelling house is also visible on the northern river bank.

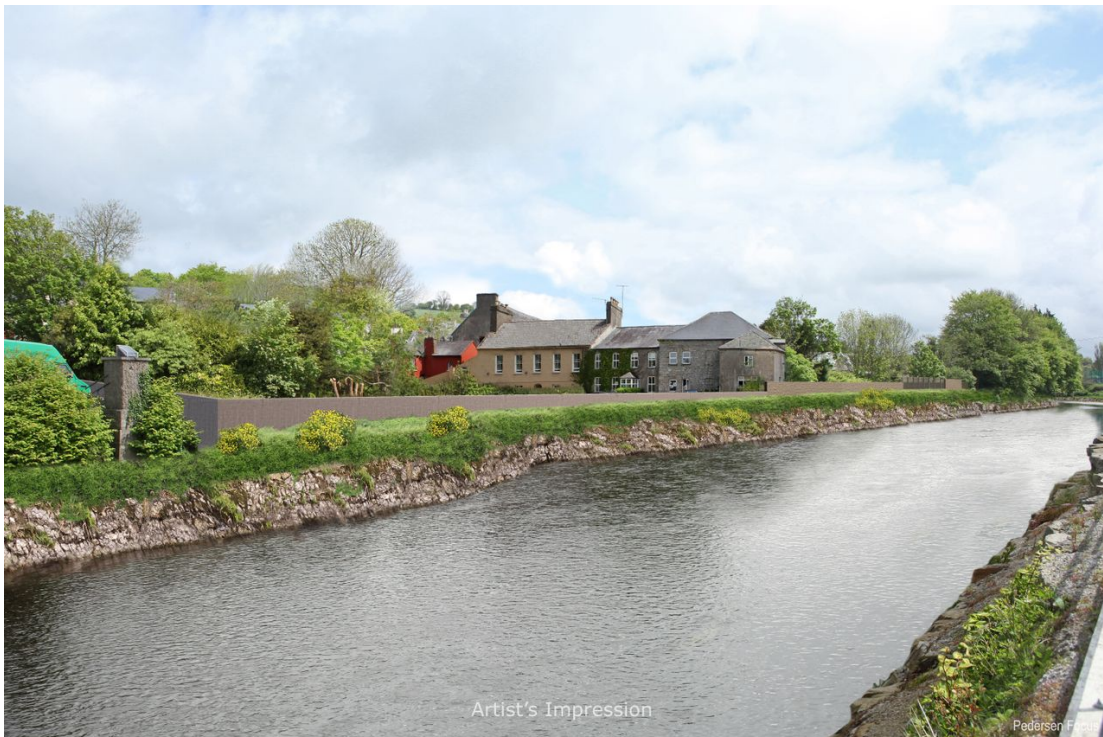
Plate 9.30 Proposed view looking downstream from photo-location 3 at average flow (d/s of Bandon Bridge on right bank)

The proposed view at average flow at photo-location 3 (Plate 9.30) presents a view of the proposed flood defence wall along the northern bank opposite this location. The construction of this flood defence wall will necessitate the removal of mature broadleaved trees along the river bank, which served to screen the residential buildings from view. The lowering of the river bed due to the proposed dredging works will also result in a drop in the river channel and the exposure of bedrock along the river bank.

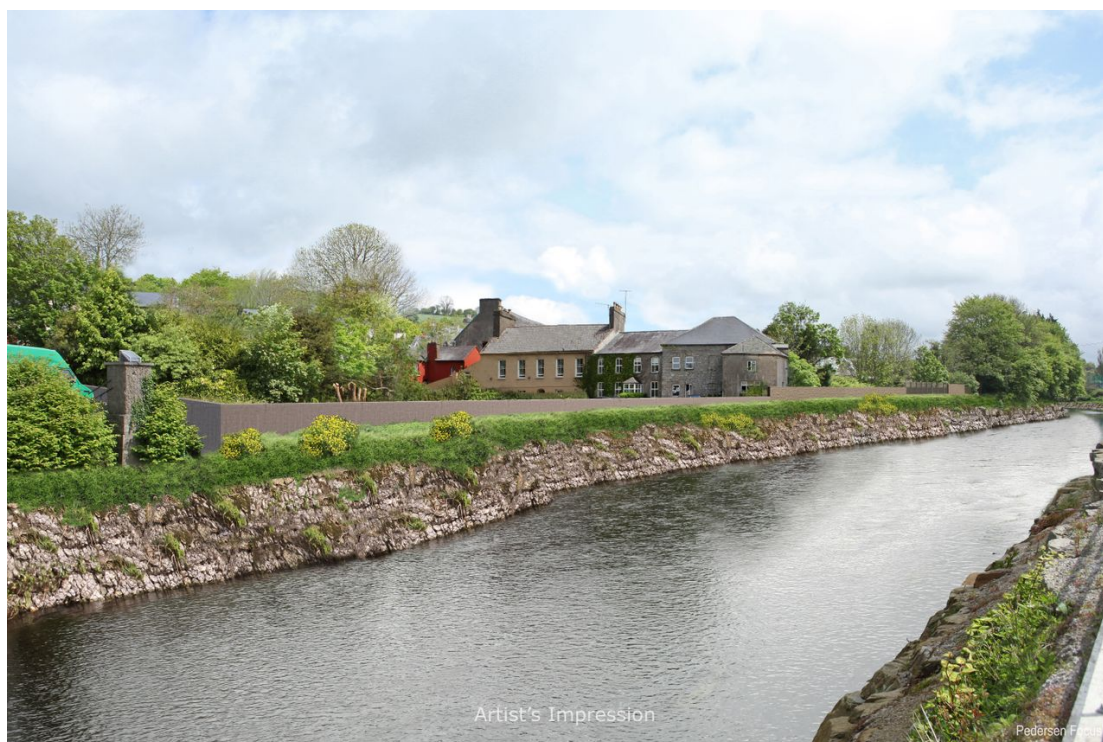
Plate 9.31 Proposed view looking downstream from photo-location 3 at low flow (d/s of Bandon Bridge on right bank)

The proposed view under low flow conditions (Plate 9.31) shows a similar scenario to the proposed average flow view, However water levels are noticeably lower in the latter montage, thus exposing a greater degree of bedrock on the banksides.

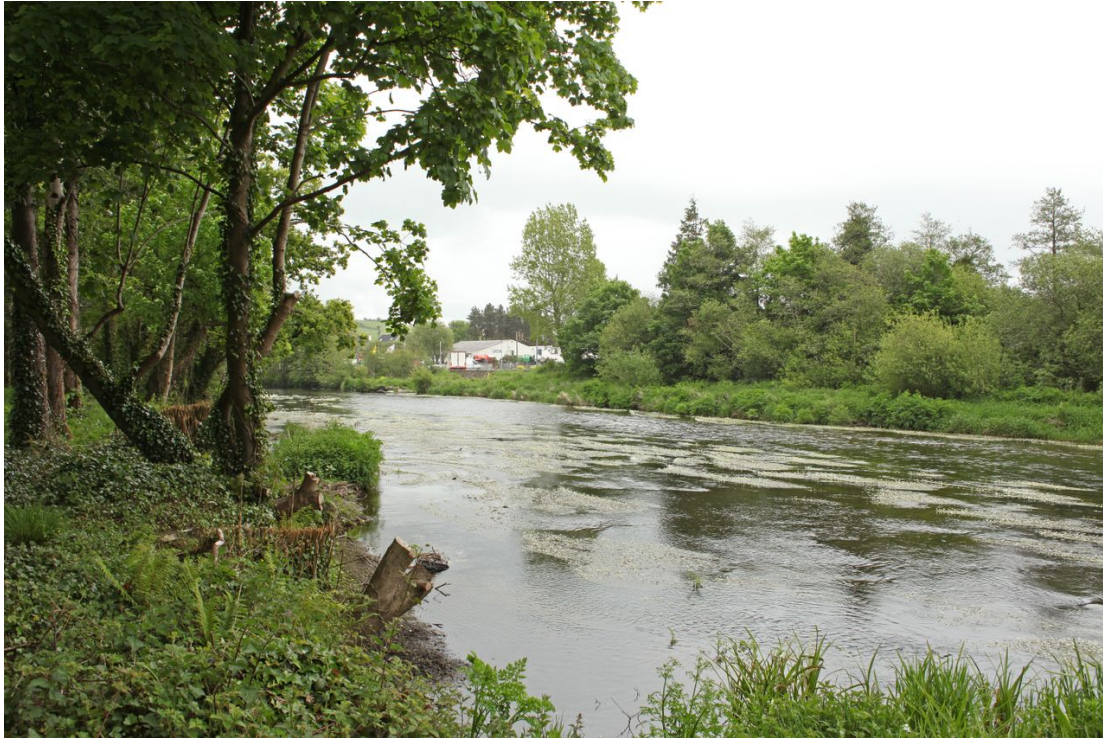
Plate 9.32 Existing view looking downstream from photo-location 4 (left bank at chainage 11700)

Photo-location 4 is approximately 650 metres downstream of photo-location 3 and the photograph presented as Plate 9.32 shows the view from the left bank of the Bandon River looking downstream in a south easterly direction. The river is shown at average flow and the water is almost level with the adjacent bank. Mixed riparian woodland is present on both banks at this location and a commercial/industrial premises is visible on the southern bank.

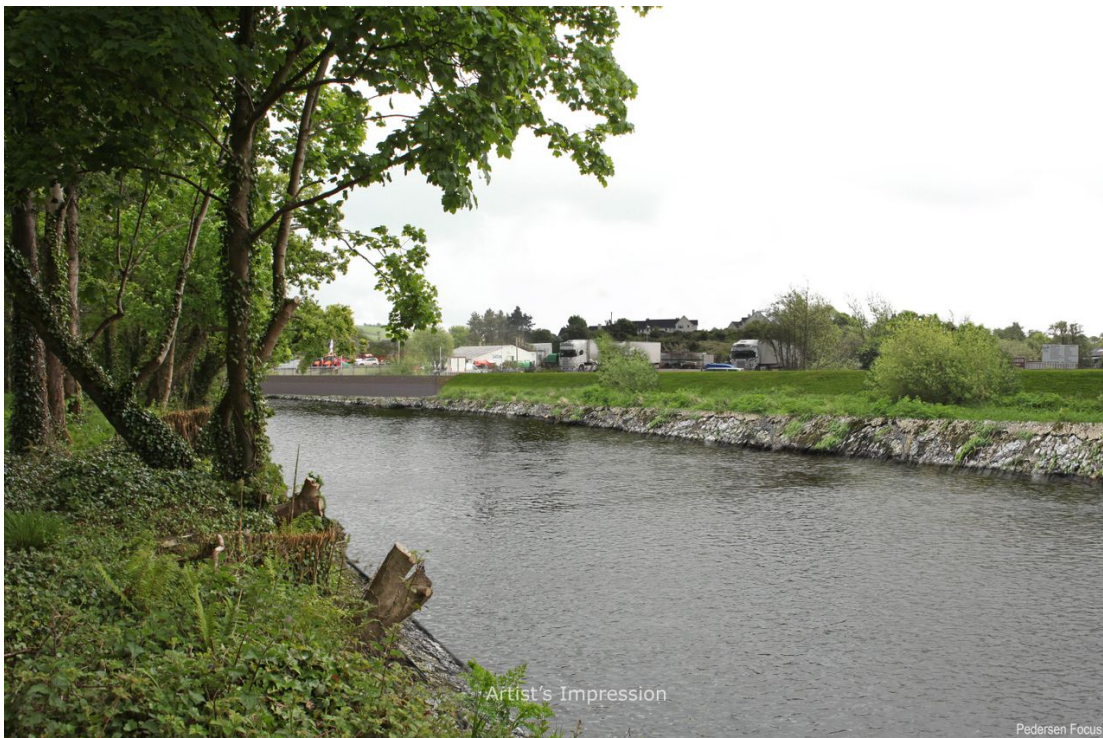
Plate 9.33 Proposed view looking downstream from photo-location 4 at average flow (left bank at chainage 11700)

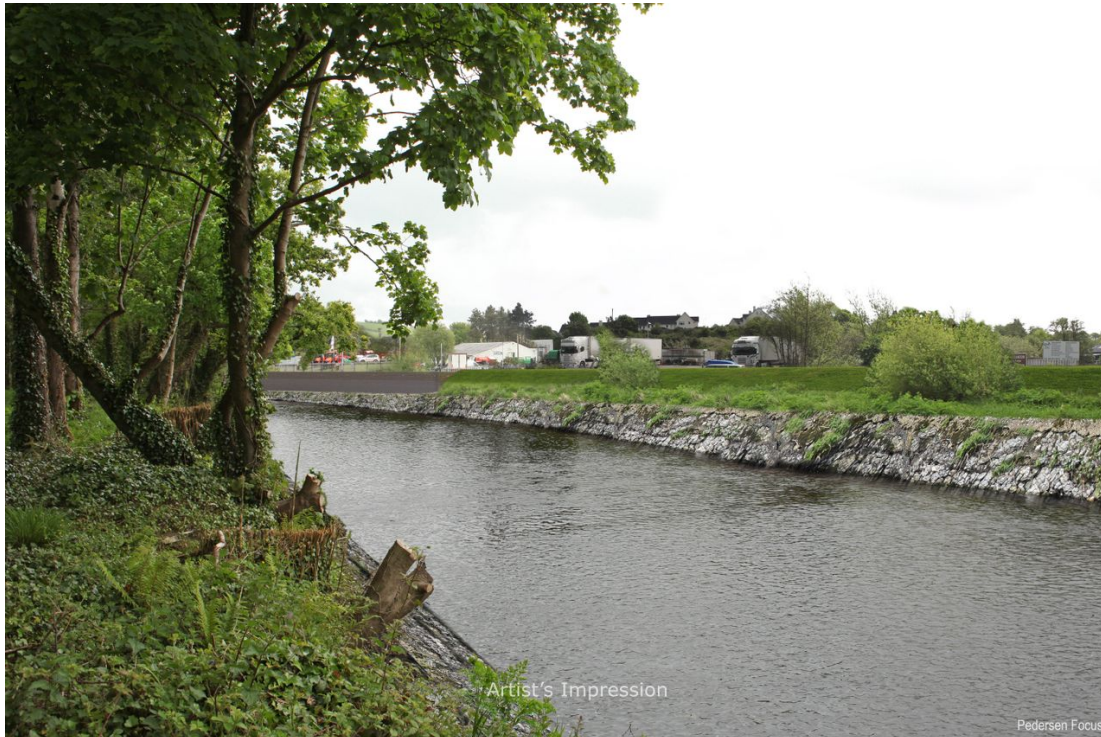
Plate 9.34 Proposed view looking downstream from photo-location 4 at low flow (left bank at chainage 11700)

The proposed view under low flow conditions (Plate 9.34) is similar reflects the same changes as shown in the proposed average flow view. However water levels are noticeably lower in the low flow montage, thus exposing a greater proportion of bedrock on the banksides.
