# **River Fealge (Clonakilty) Drainage Scheme Natura Impact Statement**

**Revision 1**

**January 2017**

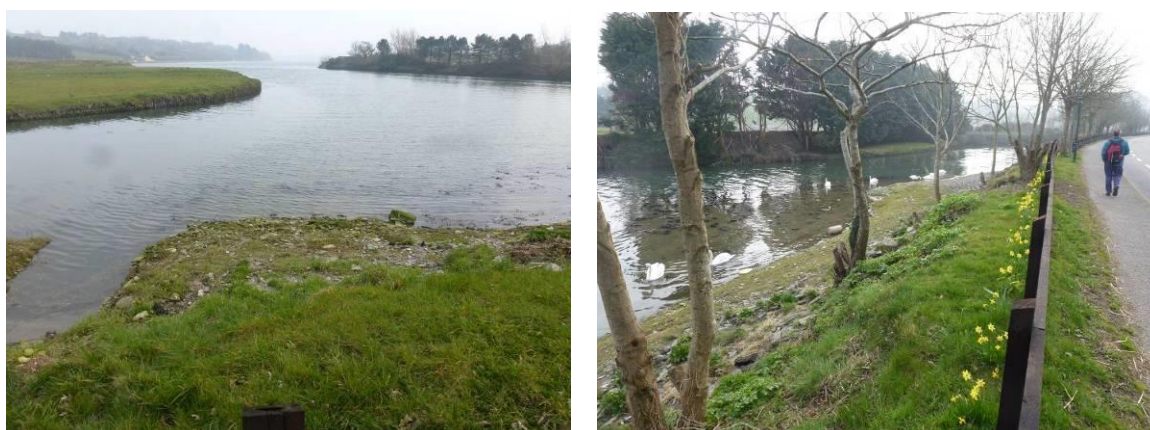
The Croppy Road is situated on an embankment at the head of the estuary and forms the initial defence to the town of Clonakilty. This embankment is also an amenity feature with small ornamental tree planting and park benches (BC4, WS3). The uppermost parts of this embankment are dominated by Perennial Rye-grass *Lolium perenne*, with common ruderal species including Ribwort Plantain *Plantago lanceolata*, Yarrow *Achillea millefolium*, Cock's-foot *Dactylis glomerata* and ornamental planting. Moving down the slope of the embankment the influence of the tidal environment is more evident, with species including Alexanders *Smyrnium olusatrum*, Sea Beet *Beta vulgaris* and Red Fescue *Festuca rubra* present. The species present on the lower embankment are more characteristic of upper salt marsh vegetation (CM2), but it is limited in extent and of poor quality due to the modified nature of the substrate and high levels of disturbance.

Figure 3-3: Estuarine habitats adjacent to The Croppy Road with the change in embankment vegetation shown on the left

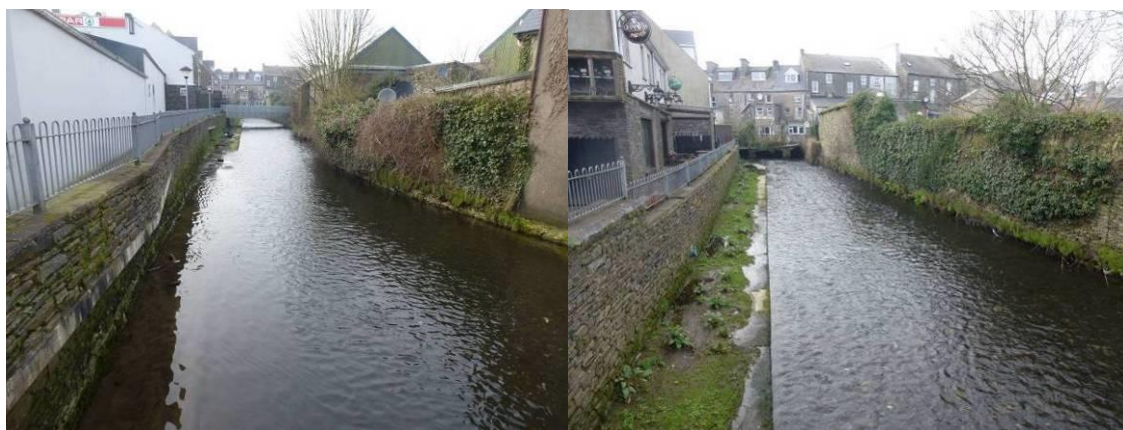
Through the town of Clonakilty, the river becomes wider, but constrained on both banks by walls and development (BL1, BL3). A number of bridges cross the river and some sections run through culverts beneath buildings. In-channel vegetation is very limited in these areas, although the walls alongside the river contain a number of species including Ivy, Polypody *Polypodium vulgare*, Broad-leaved Dock and a number of mosses and liverworts.

Figure 3-4: The River Fealge in the town of Clonakilty at the Casement Street Bridge (left) and the Seymour Street footbridge (right)

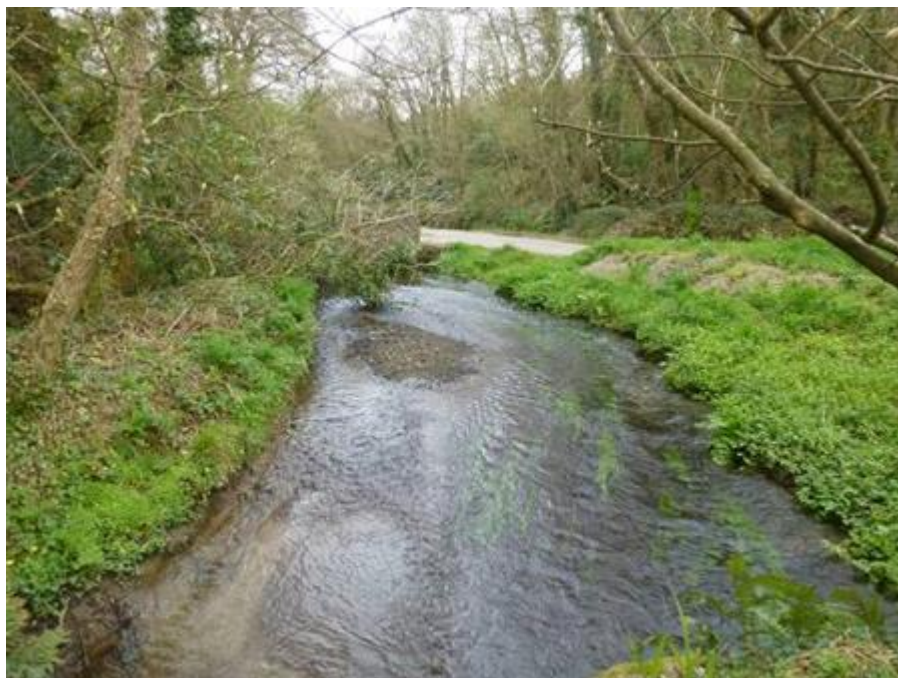
Figure C-1 : Gravel deposition in the upper reaches

The existing morphology throughout the Fealge River system is diverse and the bed of the channel is predominantly gravel based, operating naturally to move coarse sediment. This is supplied largely from glacial deposits being reworked from bank erosion and the bedrock dominated upper reaches which act to supply sediment entering the river in the upper reaches, downstream via a series of temporary in-channel bar stores. The majority of bars within the channel are dynamically stable and are replenished with sediment from upstream whilst also providing a source for transport to downstream reaches during geomorphologically effective flows.

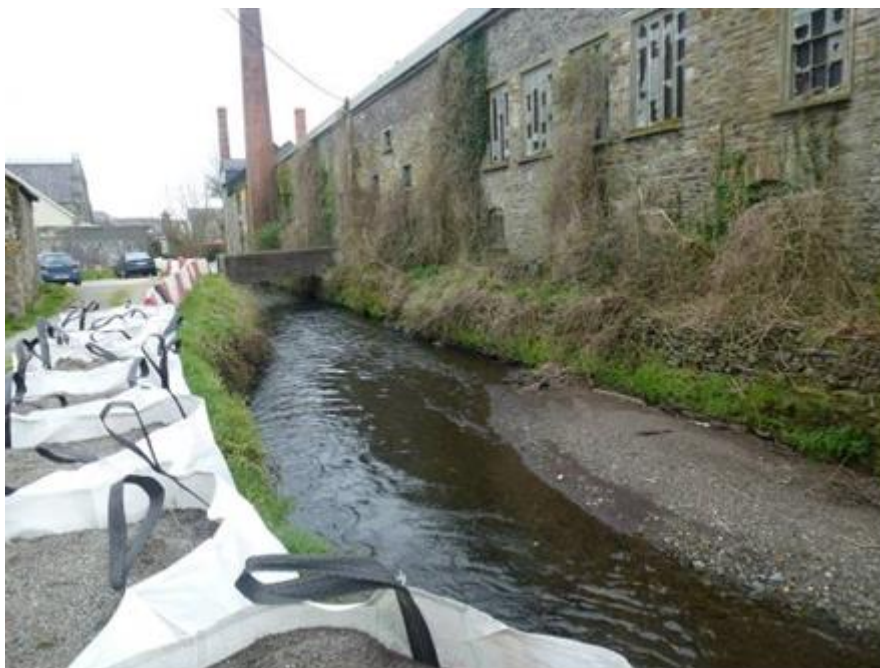
Figure C-2 : Urban Constrictions and temporary flood defences

Several barriers exist to sediment transport (such as bridges and culverts) which are currently managed to prevent flooding. Within the urban areas the channel has been modified historically as the urban area has expanded. This has resulted in a loss of floodplain and a confined channel as a result of bankside development and flood embankment construction (Figure C-2). Under natural conditions, a river would flood its floodplain frequently, often for events in exceedance of the 1 in 2yr event. The river would also be able to erode laterally during geomorphologically effective flows (again, at a 1 in 2yr event or higher), this is currently prevented due to the significant bank protection works along the channel to protect nearby and bankside infrastructure. Therefore, the river is modified significantly when compared to likely natural processes associated to this river type.

Evidence of gravel deposition within these confined sections was strong. This suggests higher flow events through these areas are low energy which gives way for deposition. High energy events have the ability to deliver coarse gravel from upstream areas. As the flood event recedes sediment carried in suspension is deposited on to dynamically stable features (i.e. by replacing sediment already transported away). The maintenance of a coarse gravel bed suggests that there is sufficient energy within the system to prevent fine sediment deposition.
